Ducks Unlimited Canada FWCP Columbia Region Partnership

COL-F21-W-3268

Ducks Unlimited Canada East Kootenay Conservation Areas: Baseline
Wildlife Surveys and Assessment of Project Effects for Mayook Marsh
and Moberly Marsh

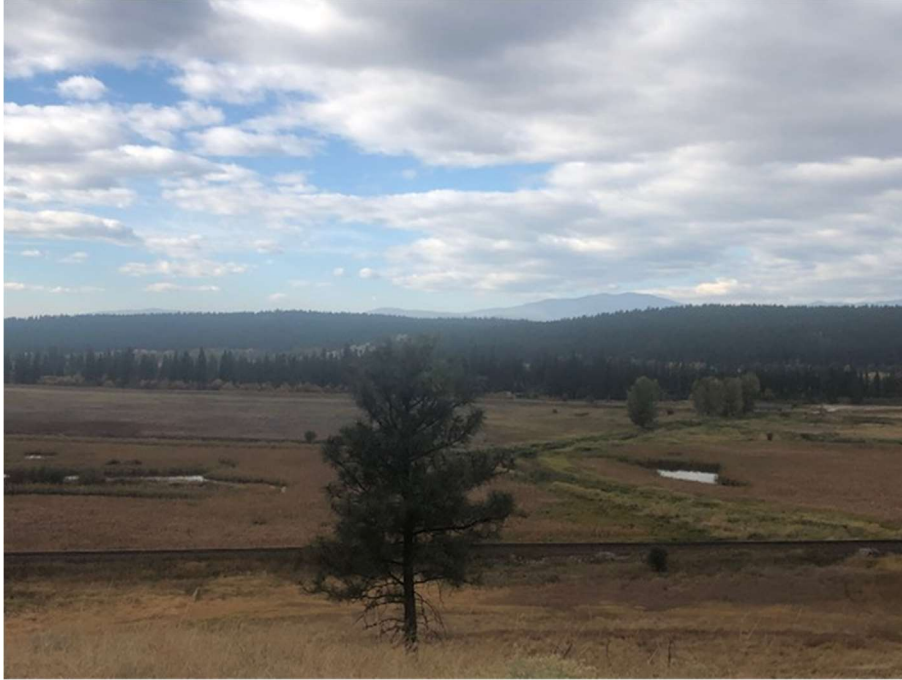
Figure 3: South Bummars Marsh. Looking west from highway 95

South Bummers Marsh is approximately 5km north of Fort Steele along highway 95. This is a 120ha diked marsh on Provincial Crown land in the Kootenay river floodplain. DUC constructed dikes in hopes of stabilizing water levels which fluctuate with freshet during waterfowl nesting season. However, substrate was too coarse to hold enough water outside of freshet, and the marsh is now dominated by dense stands of *Typha latifolia* and other emergent species (Figure 1). While this project has low value for waterfowl, other species (e.g. fish, amphibians) would likely benefit from building perched breaches to allow some influence from the Kootenay river without entirely losing the marsh habitat.

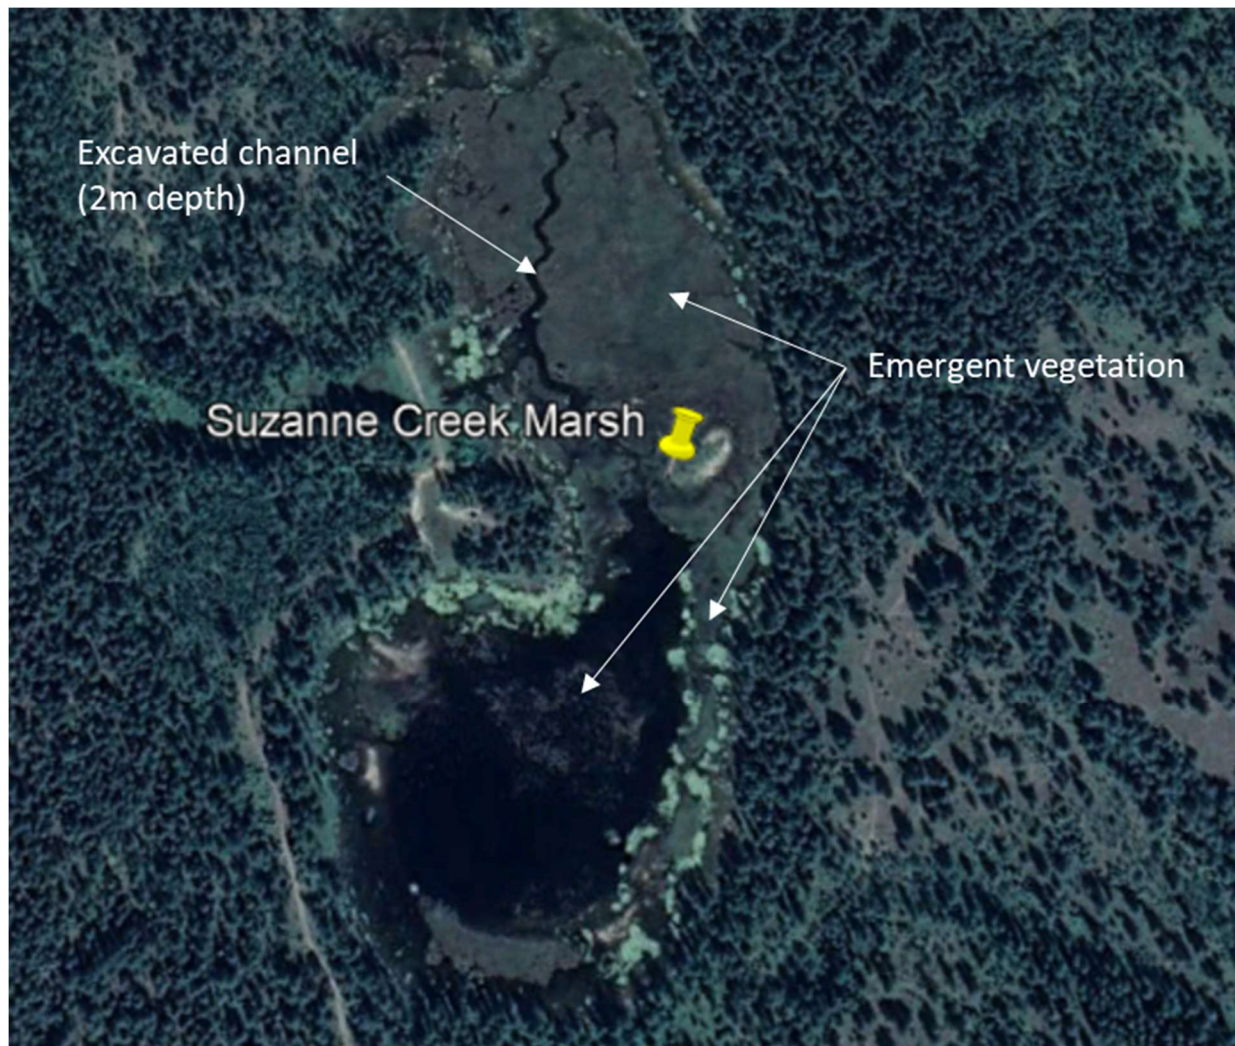
Figure 5: Aerial imagery of Suzanne Creek Marsh showing the emergent vegetation cover

Suzanne Creek marsh is located 10 km southeast of Jaffray. This is a shallow 11 ha marsh with approximately 75% emergent vegetation cover (Figure 3), of which the vast majority is *Typha latifolia*, though some Thule is present near the water control structure (Figure 4). Beaver activity is apparent at this wetland; the control structure was clogged with debris at the time of our visit (Figure 4) and we saw a large beaver lodge in the southern half of the marsh. We observed Columbia spotted frogs at this site (Figure 5). How much of the cattail cover is rooted in the bottom of the marsh versus floating cattail mat is uncertain. This uncertainty, the presence of amphibians, and the possibility of improving hydrology and habitat function on site (i.e. increasing flow through the system by re-designing the water control) make this a priority for more detailed studies in the 2021 field season.

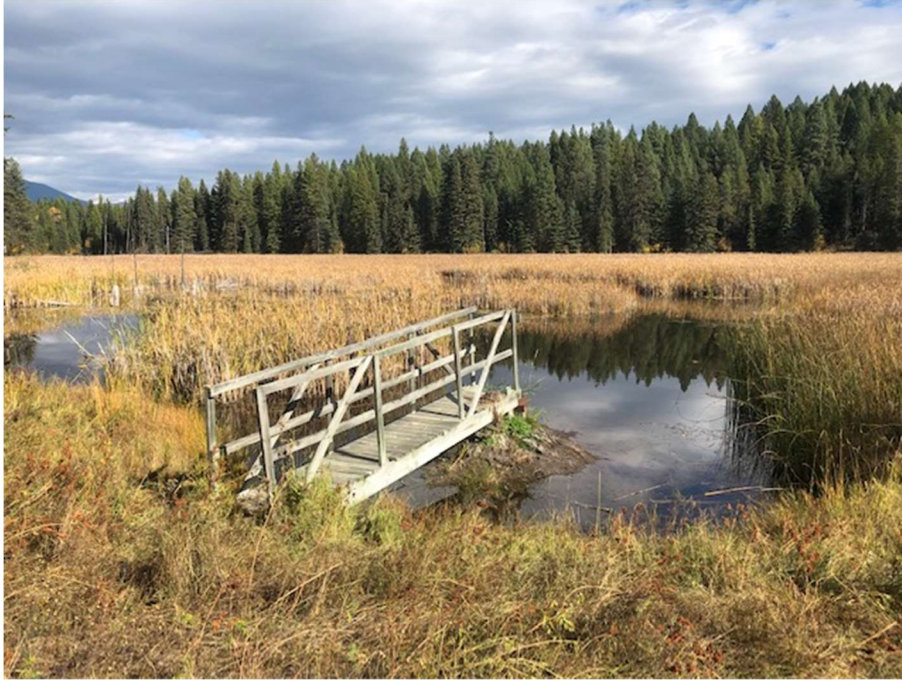
*Figure 6: Water control structure (clogged with beaver debris) and emergent vegetation at Suzanne Creek Marsh; most emergent vegetation is *Typha latifolia*; a stand of *Thule* is visible looker's right of the control structure*

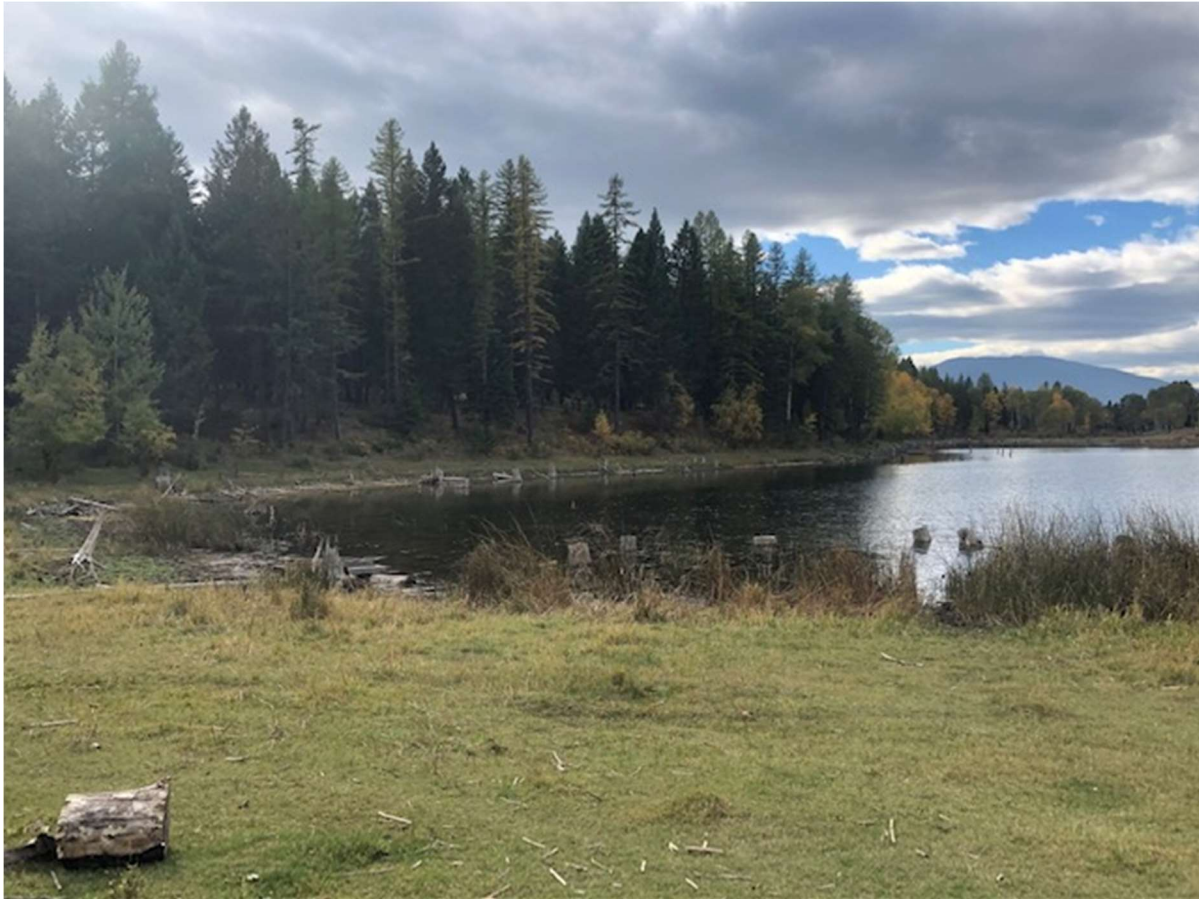
Figure 8: Pickering Lake facing north from the southern edge

This system is on marl substrate, likely driving the relatively low emergent cover (<10%) which restricted to shallow lake margins. Uplands include grazing range land to the south and east and coniferous forest to the west (Figure 6). We did not observe any waterfowl, other water birds, or amphibians on site, however we did see two turtles basking on an emergent stump (Figure 7). We were not able to see the plastron from shore and cannot confirm whether these were western painted turtles (Rocky Mountain population). This observation makes this a candidate site for more detailed wildlife surveys in the 2021 field season.

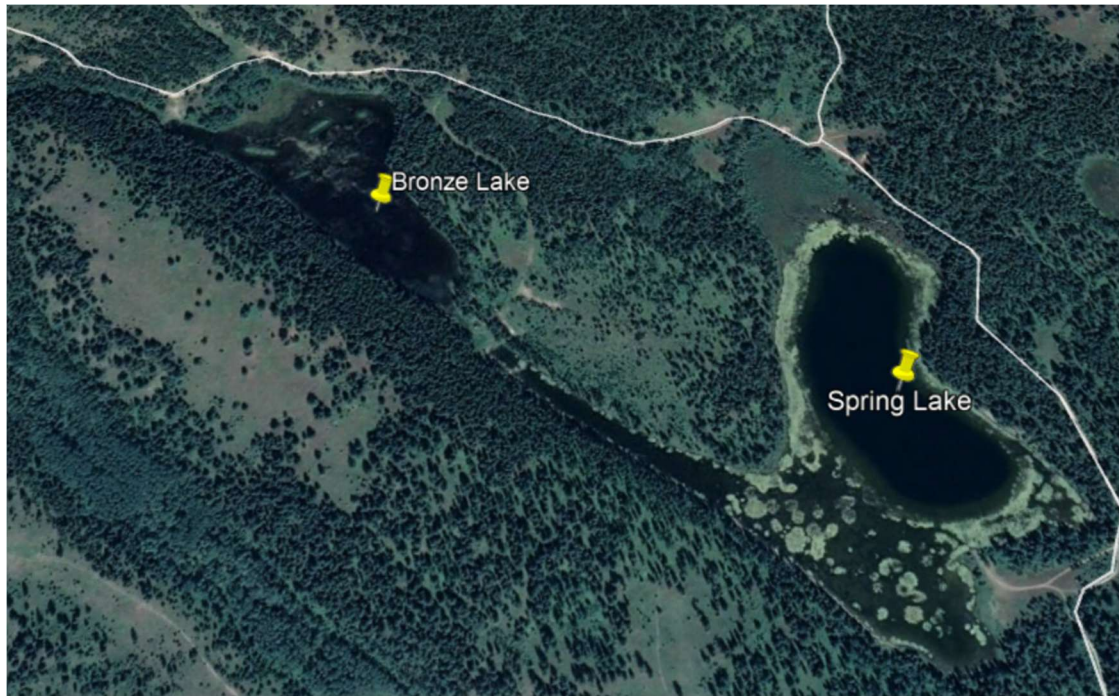
Figure 10: Aerial imagery showing Spring and Bronze Lakes

Spring and Bronze Lakes are located approximately 6 km north of Jaffray. These two shallow lakes, which total 14 ha in area, are connected by a channel running northwest from Spring to Bronze Lakes (Figure 8). The lakes are within mixed forest and range land, with approximately 30% emergent vegetation cover. We observed a group of five Trumpeter swans on Spring Lake during our site visit (Figure 9). This site would likely benefit from fencing to exclude cattle from portions of the wetland so that vegetation can recover. We would like to pursue more detailed wildlife surveys at this site in 2021 to better characterize the benefits of such a fencing project.

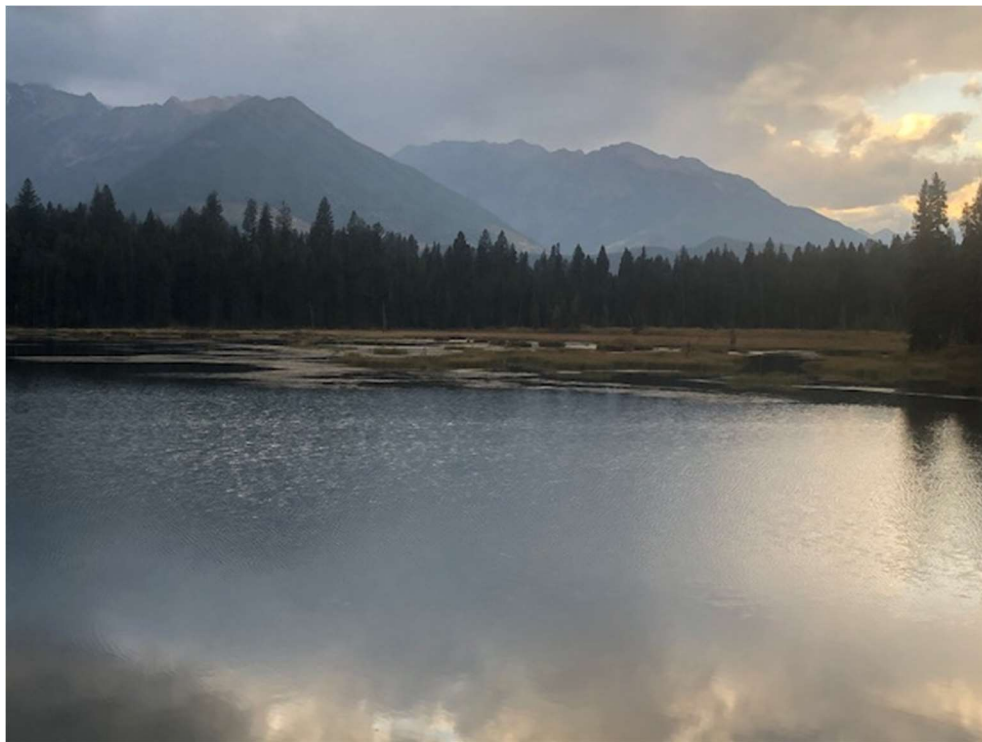
Figure 12: Dunbar Creek wetland; emergent cover visible at the far end of the wetland

Dunbar Creek is located along the Westside 43 Forest Service road, 7 km southwest of the town of Brisco (as the crow flies). DUC staff visited this site on October 4, 2020. Dunbar Creek wetland is 28 ha shallow open water lake with approximately 20% emergent vegetation cover (Figure 10). The wetland is controlled with a small weir, which is in good condition. Upland habitat is primarily coniferous, with few snags. Downstream of the weir, Dunbar Creek meanders through shrubby floodplain habitat (Figure 11). No amphibians or waterfowl were observed during the field visit.

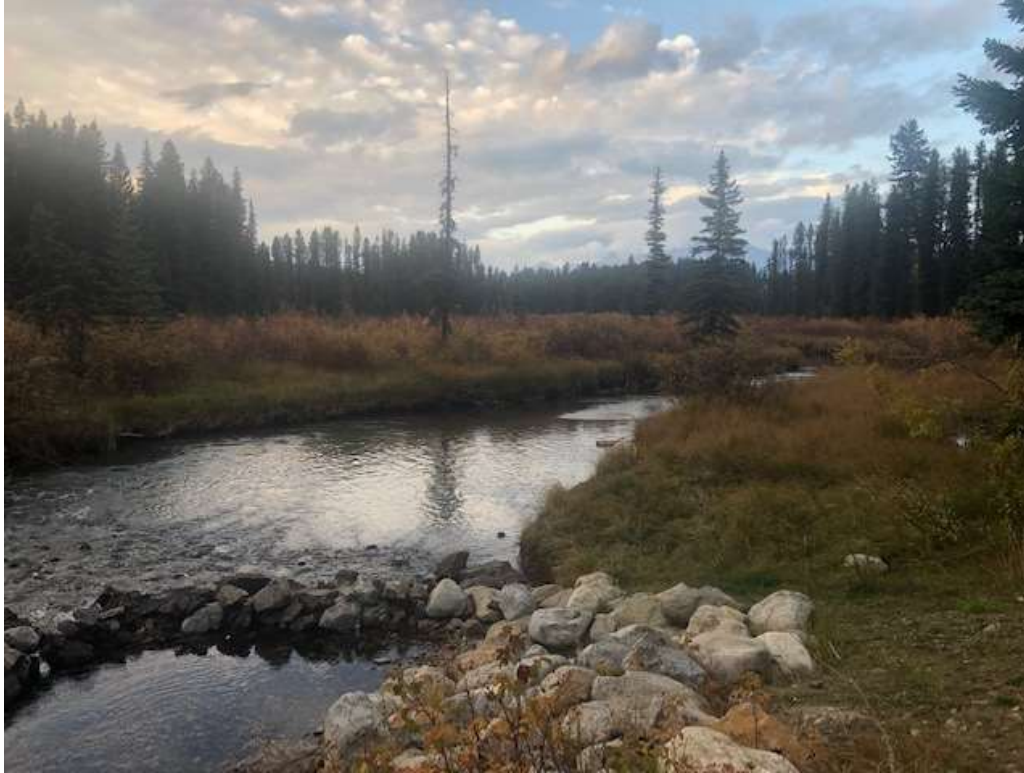
Figure 13: Dunbar Creek downstream of weir

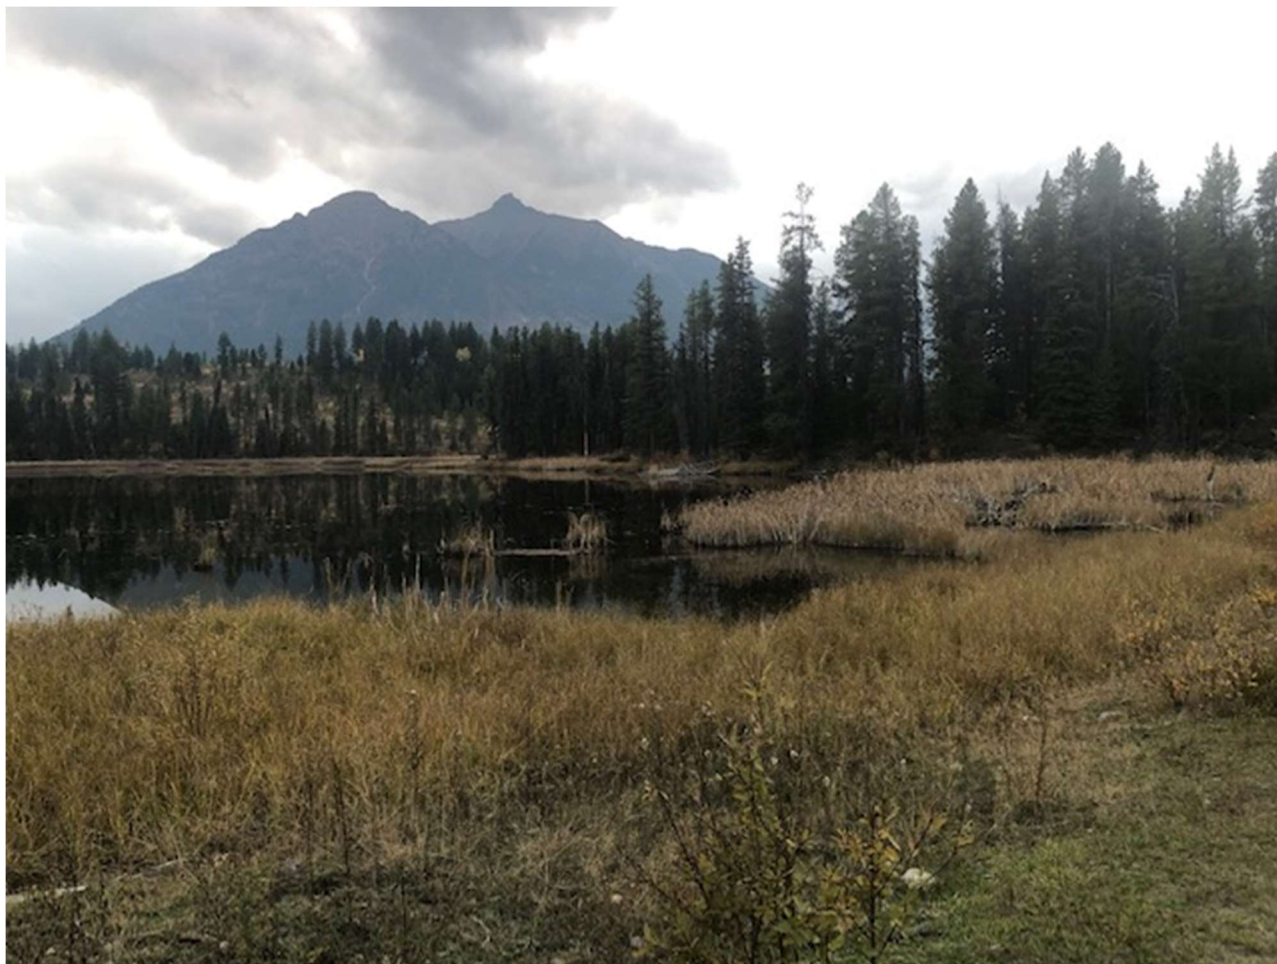
Figure 14: Westside 43 wetland, facing west from the east edge

The Westside 43 wetland is located approximately 2 km south of Dunbar Creek. Uplands surrounding the east side of this wetland have been logged within the last 10 years; upland areas are dominated by conifer saplings and deciduous shrubs including young alder and cottonwood. Uplands on the western edges are dominated by conifer forest. Emergent vegetation cover is approximately 60%, consisting of a mix of *Typha spp.*, *Carex spp.*, and *Juncus spp.* (Figure 12). Beaver activity is evident at the water control structure; however the control has not been compromised by this activity, and the structure is low risk. Given these characteristics, this project is a relatively low priority for rebuild over the next five years.

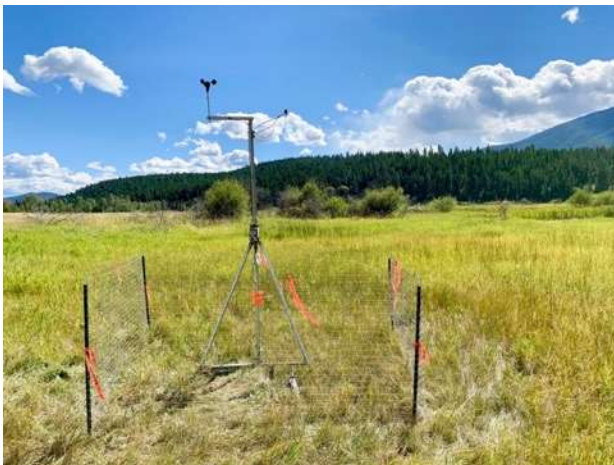
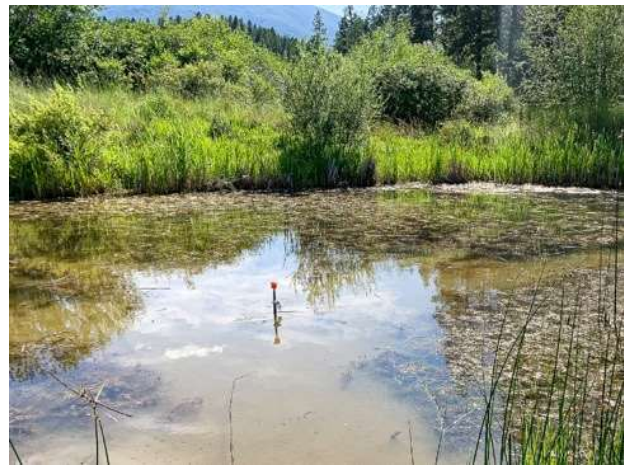
Figure 3-3. Weather station (left) and water level logger assemble (right) installed in Mayook Marsh near the water control.

An Onset™ level logger was deployed in Mayook Marsh on July 23rd, 2020 to record water depth and water temperature. The logger was programmed to collect data hourly and fastened to a 5/8" rebar near the water control. As ambient barometric pressure has a discernible influence on level logger measurement, an Onset weather station was installed to collect barometric pressure. The weather station also collects wind speed, air temperature, and photosynthetic active radiation (PAR). A 4 ft fence was installed around the weather station in September for protection from cattle. Data from the level logger will be collected and reported out following the 2021 field season.

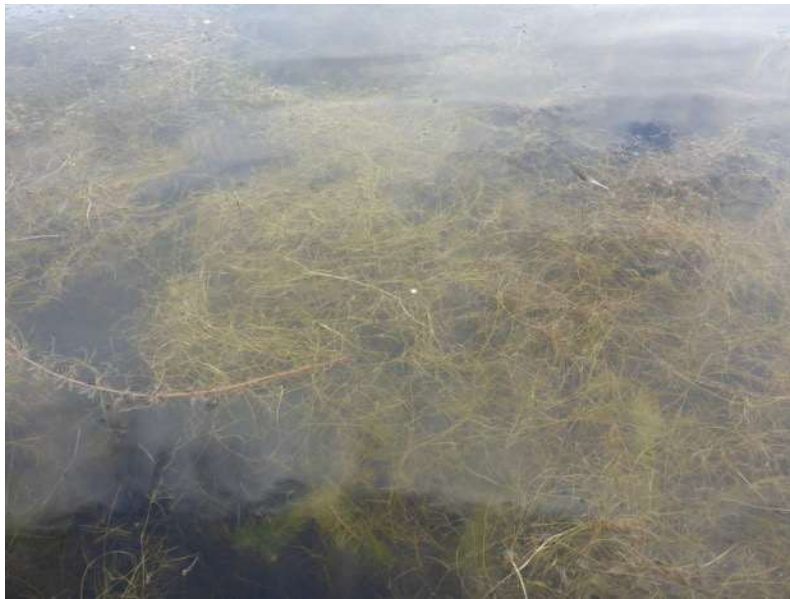
Figure 3-5. Dense coverage of *Potamogeton pusillus*, *Ranunculus aquatilis* and *Myriophyllum verticillatum* in the shallow open-water areas of Mayook Marsh.

Shallow-water wetlands comprised a third (36%; 10.6 ha) of Mayook Marsh (Table 3-3 and Figure 3-4). These wetlands include water bodies two meters or less and have less than 10% emergent cover (McKenzie and Moran 2004). The average depth of the shallow-water wetlands was 124.5 cm. Much of the open-water areas were dominated by a few prominent species (Figure 3-5), including submergent (e.g., *Chara vulgaris*, *Myriophyllum verticillatum*, *Potamogeton pusillus*, and *Ranunculus aquatilis*), and floating (e.g., *Potamogeton natans*, and *Persicaria amphibia*) macrophytes. In shallower areas, open water gave way to stands of Bulrush, Cattail Marsh, or Reed Canarygrass (*Phalaris arundinacea*). A species list is provided in the Appendix: Table 6-2.

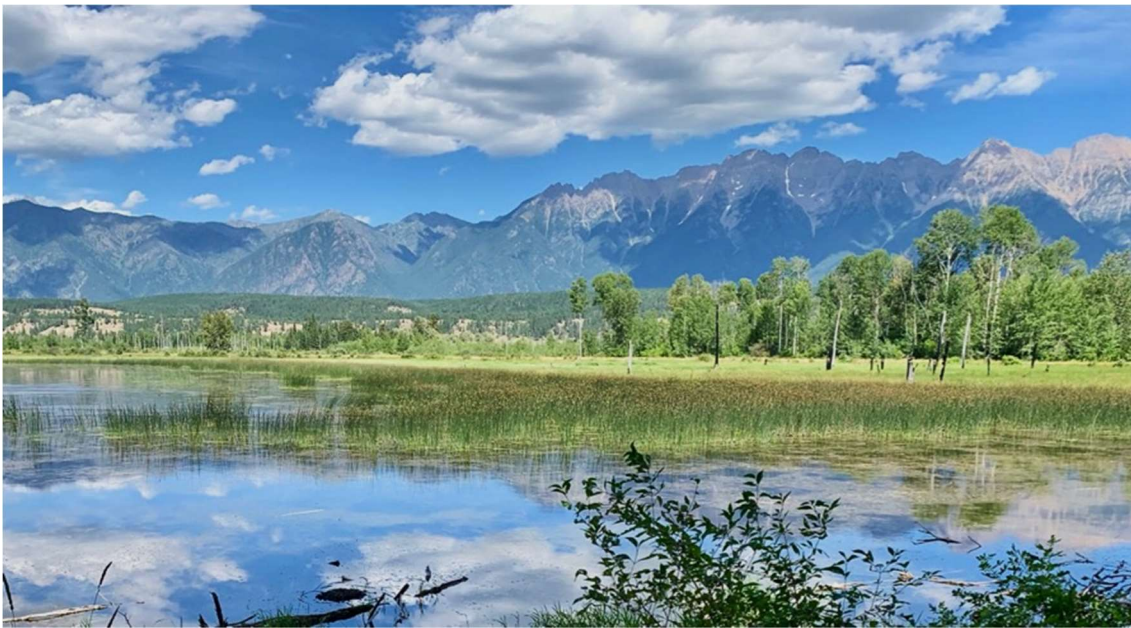
Figure 3-7. A Bulrush (*Schoenoplectus tabernaemontani*) stand at the southeast corner of Mayook Marsh.

Marsh habitat was a major component of the Mayook Marsh wetland complex, occupying 28 % (8.4 ha) of the compartment (Table 3-3 and Figure 3-4). This habitat included stands of Cattail (*Typha latifolia*) and Bulrush (*Schoenoplectus tabernaemontani*), often intergrading with Reed Canarygrass (*Phalaris arundinacea*) (Figure 3-6). The Cattail marsh communities correspond with the provincially blue listed wetland site association WM05: Cattail marsh and the Bulrush community correspond with the WM06: Great Bulrush site association (Makenzie and Moran 1004). Cattail stands mainly occurred in the western portion of the wetland complex. Bulrush occurred in several large stands in the central and eastern portions of the marsh and intermittently throughout with cattail along the edge of smaller openings (Figure 3-7).

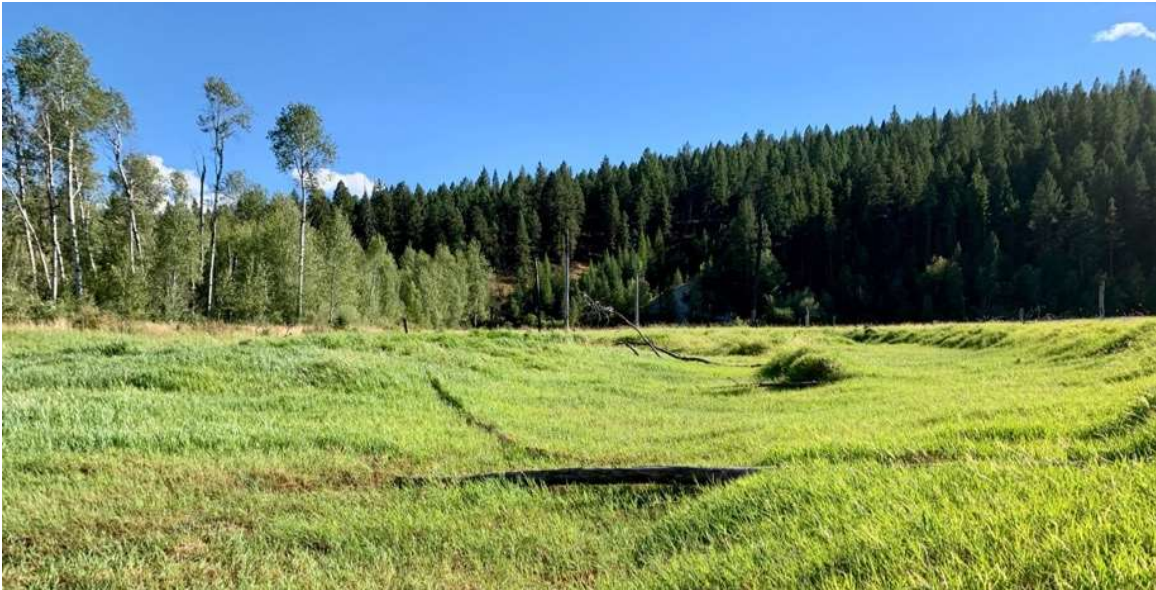
Figure 3-8. A dense stand of Reed canarygrass along the eastern edge of Mayook Marsh, Sept 1, 2020. An Aspen stand occurs between Mayook Marsh dike, and the Kootenay River can be seen on the left side of the image.

Reed Canarygrass (*Phalaris arundinacea*) occupied the entire north and eastern margins of Mayook Marsh, accounting for almost one-quarter of the total area (24.5 ha; Figure 3-4). Species richness was very low, consisting of little else other than *P. arundinacea* (Figure 3-8). Species richness increased along

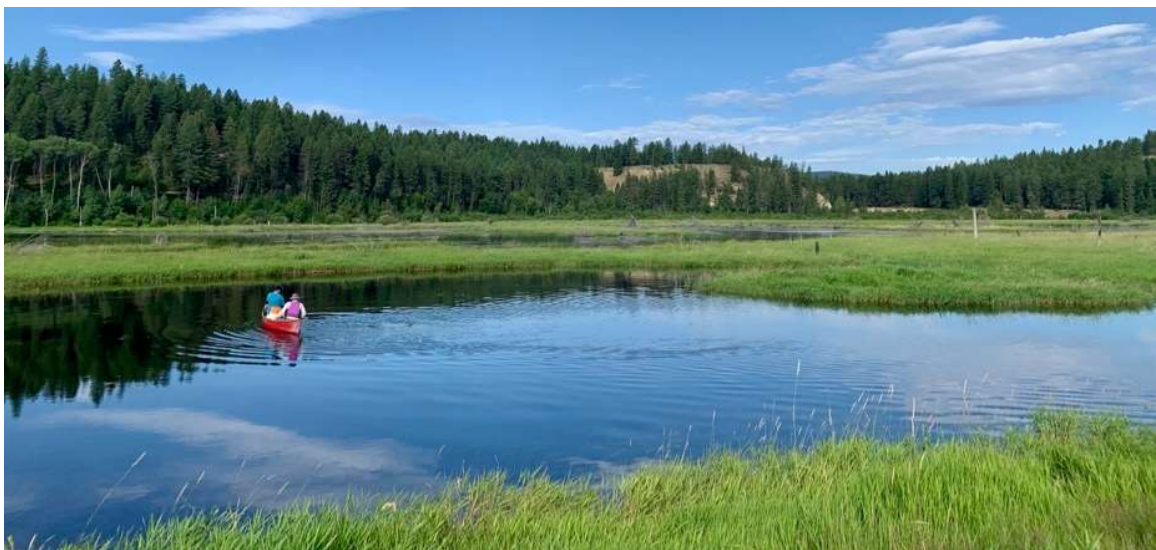
Figure 3-9. Reed Canarygrass was pervasive throughout Mayook Marsh, July 23, 2020.

Reed Canarygrass extended out into shallow open waters displacing Cattail and Bulrush marsh communities (Figure 3-9). From ground surveys, habitat photos, satellite imagery, we estimate that at least 40% of the marsh habitat was comprised of Reed Canarygrass. Along the northeast dike, Reed Canarygrass stands were inundated in late-July. In September, lush new shoots and foliage provided excellent forage for cattle (Figure 3-10).

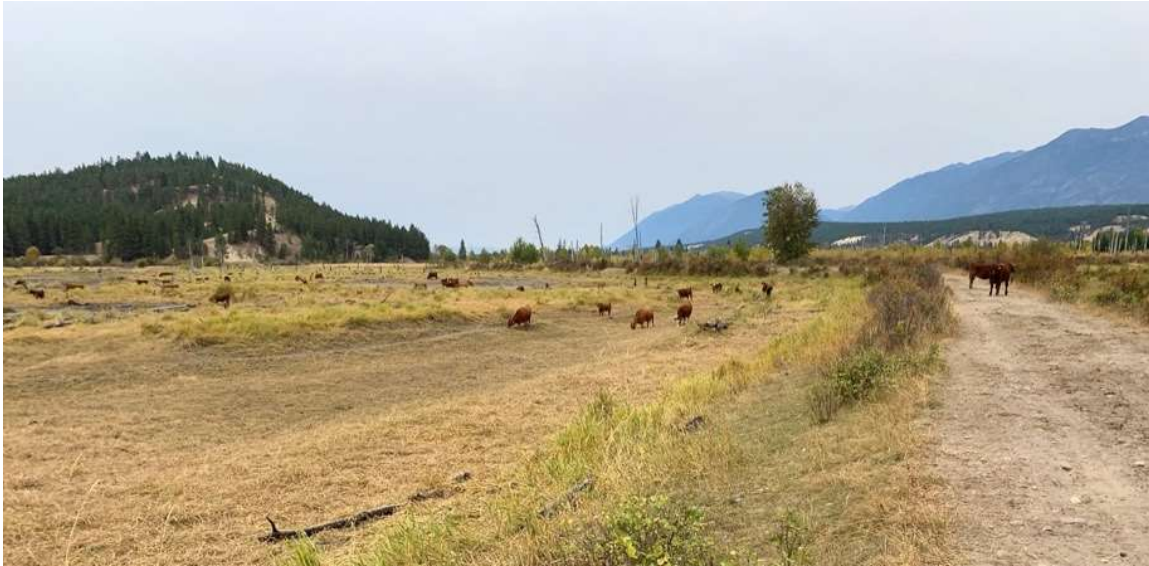
Figure 3-10. Cattle grazing Reed Canarygrass at the east end of Mayook marsh, Image date: Oct. 1, 2020. Shrubs can be seen growing along the margin of the road.

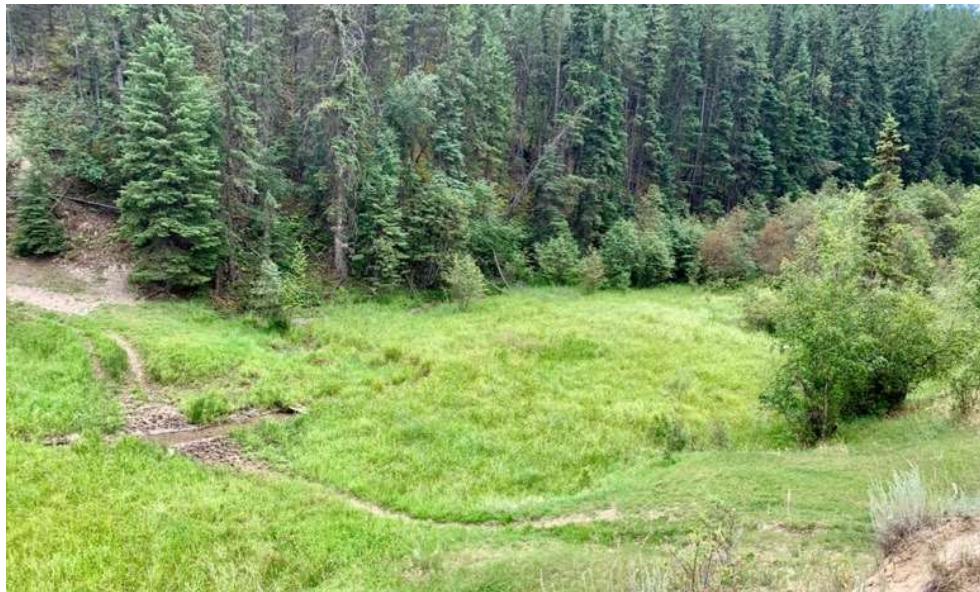
Figure 3-11. A small edge marsh and alder-sedge flood community along Mayook Creek. Soil disturbance from cattle and native ungulates can be seen along the creek's edge.

A small (0.5 ha) marsh dominated by sedges and rushes occurred along Mayook Creek at the west end of the marsh (Figure 3-4). Alder (*Alnus incana*) and willow (*Salix sp.*) encroach along the creek where the marsh transitions into a shrub/sedge community and conifers occupied the banks of the meadow (Figure 3-11). This community was difficult to classify using MacKenzie and Moran (2004). Unlike most sedge marshes with low species diversity, species richness in this community was relatively high (species list: Table 6-4)., reflecting the site's transitional position

During amphibian surveys in the fall of 2020, numerous juvenile Columbia Spotted Frogs (*Rana luteiventris*) were observed along the creek, indicating that the creek may be an overwintering site. As shown in Figure 3-11, an old jeep trail bisects the marsh. Although much of it appears to be growing over, a small area of exposed soil remains at the creek crossing.

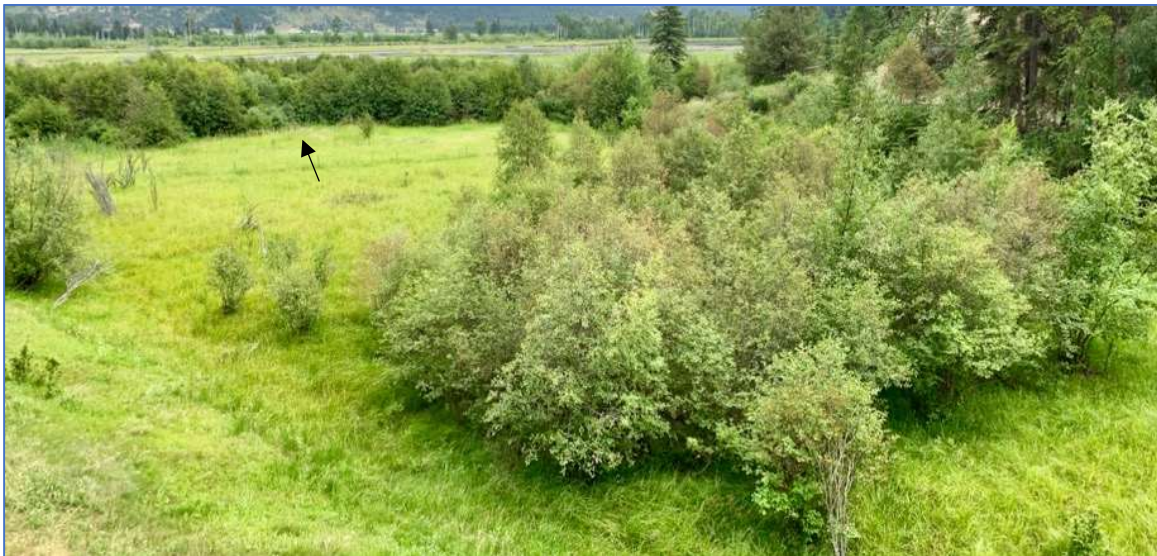
Figure 3-12. The image showing a willow community and the sedge meadow in the foreground and the Ws02: Alder/Willow swamp community in the background (arrow).

An Alder/Willow swamp community occurred at the west edge of the marsh downstream of the sedge meadow described previously (Figure 3-12). This community corresponded most closely with the Ws02: Mountain alder – Pink spirea – Sitka sedge site association (Mackenzie and Moran 2004), and due to the influence of Mayook Creek, was more hydrologically dynamic than the shrub communities located more centrally within the marsh.

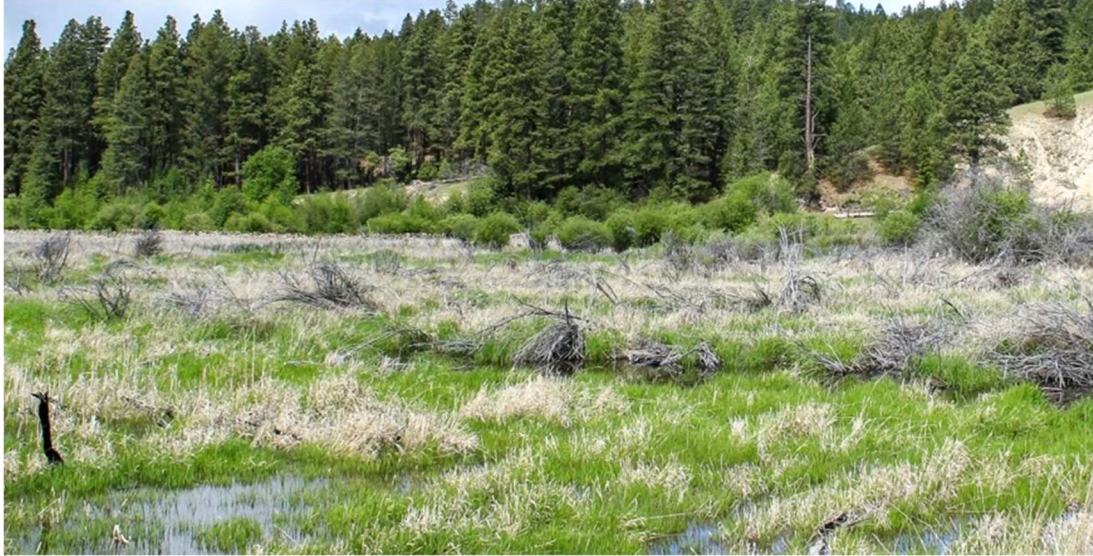
Figure 3-13. Evidence of shrub mortality due was widespread throughout Mayook Marsh. Much of the shrub community has been displaced by Reed Canarygrass.

A second riparian community occurred along old beaverdams and raised areas in the western portion of Mayook Marsh. This community was dominated by Bebb's Willow (*Salix bebbiana*), Red-Osier Dogwood (*Cornus sericea*), and Water Birch (*Betula papyrifera*) and corresponded most closely with Ws03: Bebb's willow – Bluejoint site association (MacKenzie and Moran 2004). Much of this community was burnt during a prescribed burn in the early 1990s, as evidenced by the extensive amount of burnt and dead shrub observed (Figure 3-13).

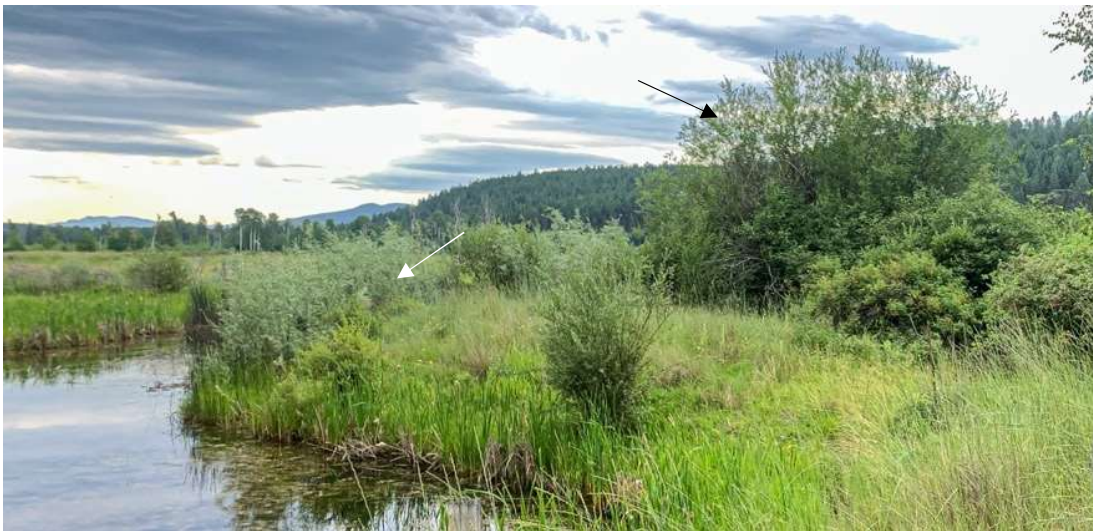
Figure 3-14. Sandbar willow (*Salix exigua*) community FI06 (indicated by the white arrow) growing along the water's edge. The tall willow (Ws03) community indicated (black arrow).

A third shrub community dominated by Sandbar Willow (*Salix exigua*) occurred in isolated stretches along the edge of open water (Figure 3-14). This community corresponded with the flood community FI06 Sandbar Willow site association (MacKenzie and Moran 2004) and was only observed in the northwest corner of the marsh.

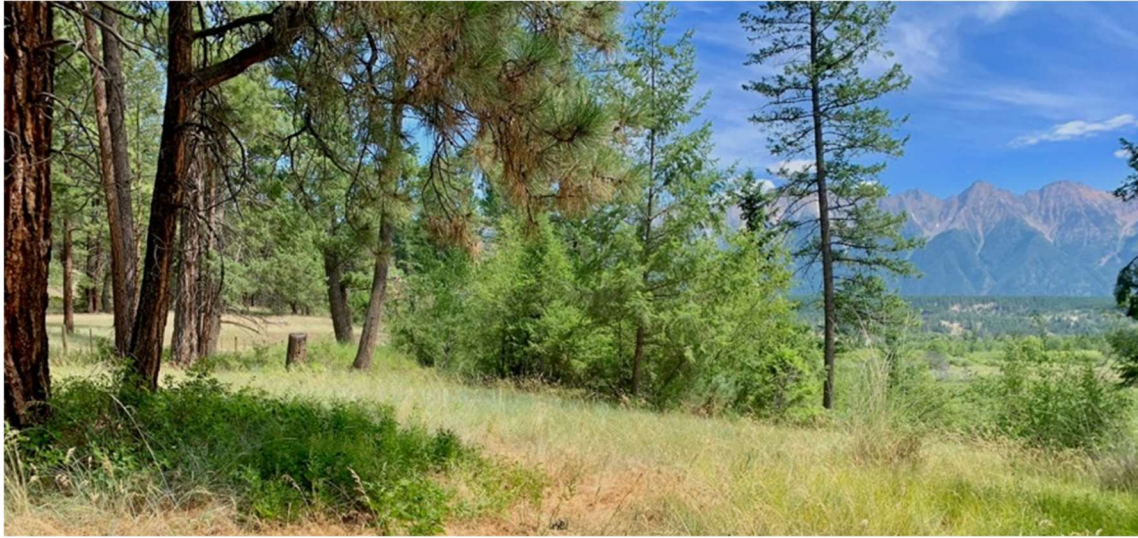
Figure 3-16. Douglas fir – Ponderosa pine open forest located along the northwest perimeter of the Mayook Marsh.

Habitats adjacent to Mayook Marsh included: 1) an open dry Douglas-fir – Ponderosa Pine forest along the west side of the Marsh (Figure 3-16), 2) a closed mesic Douglas-fir forest along the south shore of the marsh above the flood fringe shrub community (Figure 3-15), 3) a stand of Aspen between Mayook Marsh and the Kootenay River (Figure 3-7; Figure 3-8), and 4) meadows of Reed Canarygrass broken by elevated sites with shrub and Aspen stands (Figure 3-17). The structure and composition of the adjacent forested stands are summarized in Table 3-4.

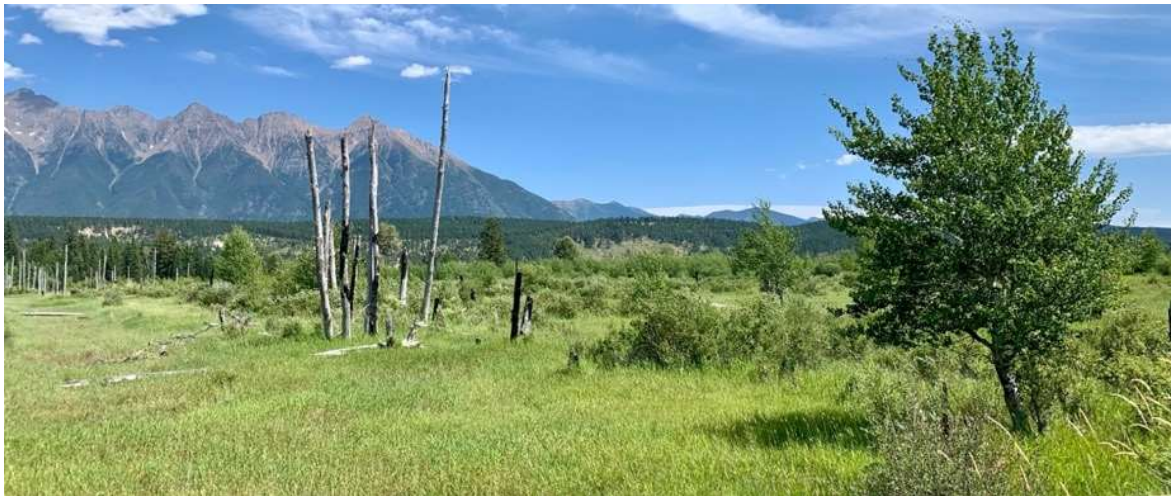
Figure 3-17. Reed Canarygrass meadows intermixed with Aspen, Cottonwood, and shrub on elevated sites extend northeast from the Mayook Marsh into Eagle Nest pasture.

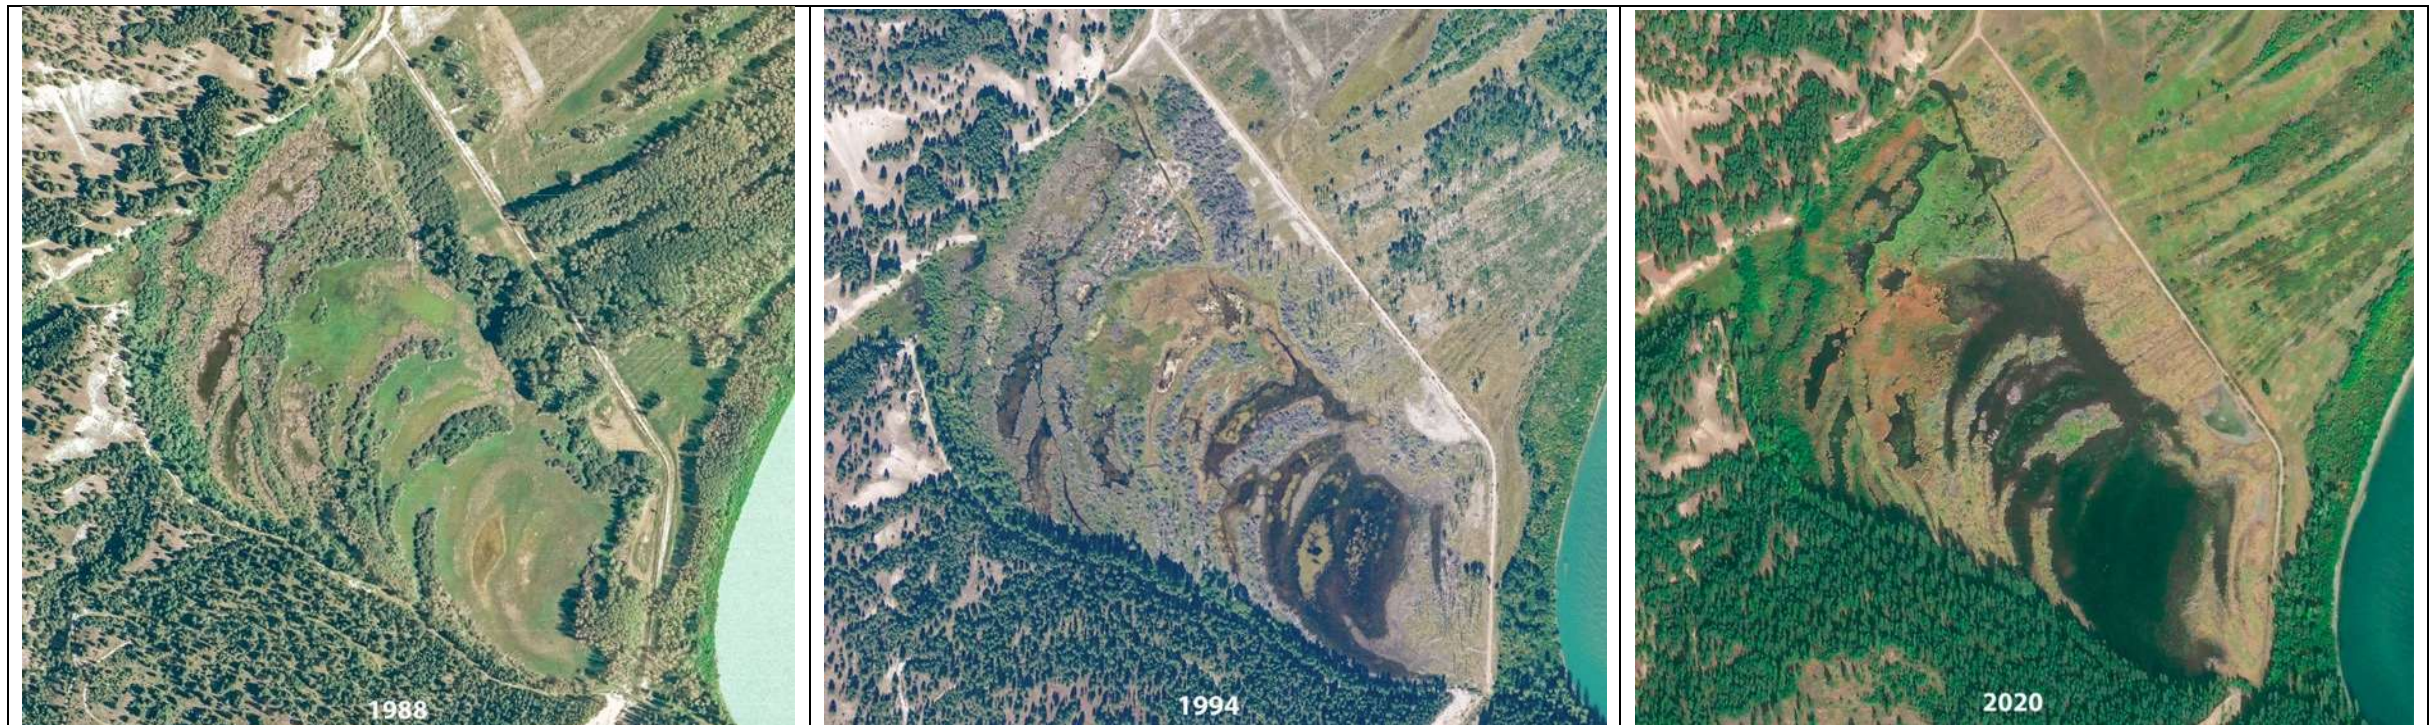
Figure 3-18. The images above show a dramatic reduction in Cottonwood, Aspen and deciduous shrub across the sequence of images: July 8, 1988 (left), Jun22, 1994 (centre), and Aug 20, 2020 (right). Evidence of the prescribed fire undertaken in the early 1990's can be seen in the centre image (1994). The displacement of the Cottonwood, Aspen and shrub stands by Reed Canarygrass is clearly visible in the right-hand image (2020). The images also show an increase in flooding over time.

An assessment of habitat conditions revealed that Reed Canarygrass has displaced mature Cottonwood and Aspen stands and shrub communities and is encroaching on marsh and shallow water communities. Air photos from 1988, 1994, and 2020 show a dramatic shift in habitat following a prescribed burn that destroyed the shrub, Cottonwood, and Aspen stands in the early 1990s, allowing Reed Canarygrass to establish. Now established, Reed Canarygrass occupies approximately a third of the entire marsh.

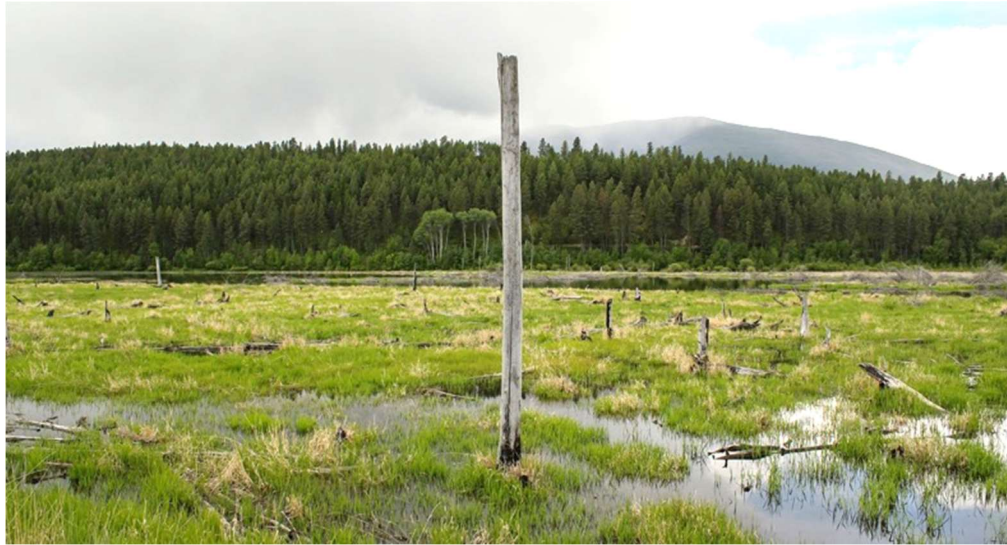
Figure 3-19. The flooded remnants of an Aspen/Cottonwood stand. Image taken June 9, 2020. These stands were destroyed by a prescribed fire in the early 1990's.

water levels would have also contributed to the proliferation of Reed Canarygrass Mayook Marsh (Figure 3-19).

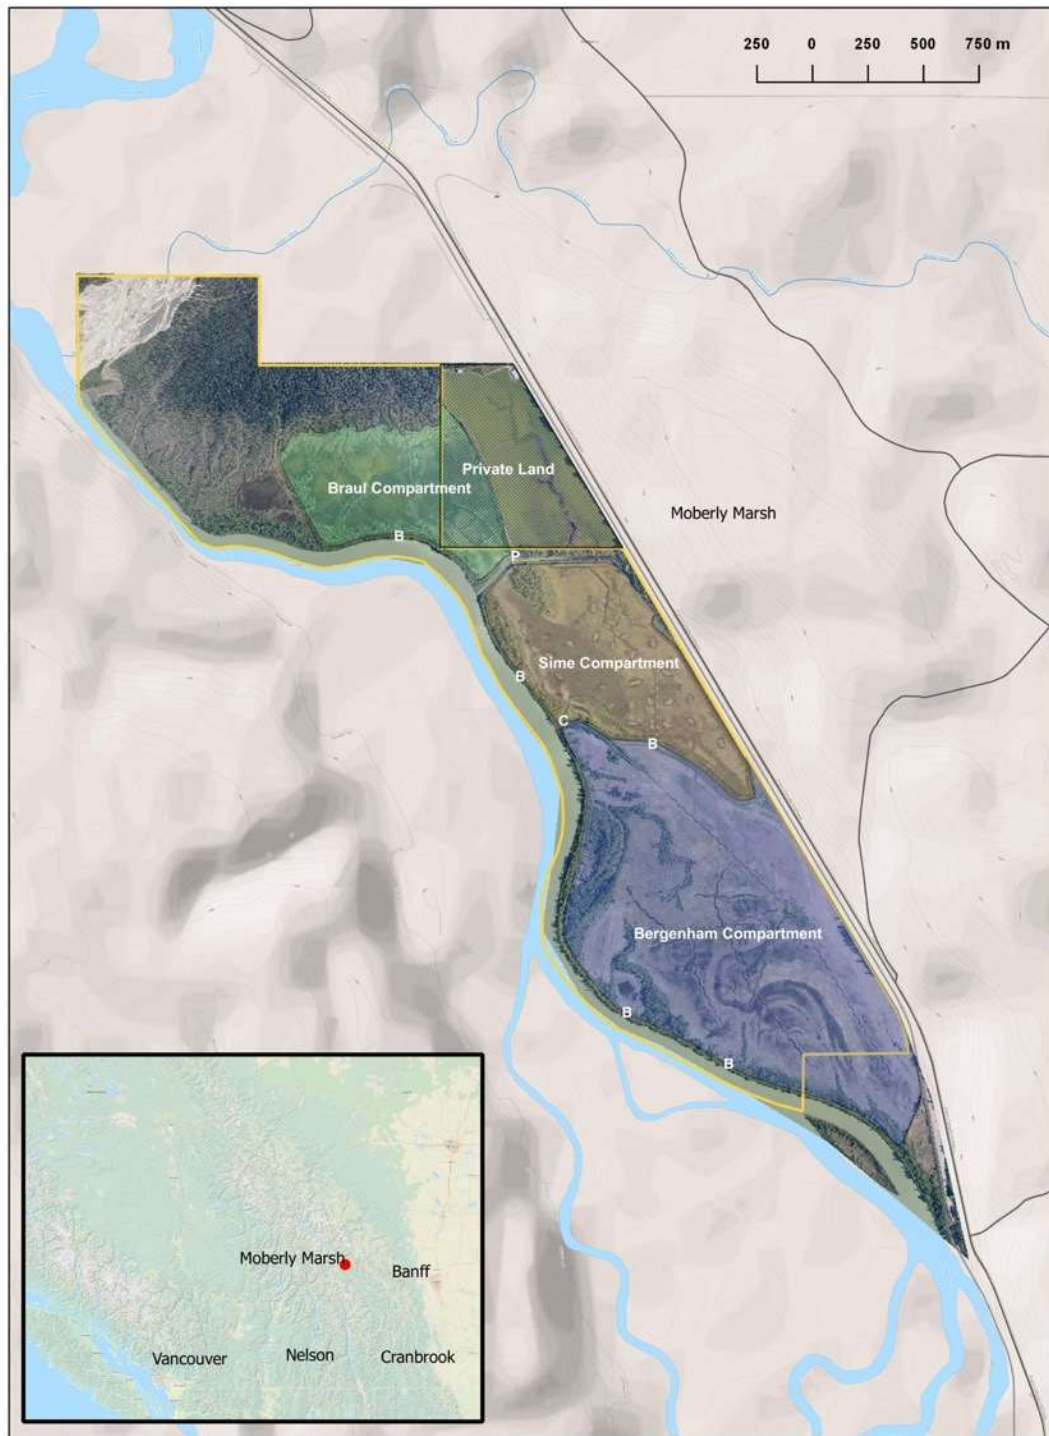
Figure 4-1. Map showing the location of the wetland compartments of Moberly Marsh. The boundary of Burges and James Gadsden Provincial Park is marked in yellow. The location of proposed dike breaches are identified by the letter “B,” and the existing water control structures are indicated by P (pump) and C (inlet/outlet control).

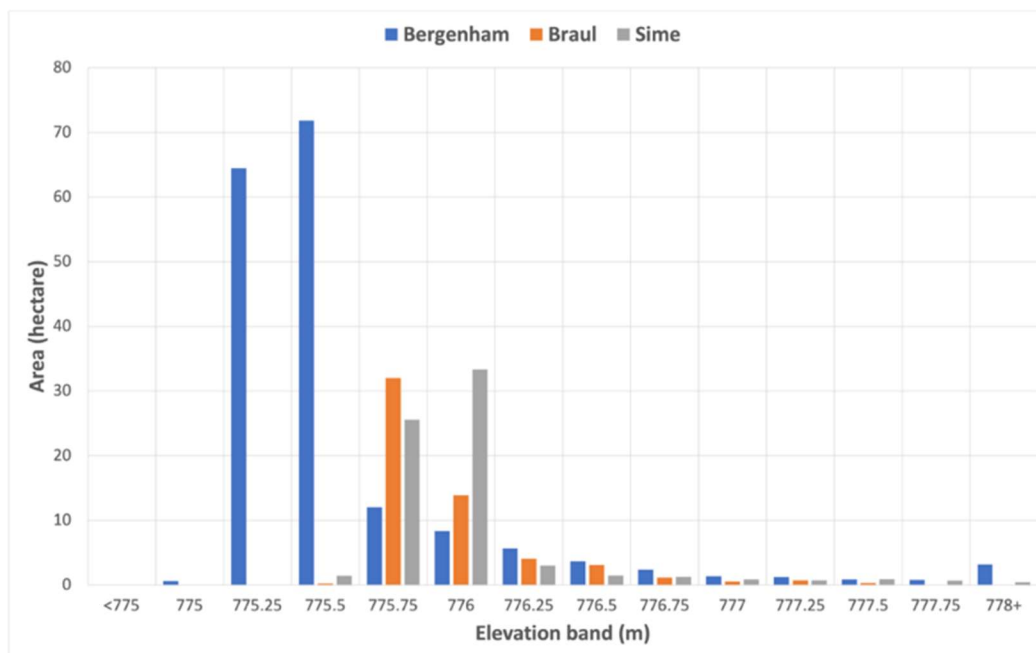
Figure 4-4. Distribution of 25 cm elevation bands in the three compartments of Moberly Marsh.
