## **COLD SPRING CREEK DEBRIS FLOOD MITIGATION**

# **Cold Spring Creek Hazard Assessment**

**Final**  
**September 25, 2020**

**BGC Project No.: 1572005**

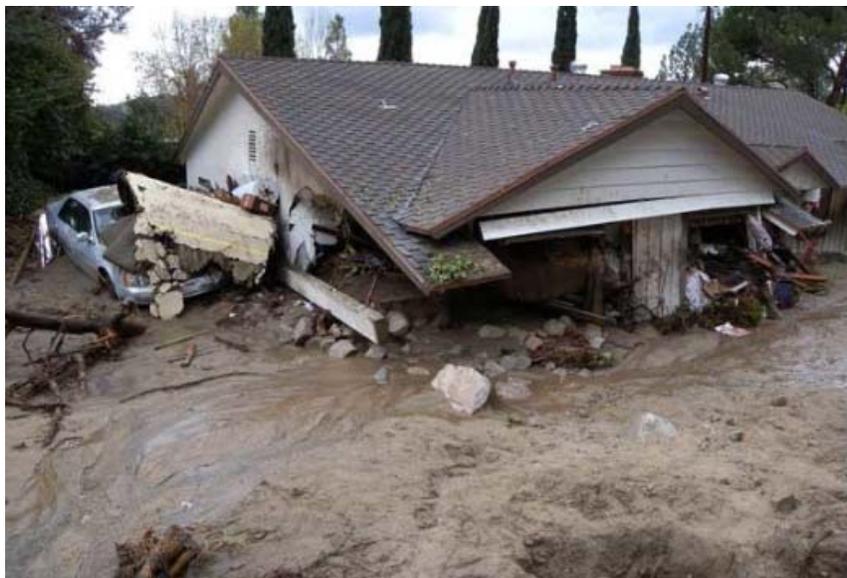
**Figure E-1-1. Home damaged by debris flow at Montecito, California in January of 2018. Photo by USGS (public domain), <https://www.usgs.gov/media/images/1s-post-fire-debris-flow>. This type of destruction is entirely possible and even likely at Cold Spring Creek in the future.**

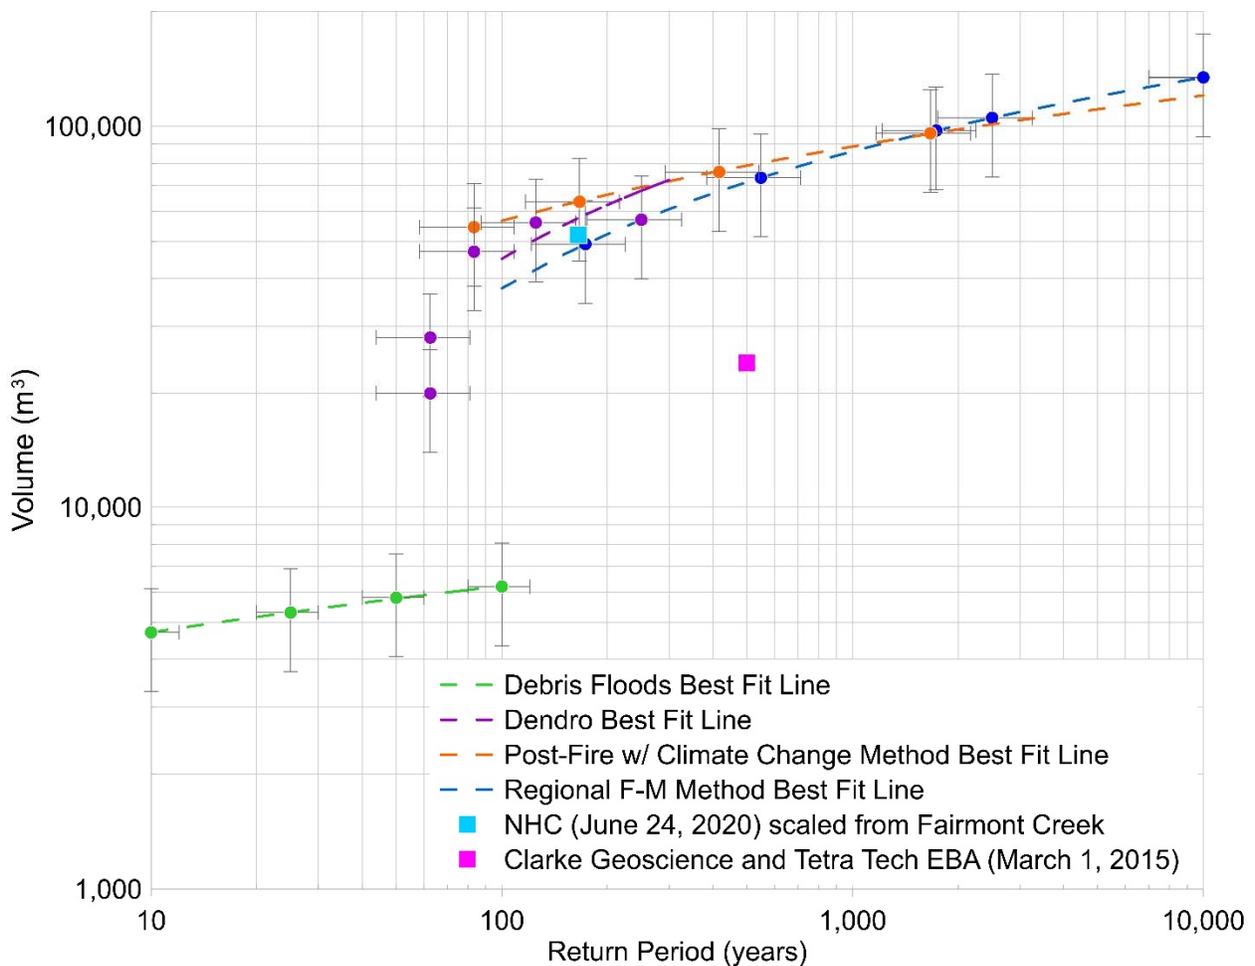
**Figure E-1-2. The frequency-volume methods considered reasonable for Cold Spring Creek. Best fit lines are trimmed at the 100-year return period as BGC considers debris flows below that return period are unlikely. The figure also shows the Clarke Geoscience and Tetra Tech EBA (March 1, 2015) F-M estimate as well as the recently updated (NHC, June 24, 2020) estimate for Fairmont Creek adjusted by watershed area. Error bars are based on judgement.**

Debris-flood and debris-flow frequency-magnitude relationships were developed through a model ensemble in which BGC compared different approaches relating to a regional frequency-magnitude approach, dendrochronological investigation, radiocarbon dating from organic materials found in test trenches, stratigraphic analysis of test trenches and natural exposures and a post-fire debris-flow magnitude analysis (shown in Table E-1), and summarized graphically in Figure E-2.

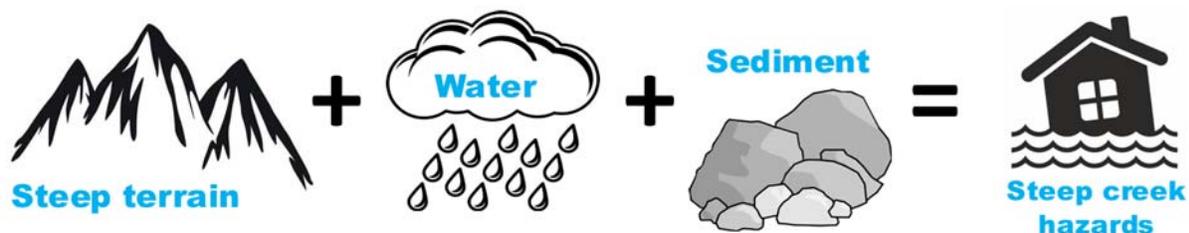
Figure 2-1. Illustration of steep creek hazards.

Steep creek or hydrogeomorphic hazards are natural hazards that involve a mixture of water and debris or sediment (Figure 2-1). These hazards typically occur on creeks and steep rivers with small watersheds (usually less than 100 km<sup>2</sup>) in mountainous terrain, usually after intense or long rainfall events, sometimes aided by snowmelt and worsened by forest fires.

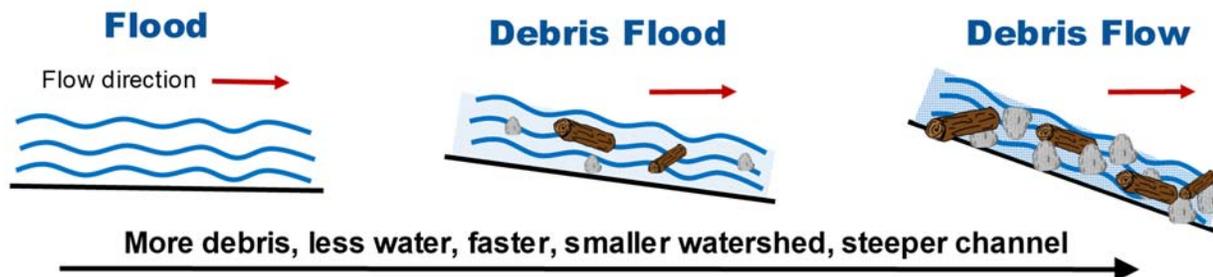
Figure 2-2. Continuum of steep creek hazards.

Steep creek hazards span a continuum of processes from clearwater floods (flood) to debris flows (Figure 2-2). Debris floods and debris flows are described further in the following sections.

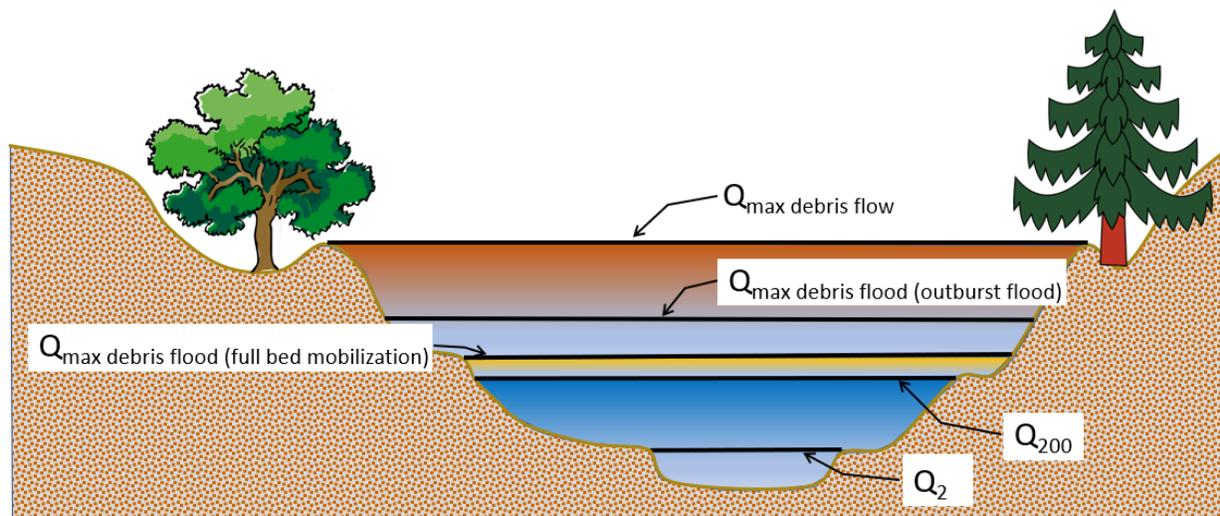
**Figure 2-3. Conceptual step creek channel cross-section showing peak discharge levels for different events. Note that for some outburst floods or debris flows the discharge may exceed what is shown here.**

- $Q_2$ ; Clearwater flow with 2-year return period
- $Q_{200}$ ; Clearwater flow with 200-year return period (i.e., a clearwater flood)
- $Q_{\max}$  debris flood (full bed mobilization); Type 1 debris flood generated by full bed mobilization
- $Q_{\max}$  debris flood (outburst flood); Type 3 debris flood generated by an outburst flood
- $Q_{\max}$  debris flow; Debris flow.

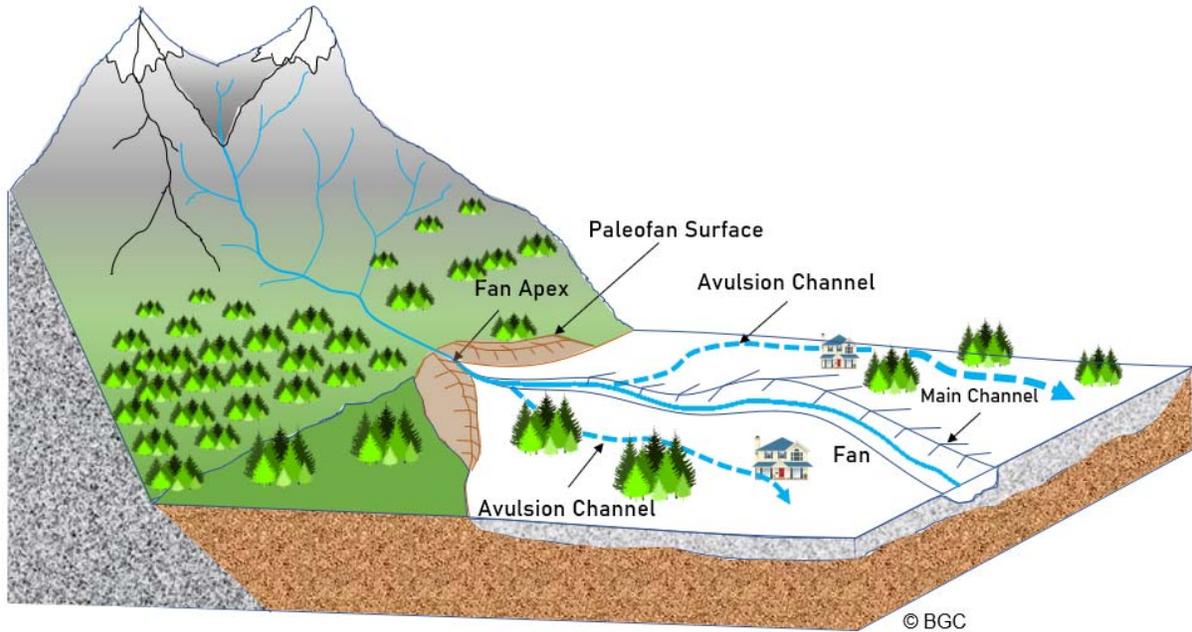
**Figure 2-4. Schematic of a steep creek channel with avulsions downstream of the fan apex. Artwork by BGC.**

In Figure 2-4, a schematic of a steep creek and fan is shown where the creek avulses on either side of the main channel. The avulsion channels are shown as dashed blue lines as avulsions only occur during severe floods (i.e., rarely). On high resolution topographic maps generated from LiDAR, avulsion channels are generally visible and are tell-tale signs of past and potential future avulsions.

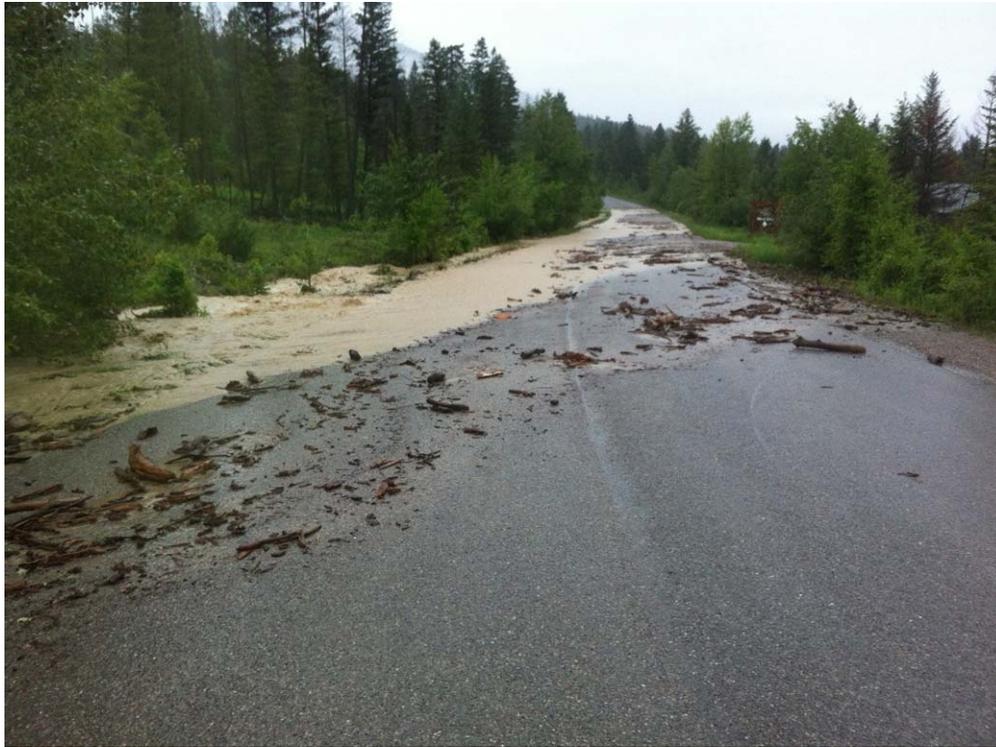
**Figure 3-1.** View upstream (east) on Fairmont Resort Road at approximately the crossing with Hot Springs Road showing muddy water and debris from an avulsion at the uppermost culvert beneath Fairmont Resort Road. RDEK photograph of June 20, 2013 7:00 AM.

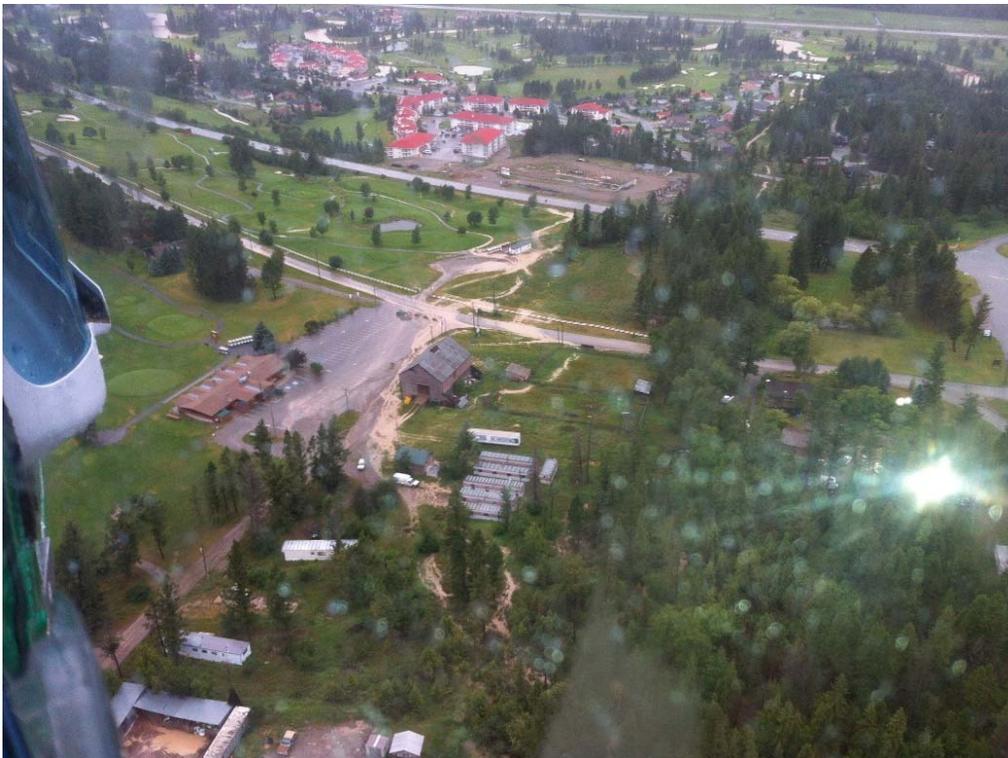
**Figure 3-2.** Avulsions associated with the debris flood of June 20, 2013. Debris is seen to flow past the old Barn towards Highway 95. RDEK photograph of June 20, 2013 2:15 PM.

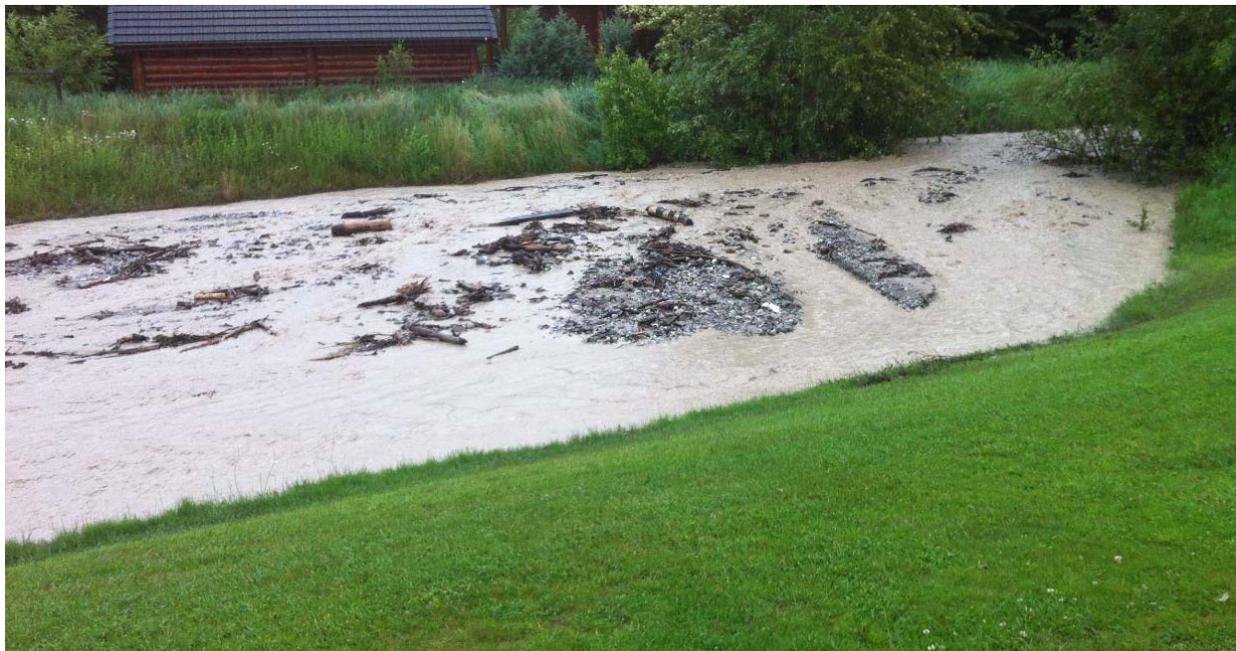
**Figure 3-3. Lower sedimentation basin at Glen Eagle Drive looking North. RDEK photograph of June 20, 2013 9:00 AM.**

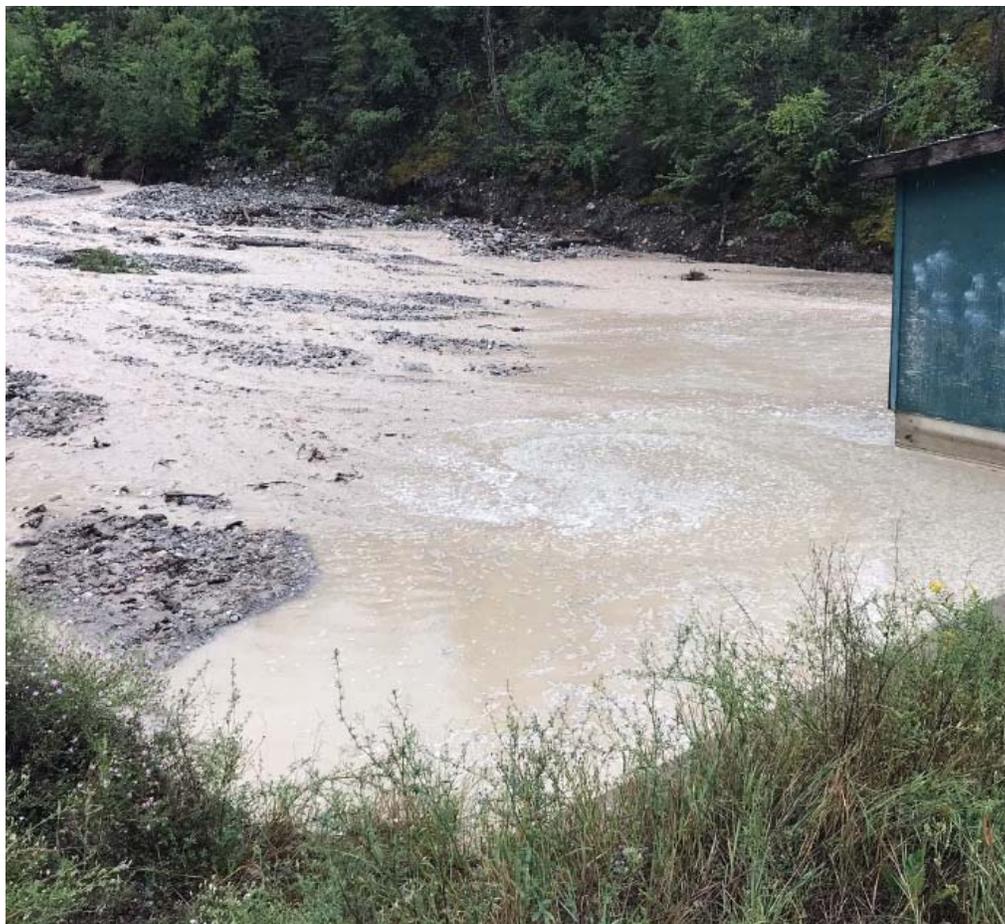
**Figure 3-4. Cold Spring Reservoir shortly after the August 12, 2020 debris flood showing the reservoir full of sediment. Photo: RDEK.**

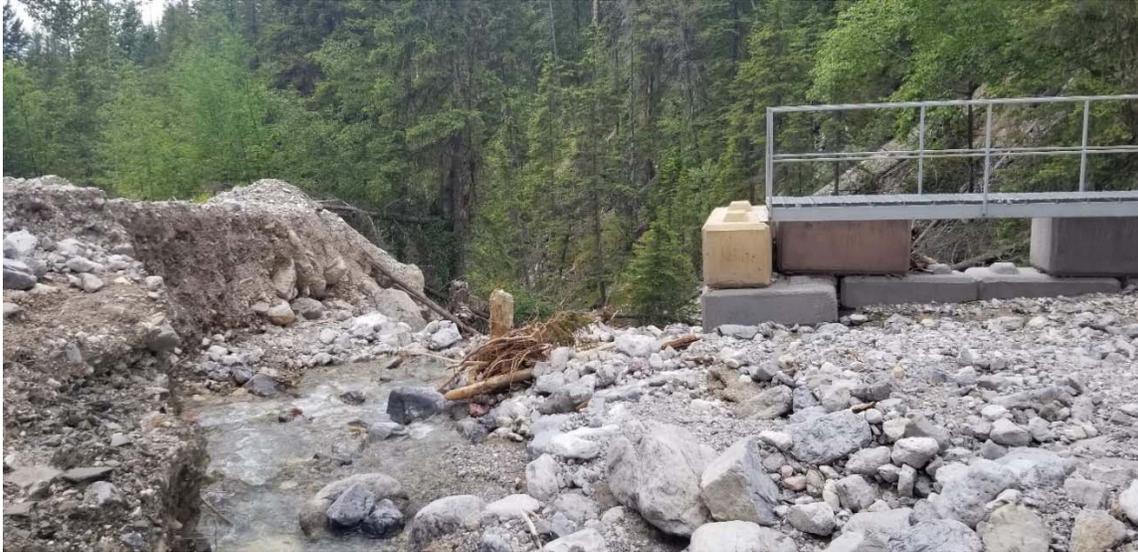
**Figure 3-5. Destroyed path across Cold Spring Creek at an elevation of approximately 1285 m, looking downstream (west). The structure likely failed through outflanking on the left (south) which subsequently eroded the foundation of the lock blocks and leading to their toppling downstream. Photo: BGC July 14, 2020.**

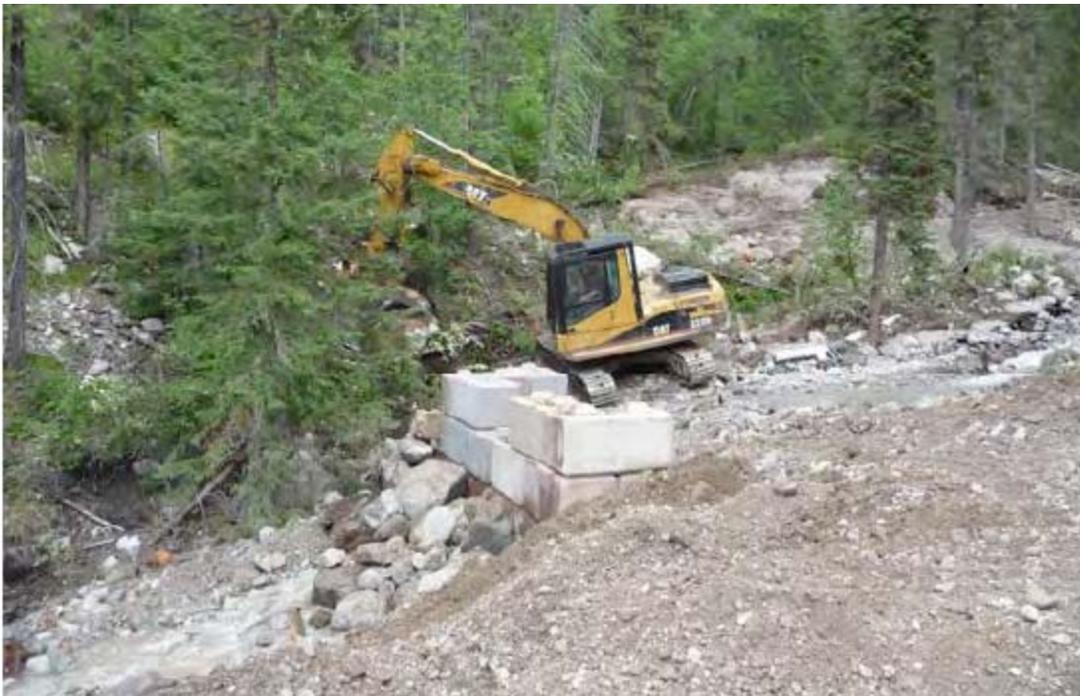
**Figure 3-6. RDEK photograph of the reconstruction of the FHSR after the 2012 debris flood (photo date unknown). This is the same location as in the previous photograph.**

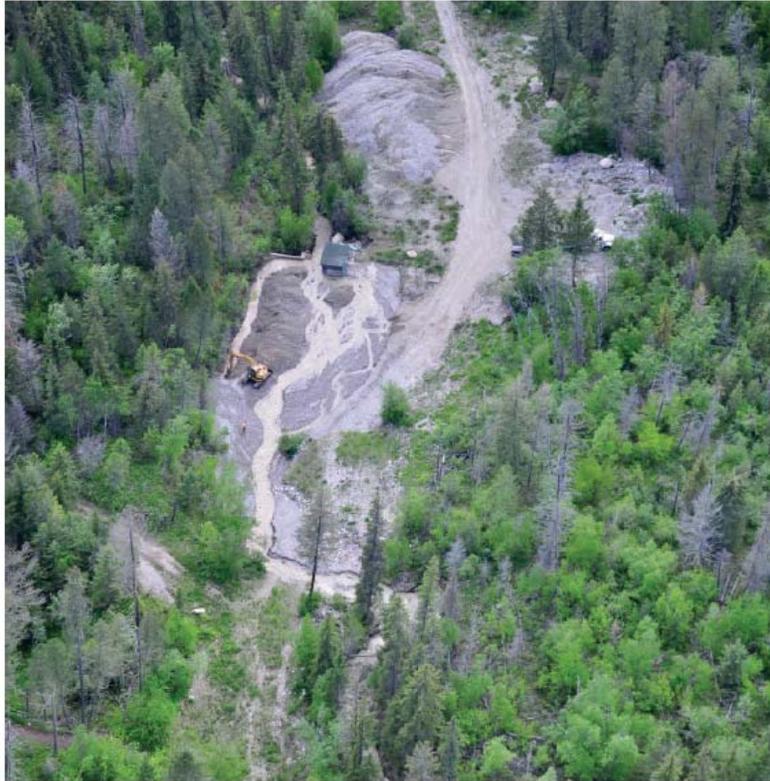
**Figure 3-7. Sediment removal after the May 31, 2020 debris flood on Cold Spring Creek. Photo: NHC, June 1 or 2, 2020.**

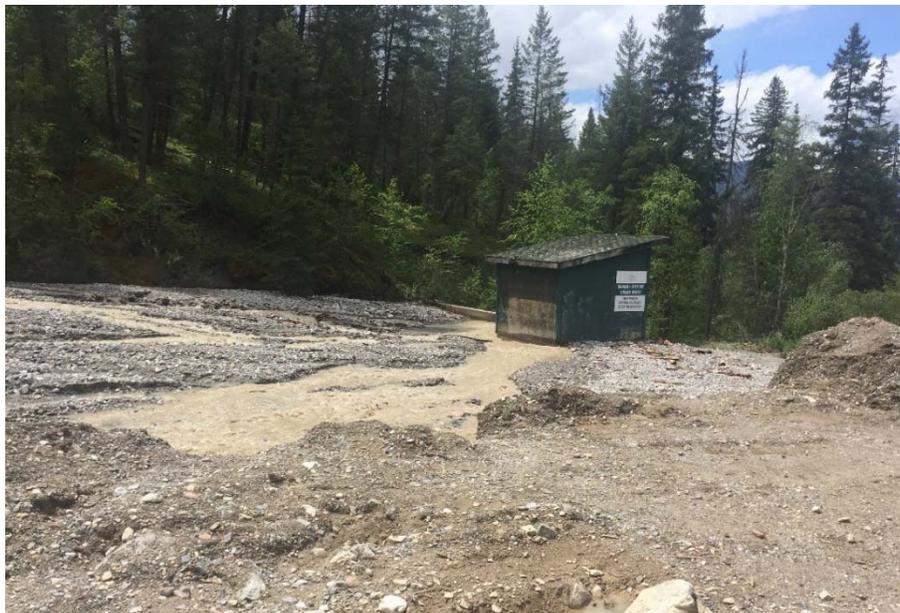
**Figure 3-8. RDEK image of the Cold Spring Creek reservoir dam entirely filled with sediment. Note that debris also overtopped to the right of the structure which is shielding the spillway from view. June 1, 2020.**

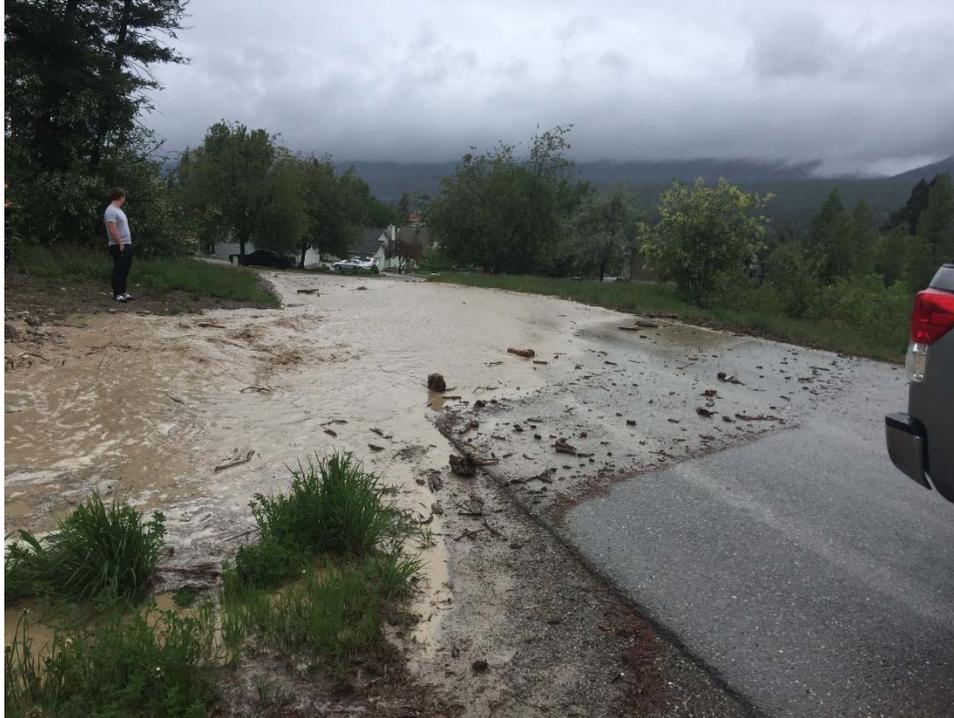
**Figure 3-9. RDEK image of Cold Spring Creek at Fairview Drive downstream of Highway 95. The culvert is not visible to the left of the road and water is flowing down Fairview Drive. May 31, 2020, 3:45 PM.**

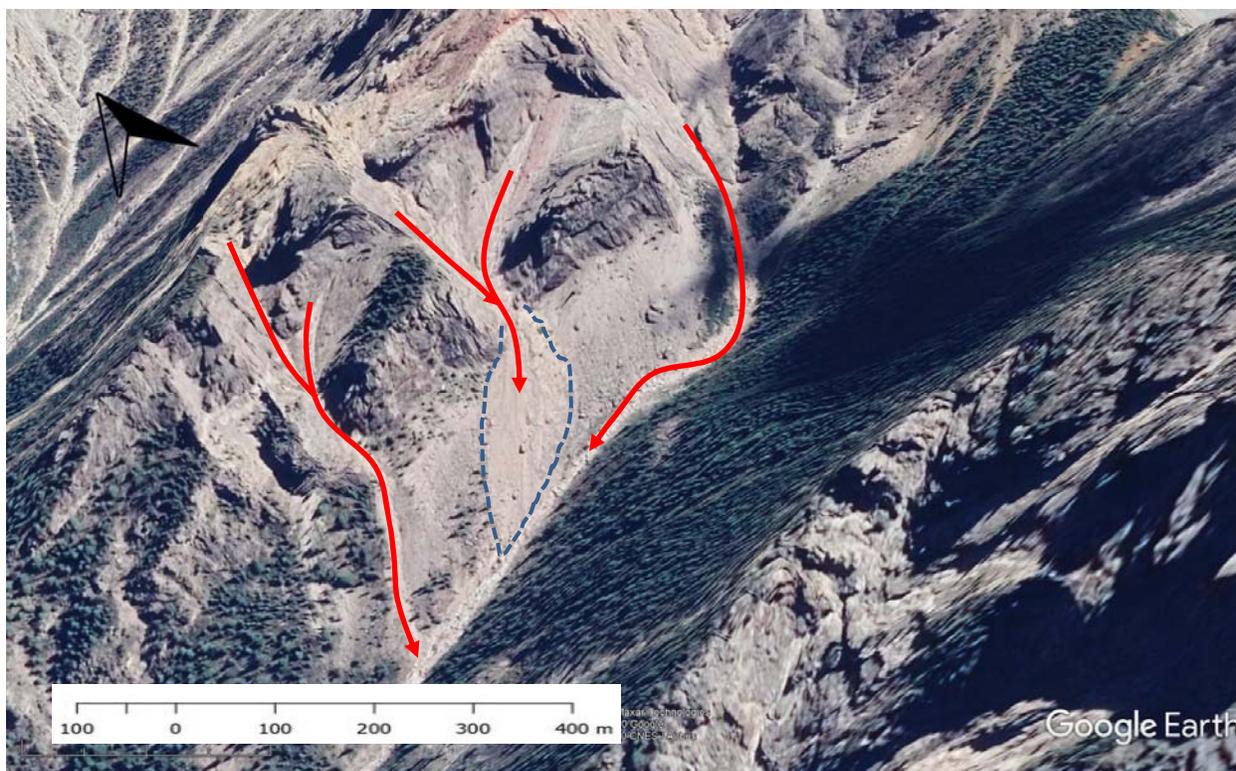
**Figure 3-10. Extensive talus slopes in the upper watershed of Cold Spring Creek at an elevation of 2000 to 2300 m facing South. Permafrost is possible on north-facing slopes in this elevation band. Google Earth.**

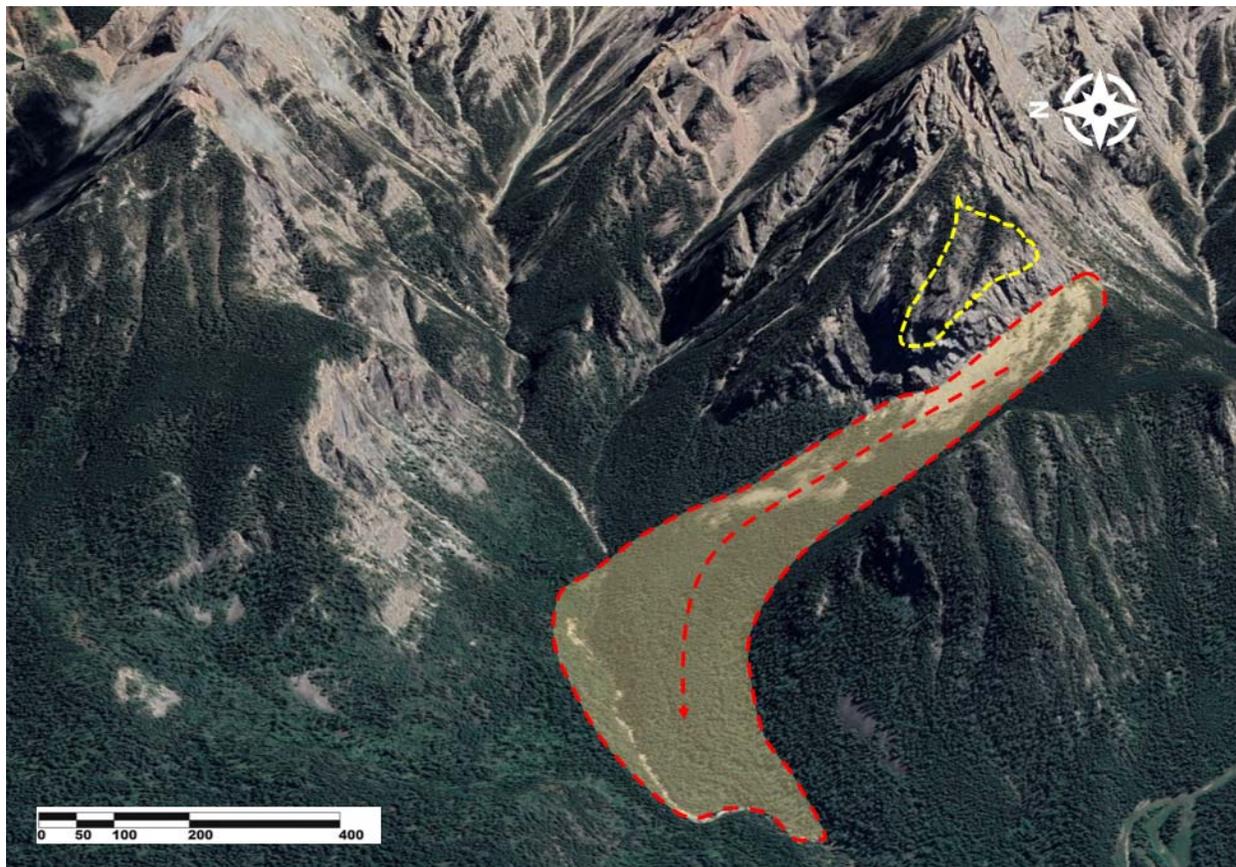
**Figure 3-11. Oblique view of the “Cold Spring Landslide” delineated in red with the potential source zone rock slide shown in yellow. View is towards the East. Google Earth imagery (date 8/4/2019).**

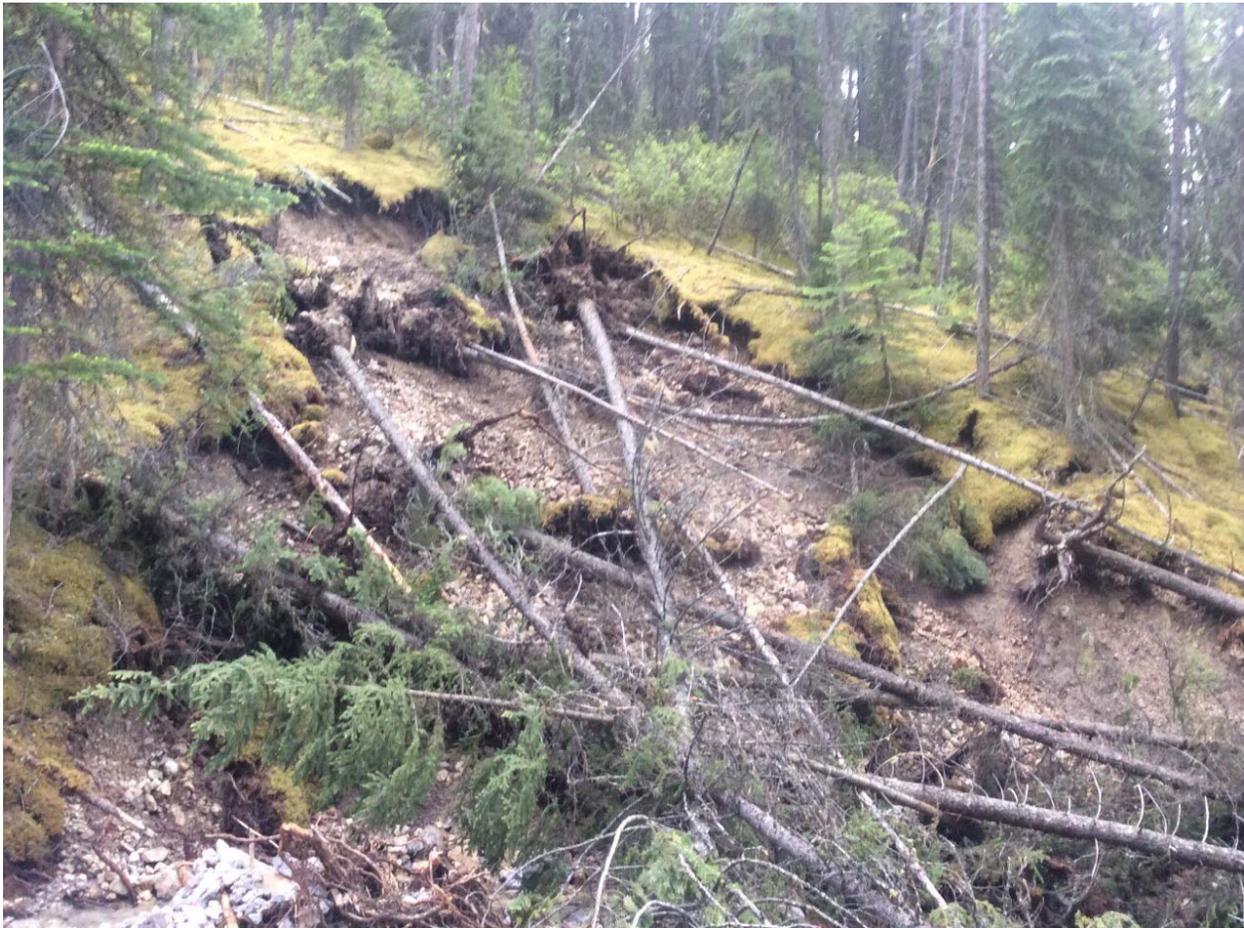
**Figure 3-12. Example of an undercut slope on the mid-reaches of Cold Spring Creek at an elevation of approximately 1270 m. Photo: BGC, June 23, 2020.**

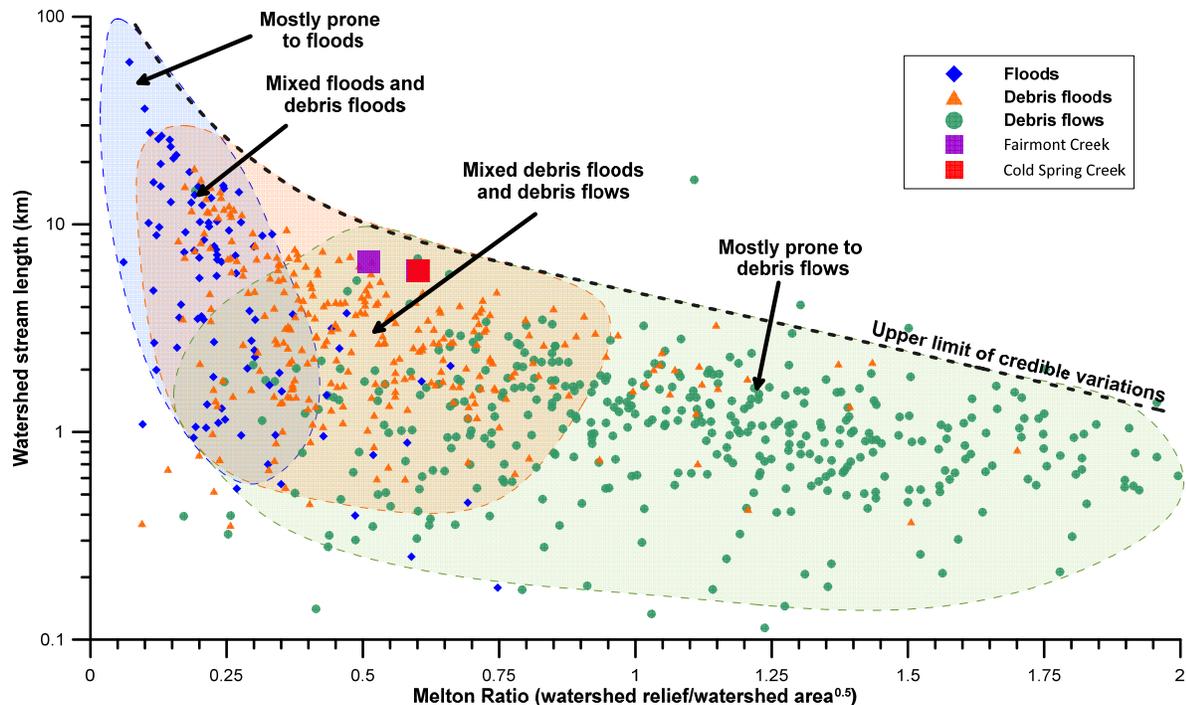
**Figure 3-13. Tendency of creeks to produce floods, debris floods and debris flows, as a function of Melton Ratio and stream length (data from Holm et al., 2016 and Lau, 2017). See Section 3.4.2 for Cold Spring Creek watershed data.**

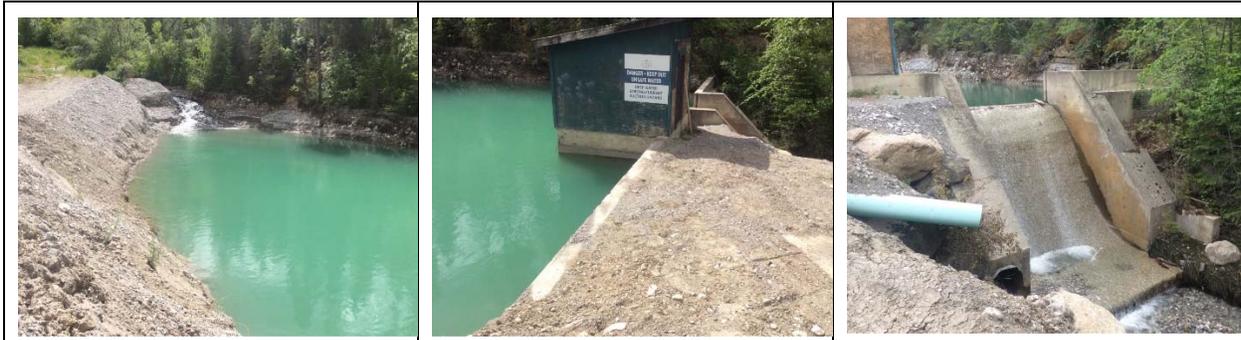
**Figure 3-14. Images of the Cold Spring Creek Dam and Reservoir looking upstream, across the dam and from downstream of the dam. BGC photographs of July 14, 2020.**

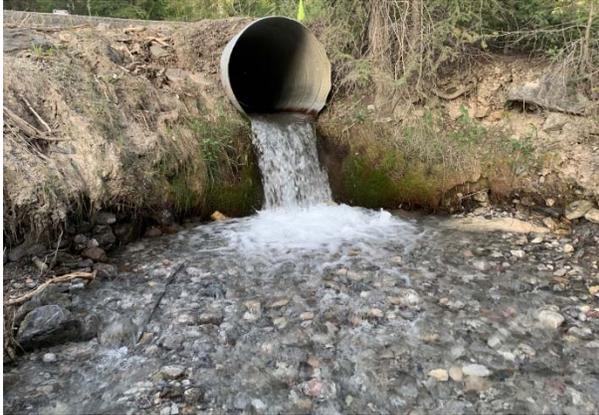
**A) Fairmont Resort Road outlet**

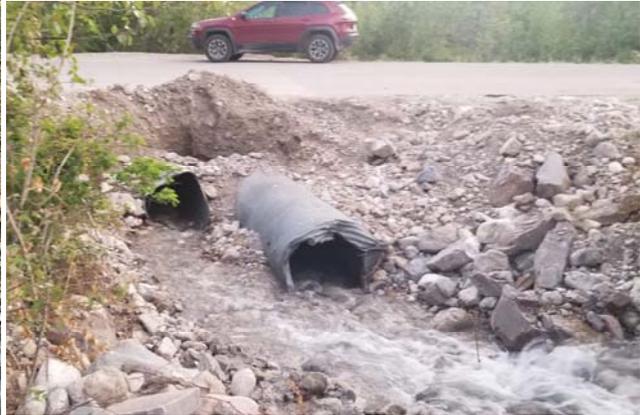
**B) Fairway Drive inlet**

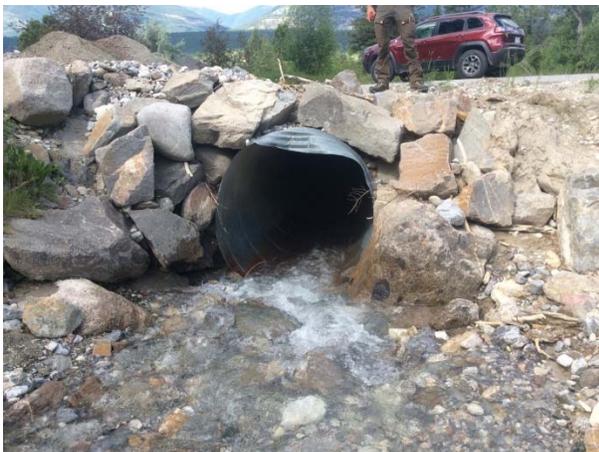
**E) Riverview Road inlet**

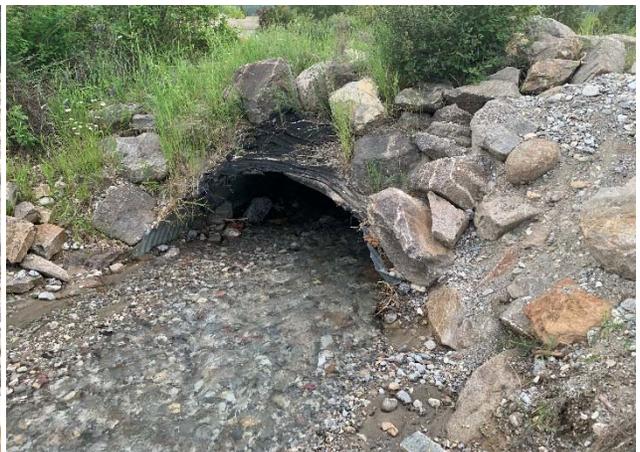
**F) Golf course culvert inlet**

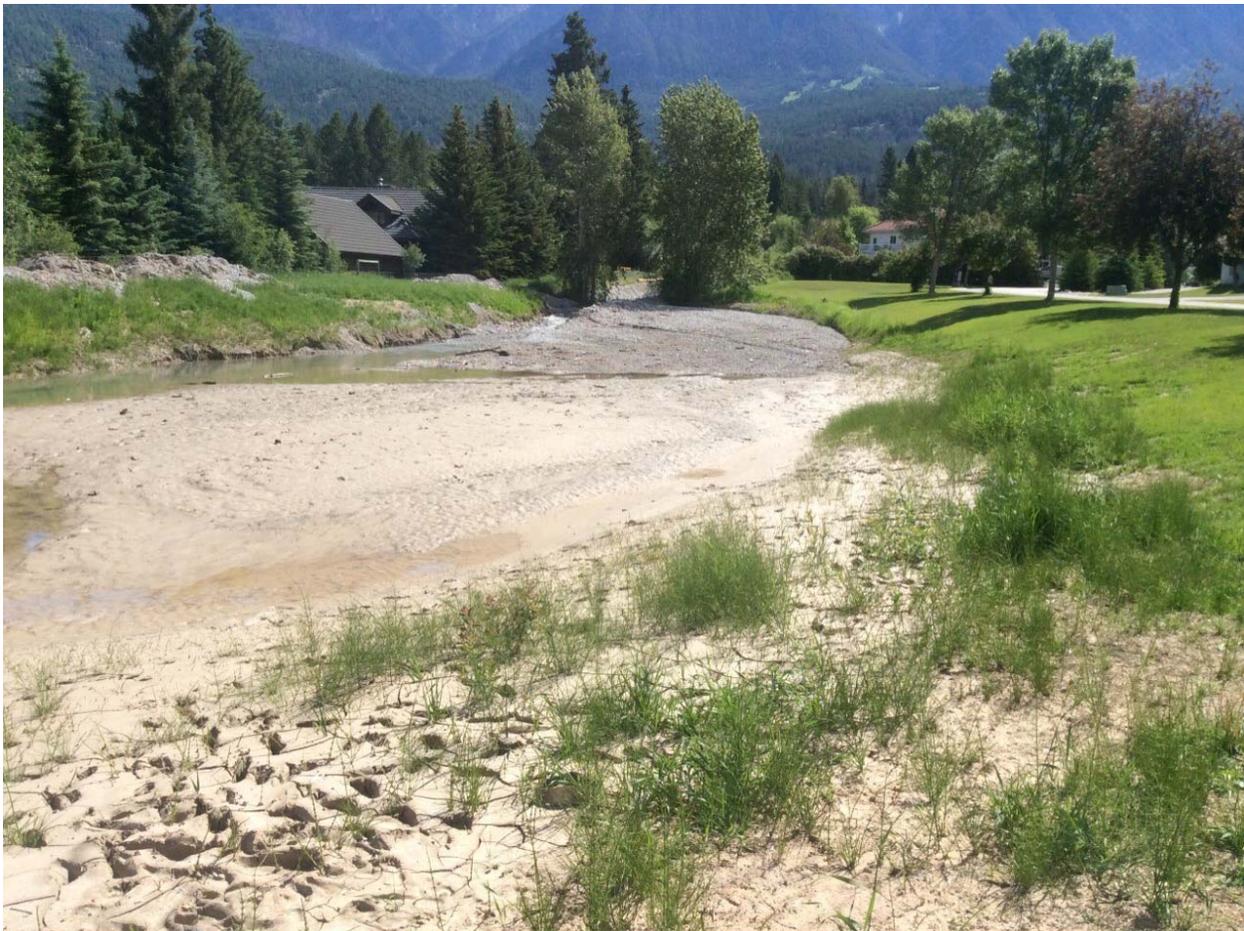
**Figure 3-16. Sedimentation pond upstream of golf course culvert on Cold Spring Creek, looking upstream. BGC photo taken June 2020.**

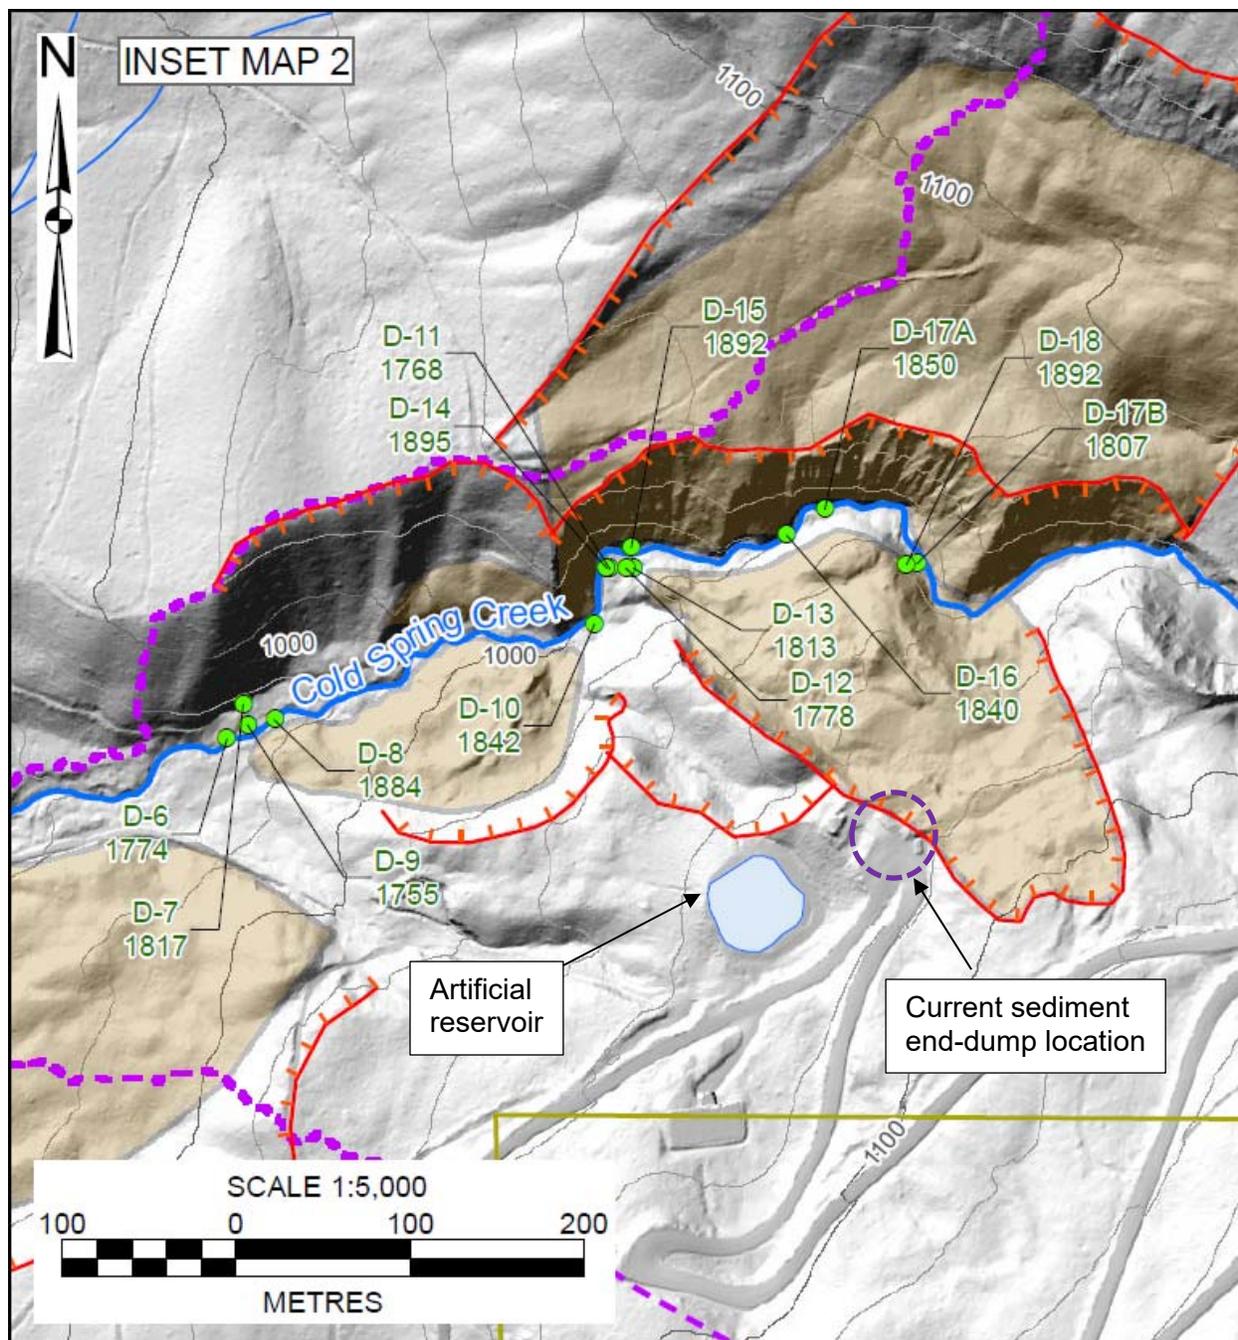
Figure 3-17. Inset map from Drawing 01, showing the location of sediment end-dumping from a switch back of the Fairmont Ski Area access road.

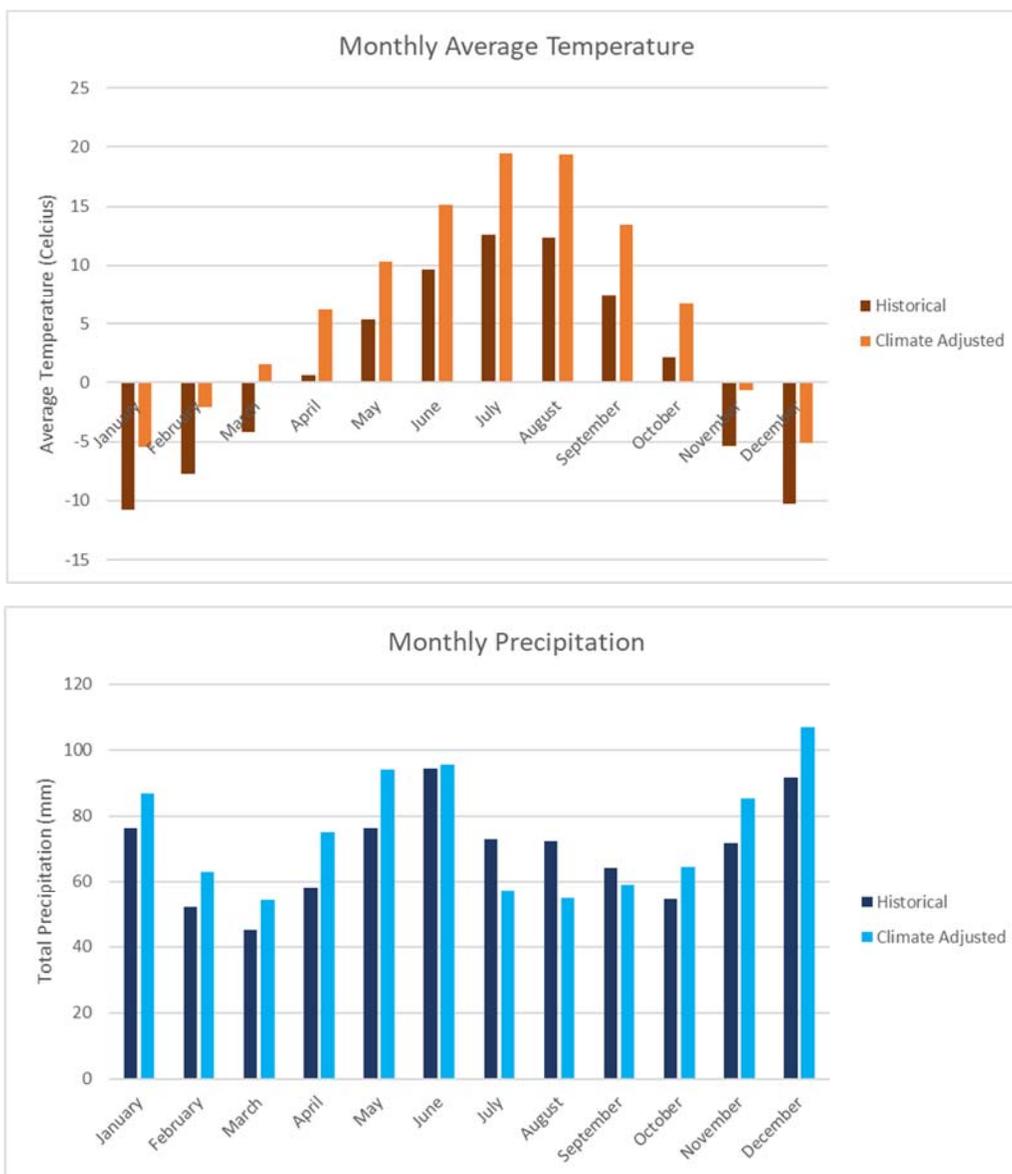
Figure 3-18. Projected change (RCP 8.5, 2050) from historical (1961 to 1990) monthly average temperature and precipitation for the Cold Spring Creek watershed.

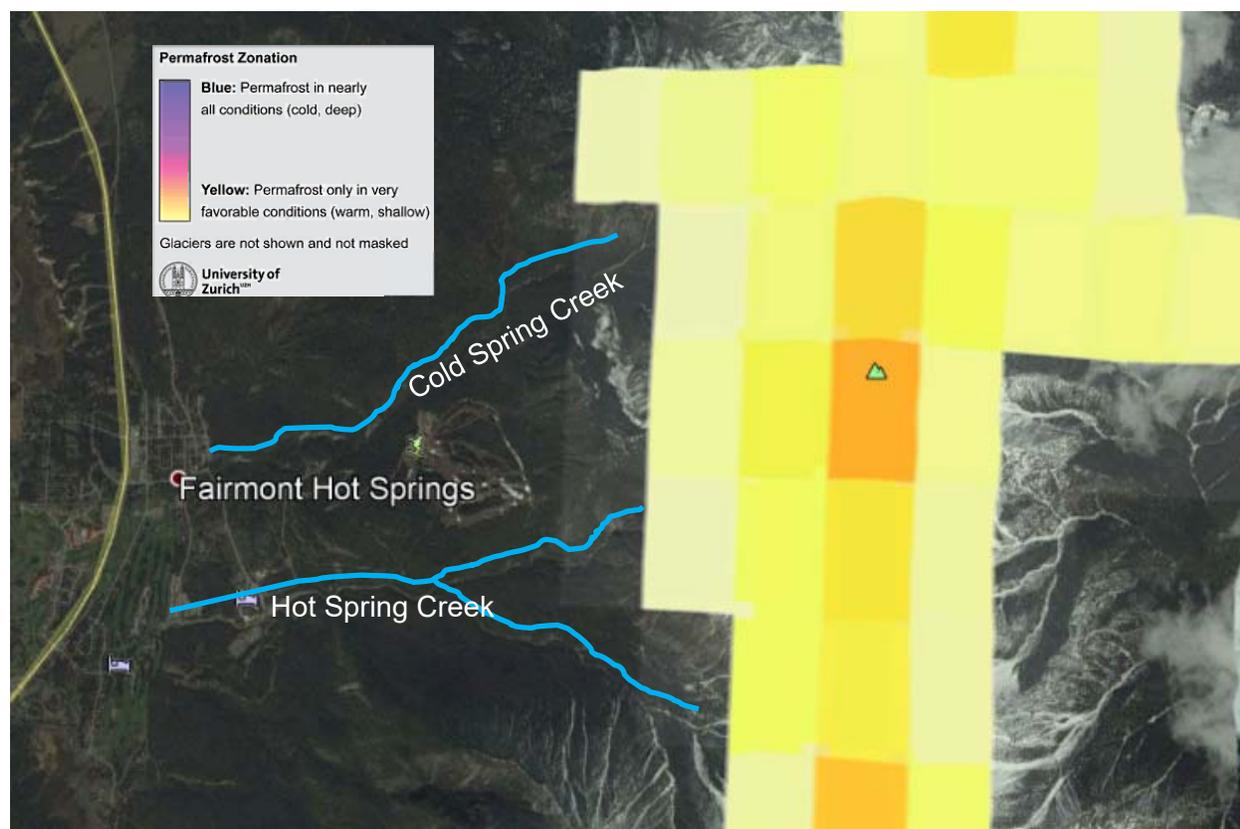
**Figure 3-19. Approximate permafrost distribution in the Cold Spring and Fairmont Creek watersheds (mapping from Gruber, 2012). The mapping indicates that permafrost is possible in favourable location but will be shallow and “warm”, meaning near zero degree Celsius and thus particularly sensitive to climate change.**
