## **COLD SPRING CREEK DEBRIS FLOOD MITIGATION**

# **Cold Spring Creek Hazard Assessment**

**Final**  
**September 25, 2020**

**BGC Project No.: 1572005**

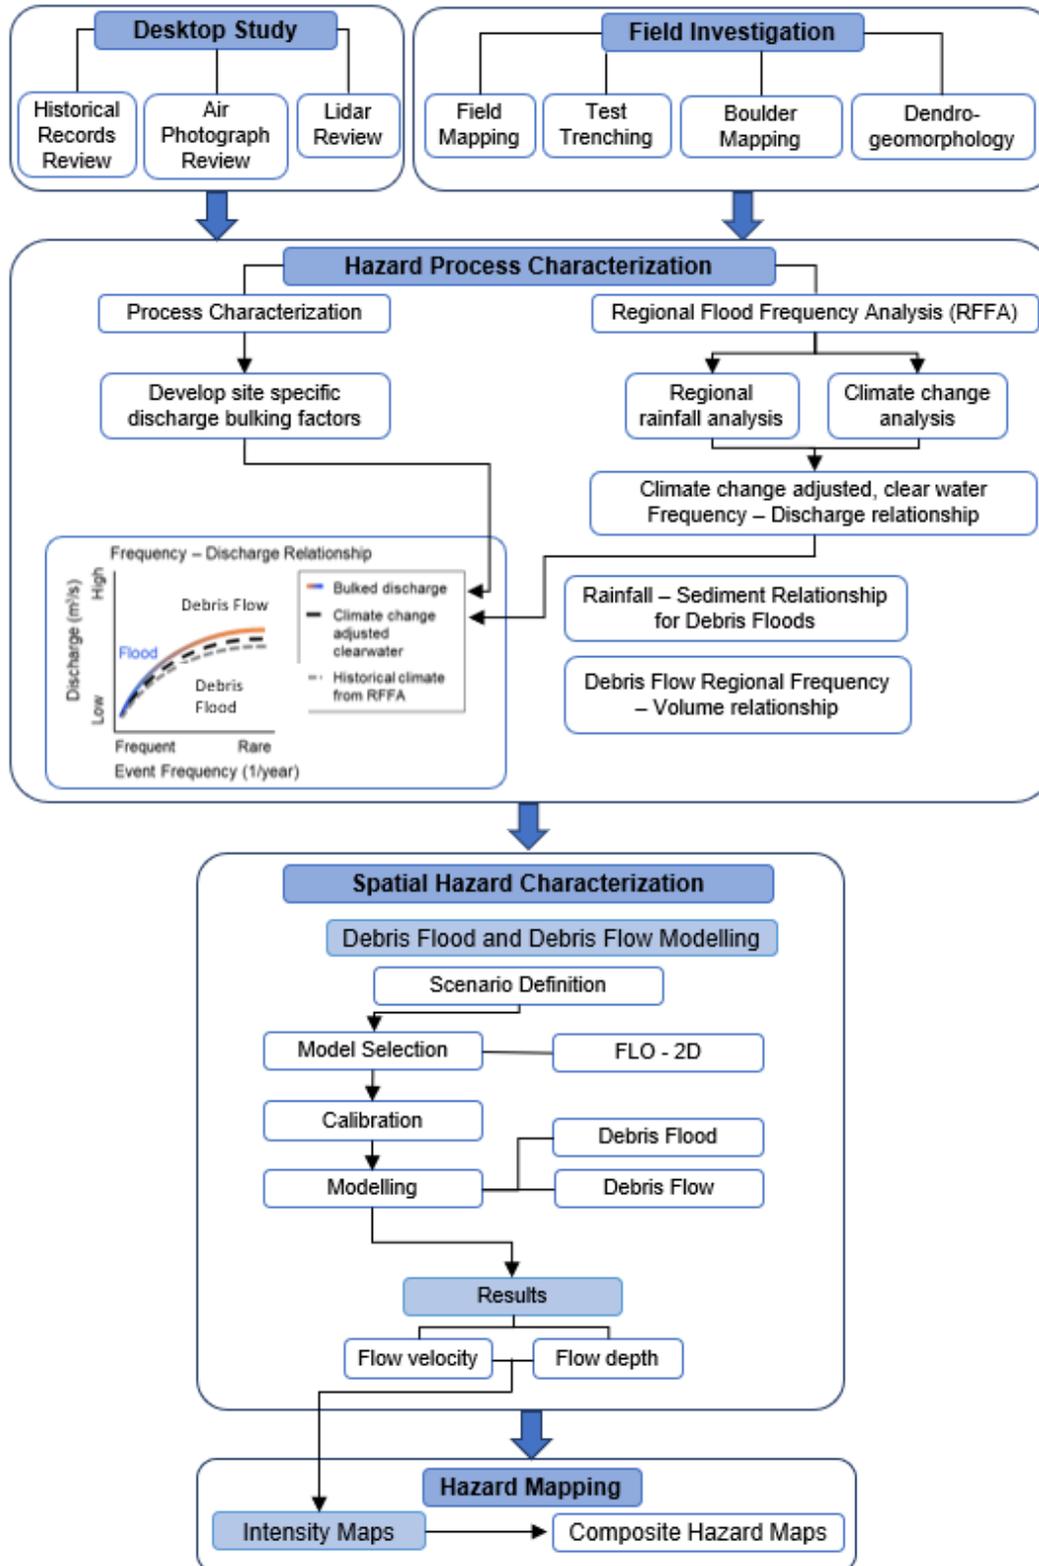
Figure 5-1. Flood and debris flow prone steep creeks workflow used for developing frequency-magnitude relationships, modeling, and preparing hazard maps.

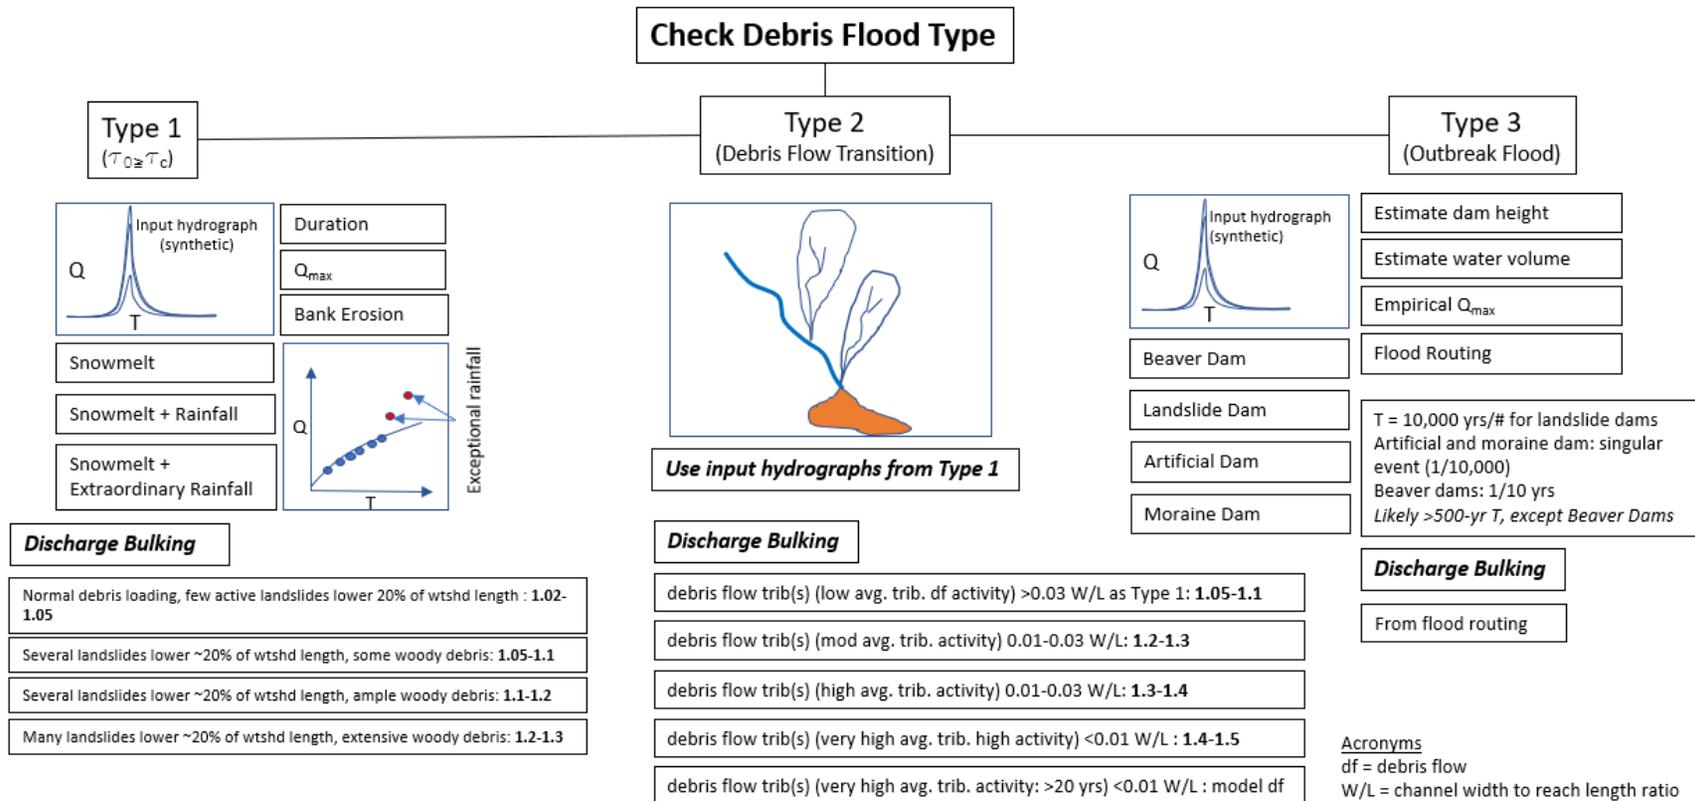
Figure 5-2. Debris flood bulking method logic chart for Cold Spring Creek. Only Type 1 and Type 2 debris floods were considered for Cold Spring Creek as the return period for Type 3 events is unknown.

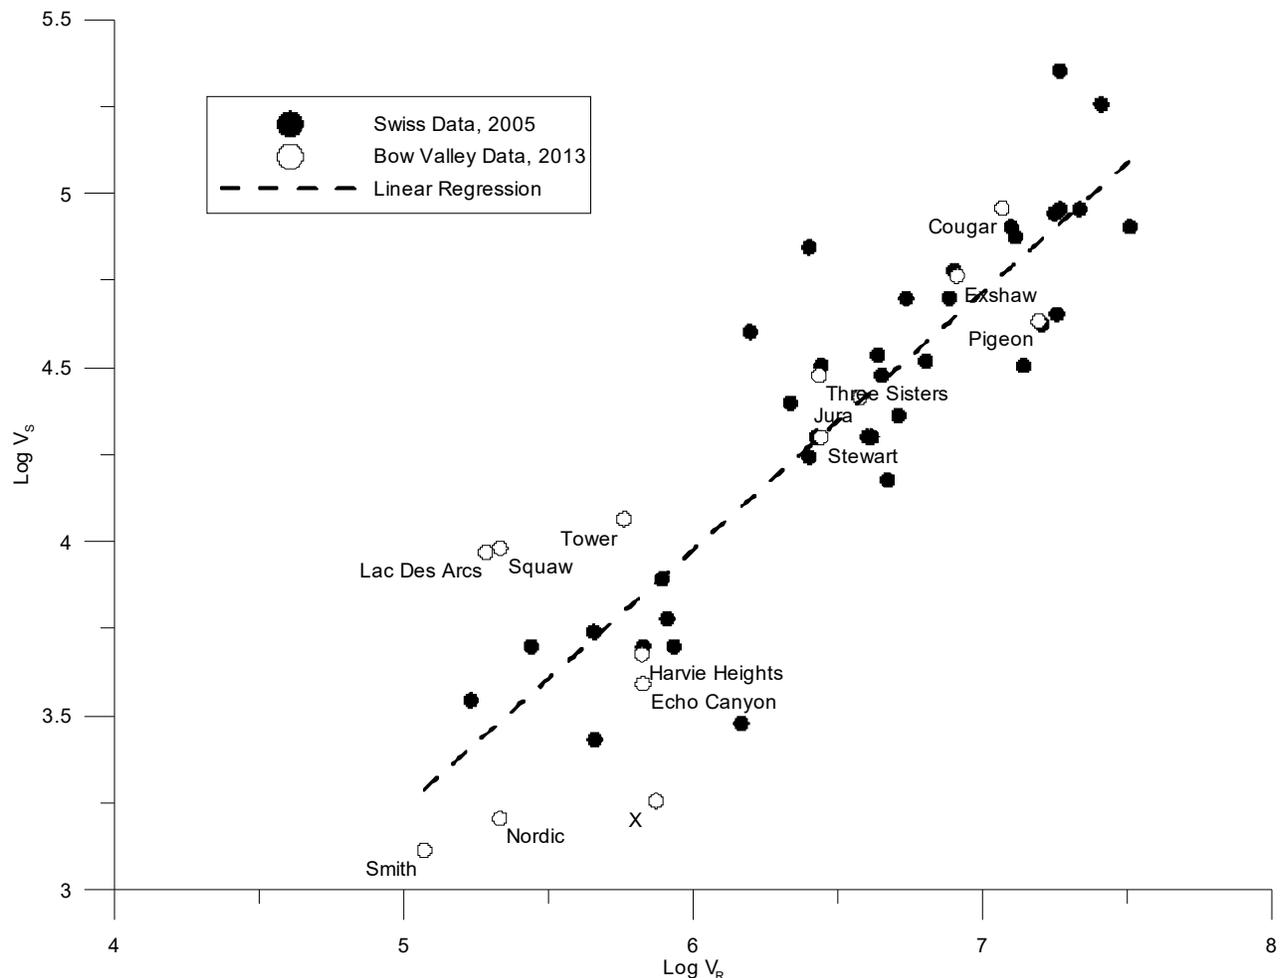
**Figure 5-3. Log transformed sediment (V<sub>S</sub>) and available water (V<sub>R</sub>) data from the Swiss and Bow Valley datasets compiled by Rickenmann and Koschni (2010) and BGC, respectively.**

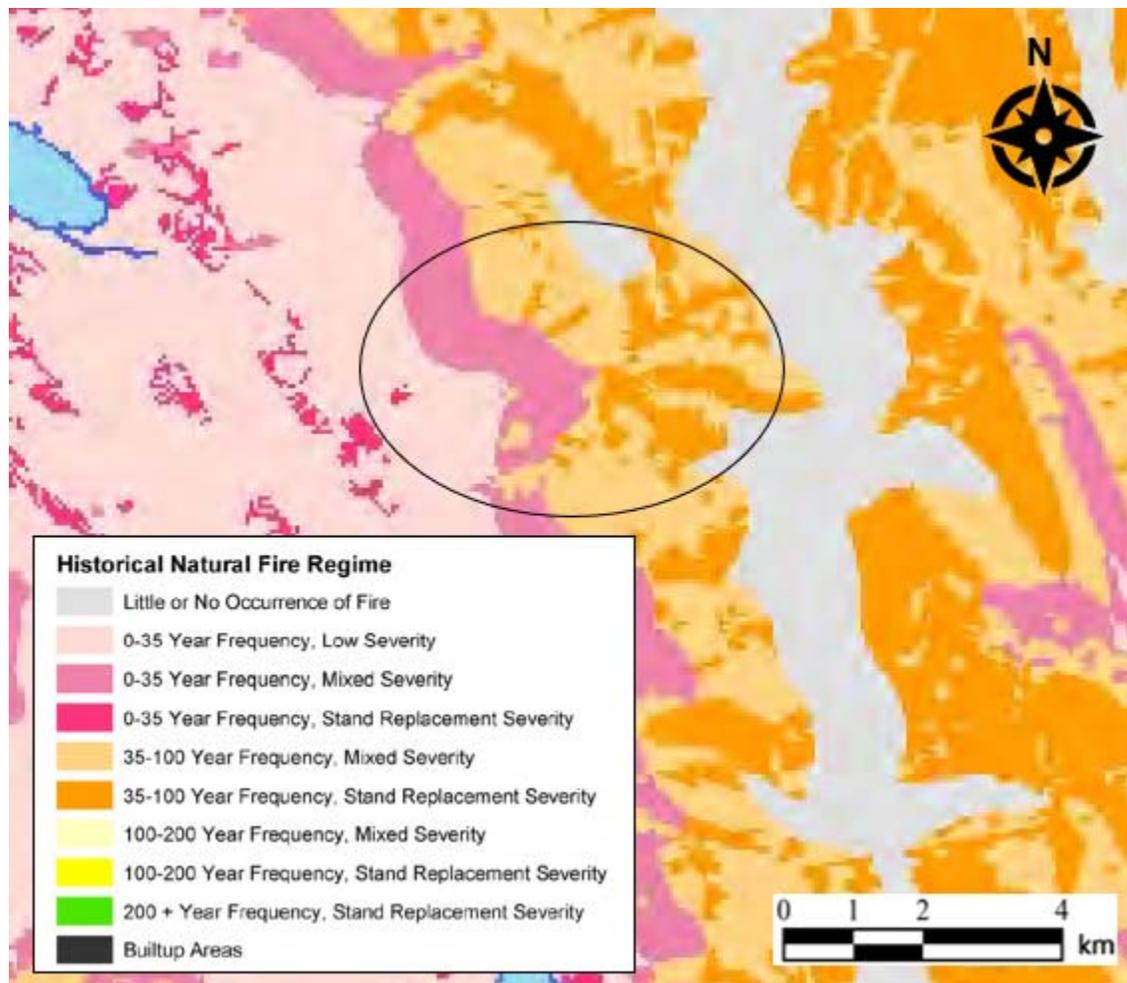
**Figure 5-4. Cut-out image of historic natural fire regime in the Cold Spring Creek watershed circled in black (Blackwell, Grey, & Compass, 2003).**

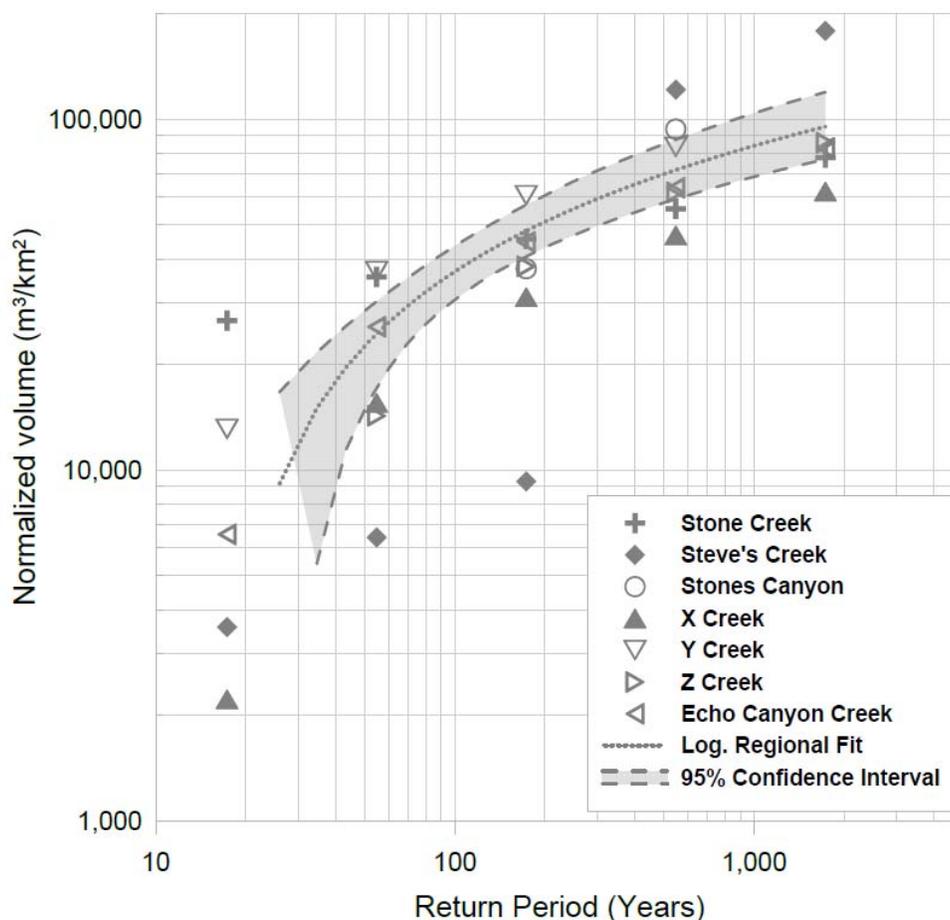
Figure 5-5. Regional debris flow frequency-magnitude data normalized by fan area for seven detailed studies in the Bow Valley, AB. From Jakob et al. (2020).

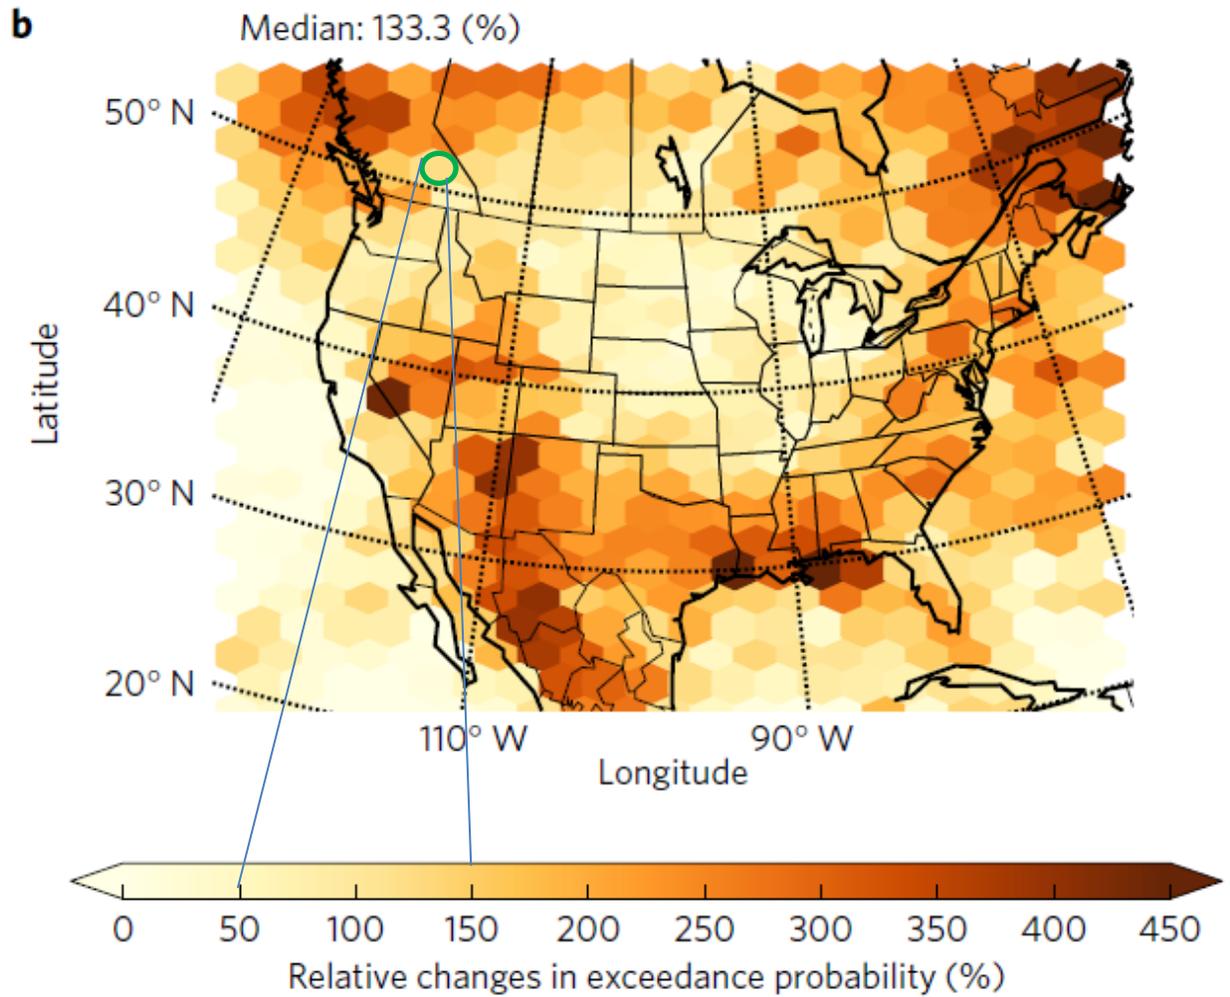
**Figure 5-6.** Relative changes in the exceedance probability of the 99.95th percentile of hourly precipitation intensities for June, July and August in large portions of North America (Prein et al., 2017). The rainfall intensity changes are estimated between 100 to 150%. A 100% increase implies a halving of the rainfall intensity return period. The approximate study site is circled in green.

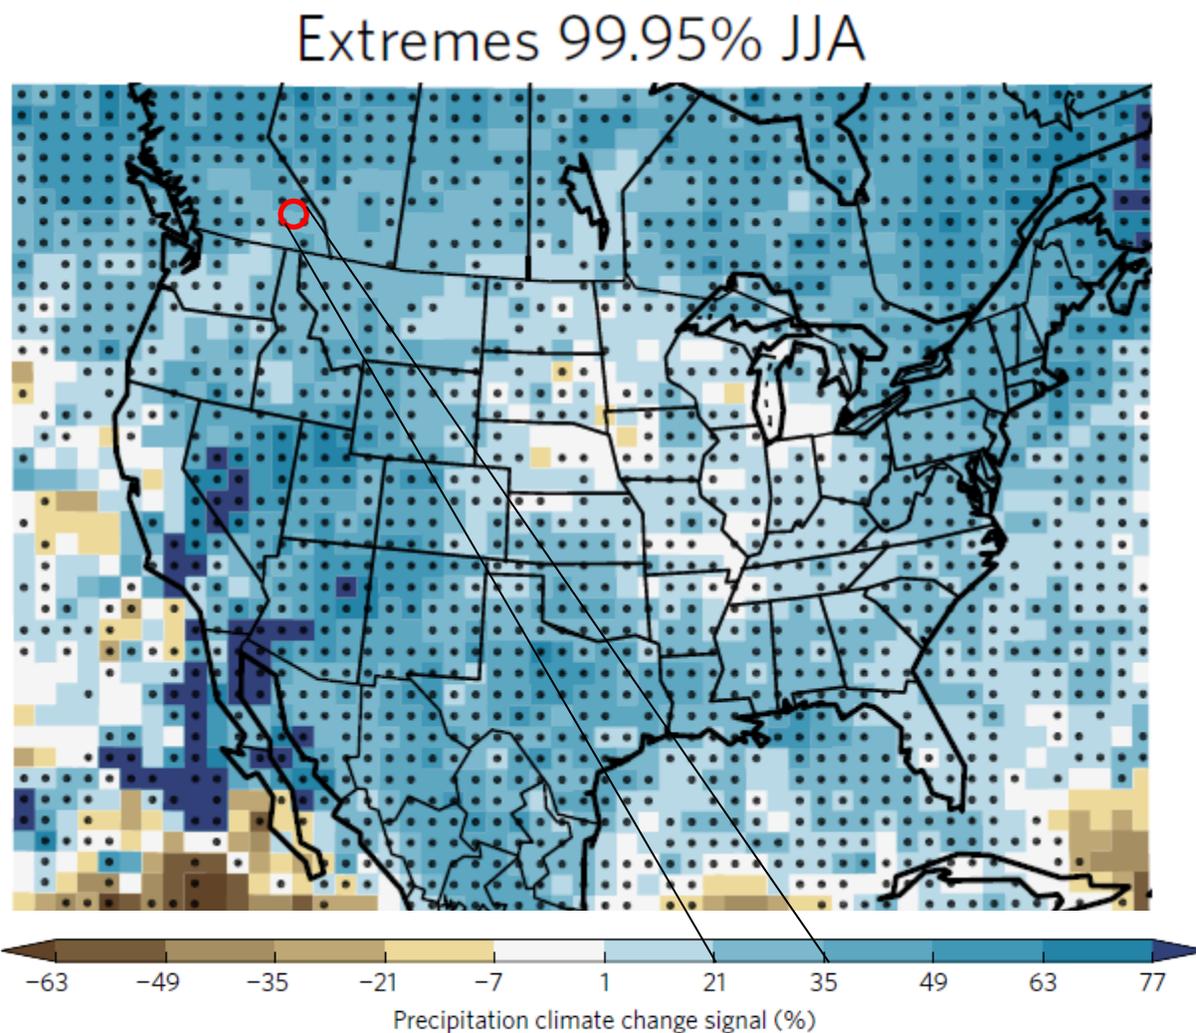
**Figure 5-7.** Hourly extreme precipitation for June, July and August expressed as relative changes for 100 x 100 km grid boxes. Dots indicate statistically significant changes. The approximate changes for the area of interest is between 21 and 35% (Prein et al., 2017).

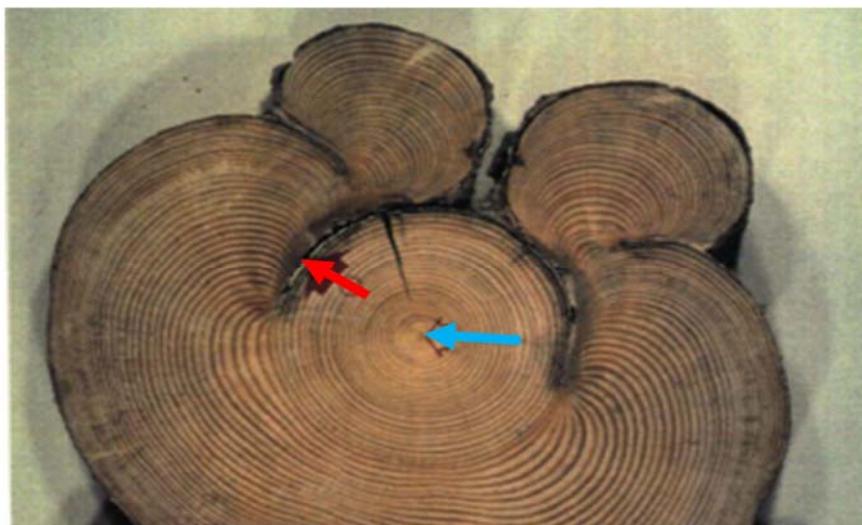
**Figure 5-8. Impact scars on a spruce tree near Fergusson Creek in southwest BC showing an example of scars that can be dated precisely. The red arrow points at a scar, and the blue arrow points at the center of the tree (from Jakob, 1996).**

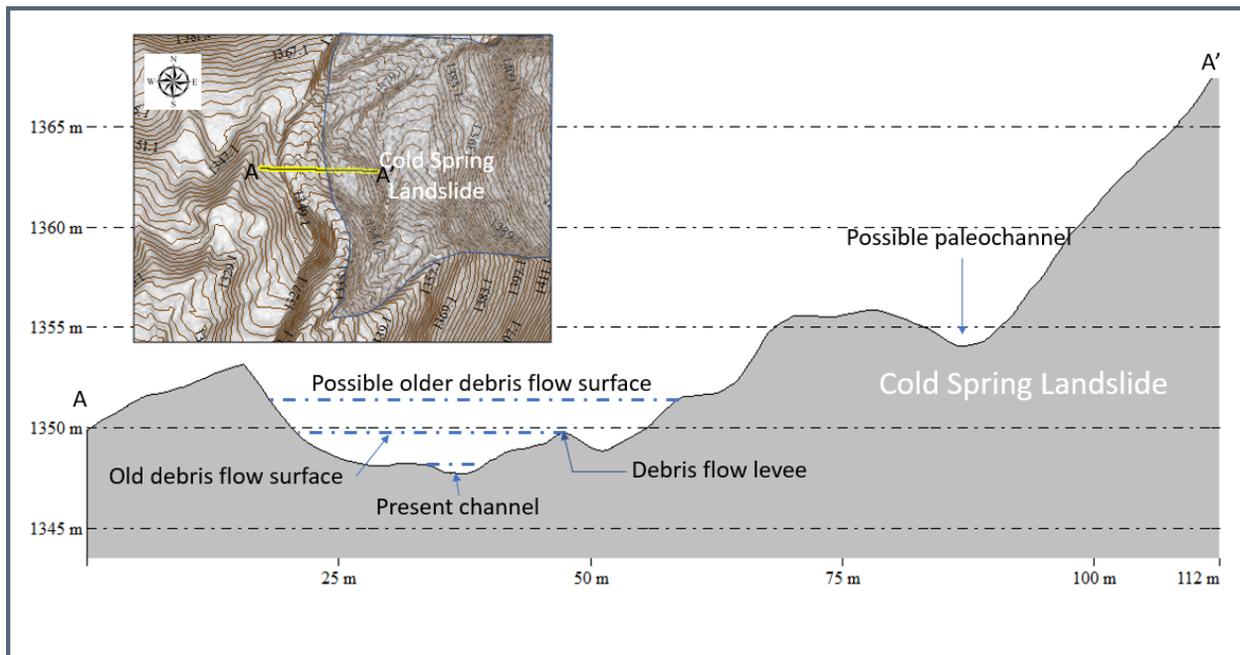
**Figure 5-9. Cross-section at approximately 1350 m across the Coldspring Creek channel looking upstream.**

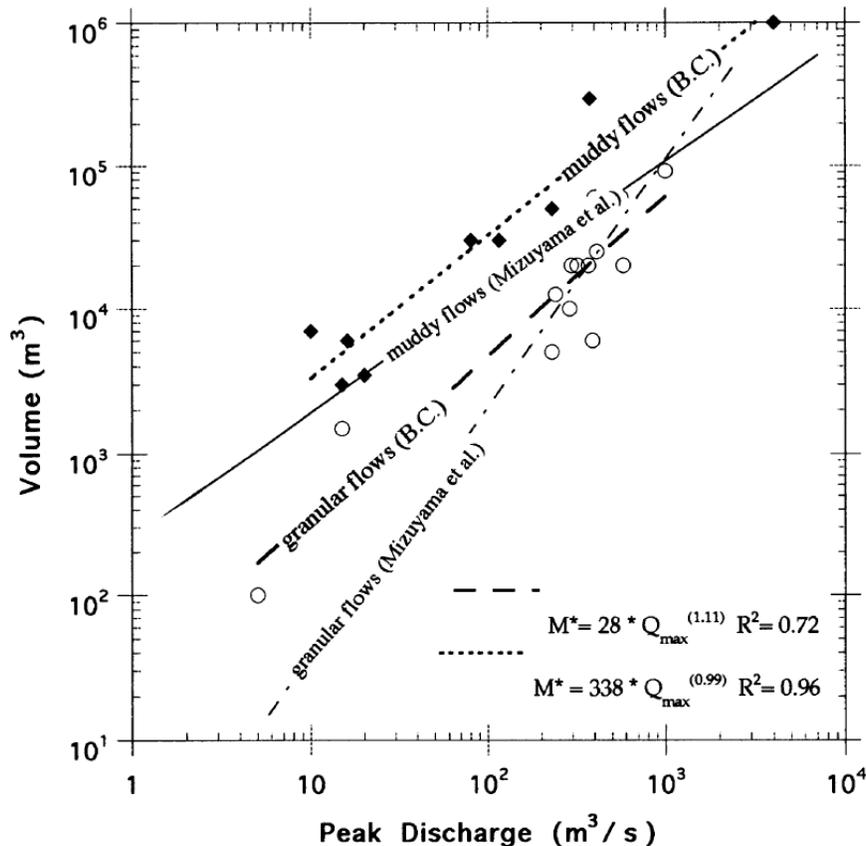
Figure 5-10. Bovis and Jakob (1999) relationship between peak discharge and volume for British Columbia, with comparison regressions computed by Mizuyama et al. (1992).

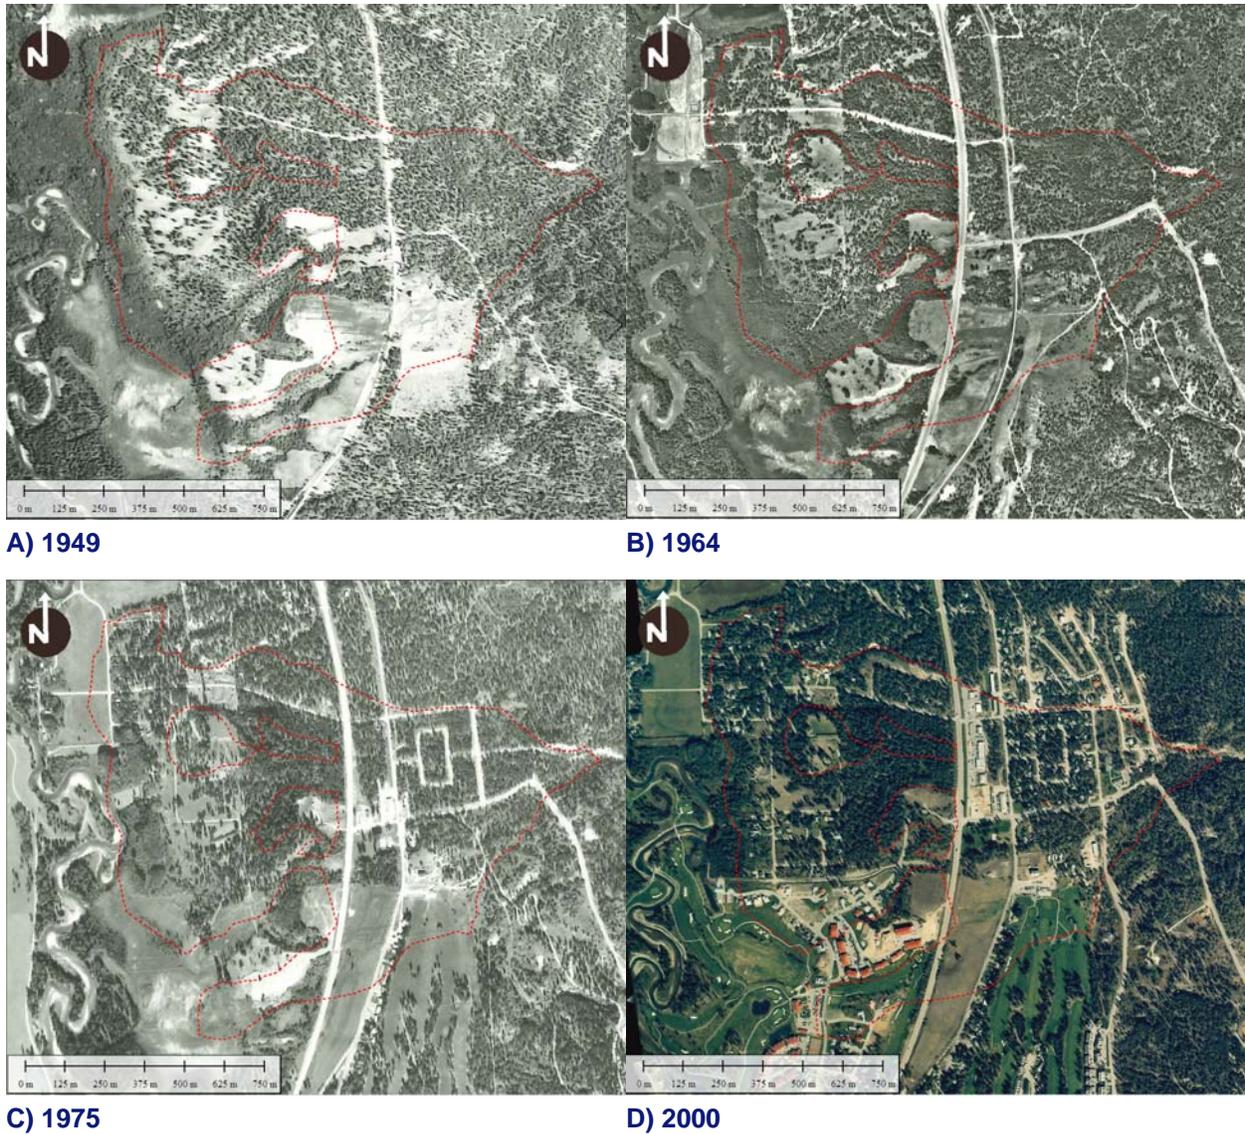
**Figure 6-1. Air photos of Cold Spring Creek fan from A) 1949, B) 1964, C) 1975, and D) 2000 showing development on the fan. Air photos have been manually georeferenced by BGC.**

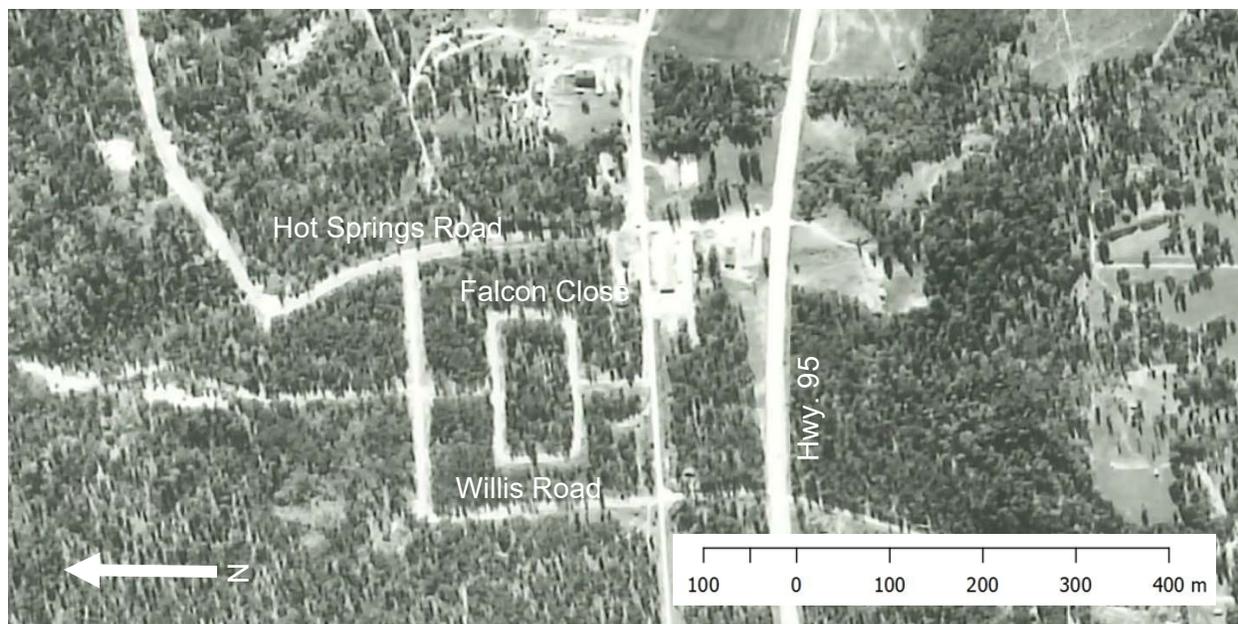
**Figure 6-2. Cutout of 1975 air photograph BC 7818, No. 17 (approximate scale: 1:20,000). The channel alignment of Cold Spring Creek is unclear at this time. Fairmont Close and Falcon Drive and Willis Road appear to just have been built.**

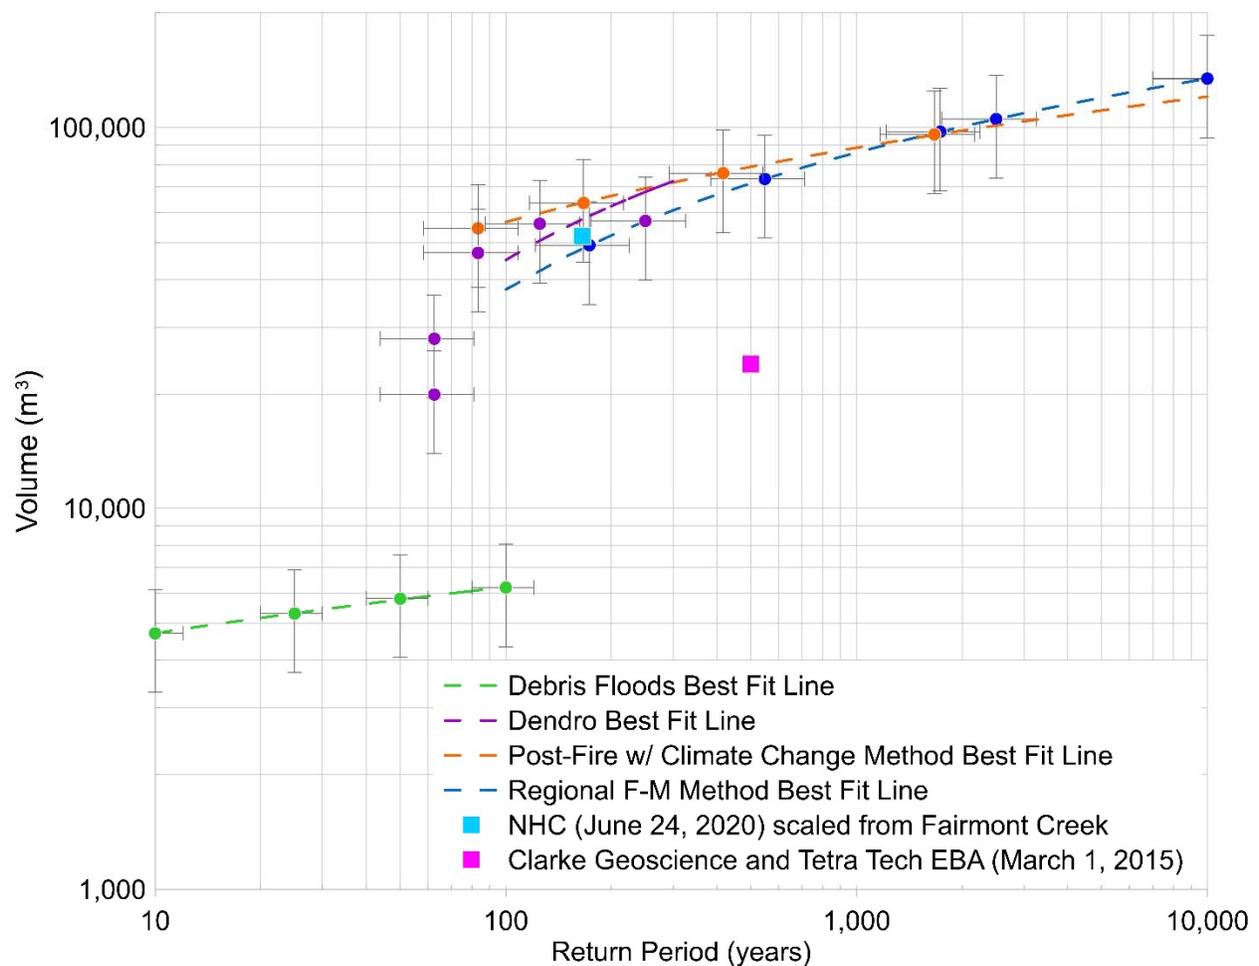
**Figure 6-3. The frequency-volume methods considered reasonable for Cold Spring Creek. Best fit lines are trimmed at the 100-year return period as BGC considers debris flows below that return period are unlikely. The figure also shows the Clarke Geoscience and Tetra Tech EBA (March 1, 2015) F-M estimate as well as the recently updated (NHC, June 24, 2020) estimate for Fairmont Creek adjusted by watershed area. Error bars are based on judgement.**

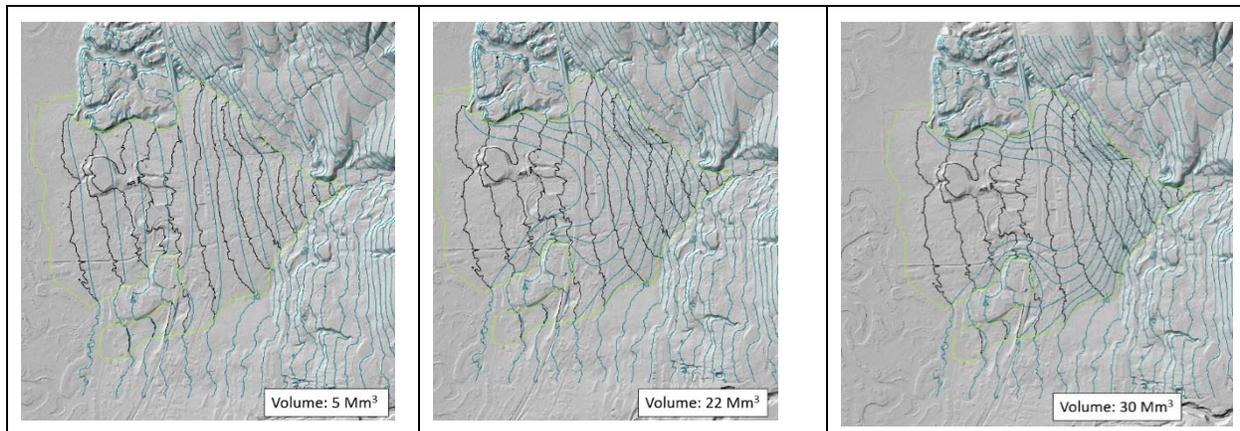
**Figure 6-4. Different models for fan volume reconstruction using the SLBL model.**

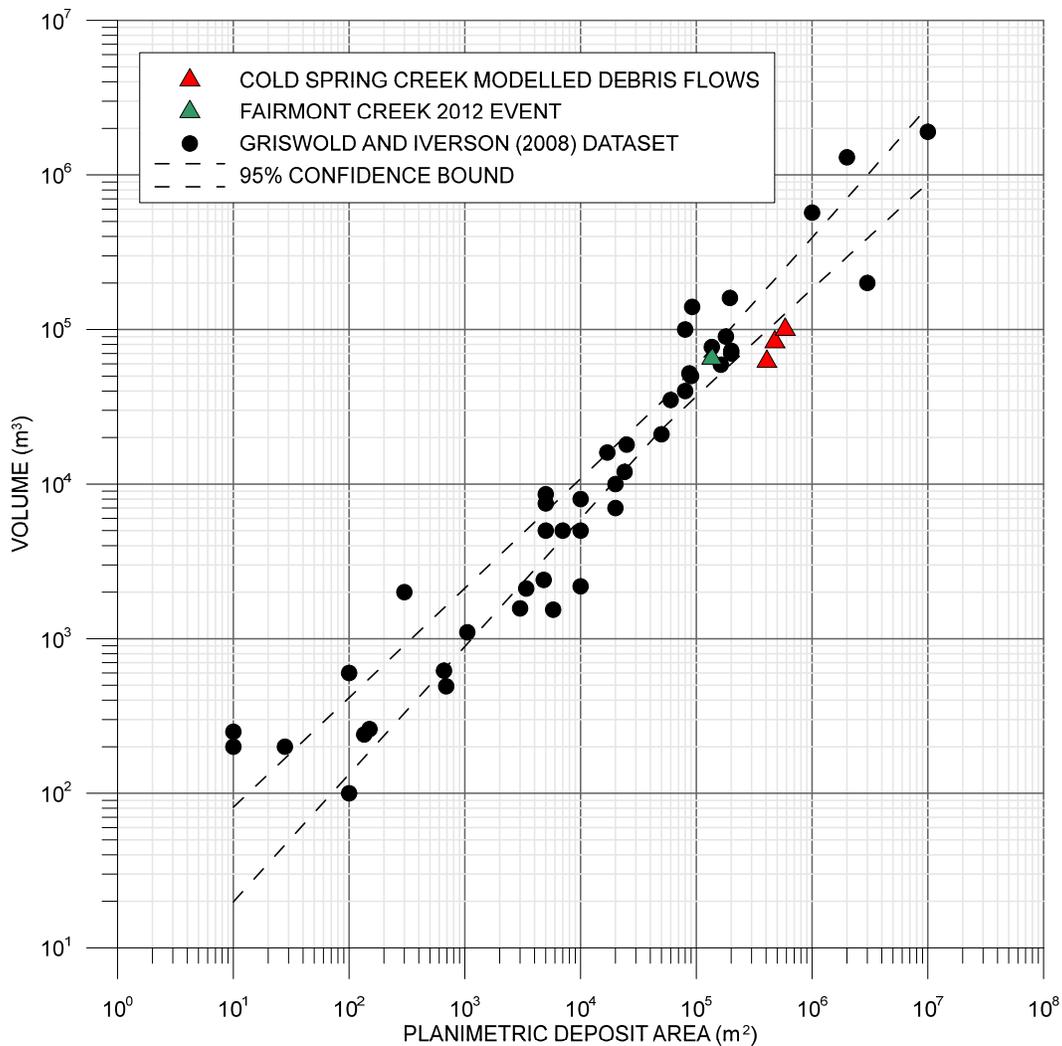
**Figure 6-5. Modeled event volumes for Cold Spring Creek (red) in comparison to typical non-volcanic debris flow dataset (black) developed by Griswold and Iverson (2008). The Fairmont Creek 2012 event (green) is shown for comparison.**

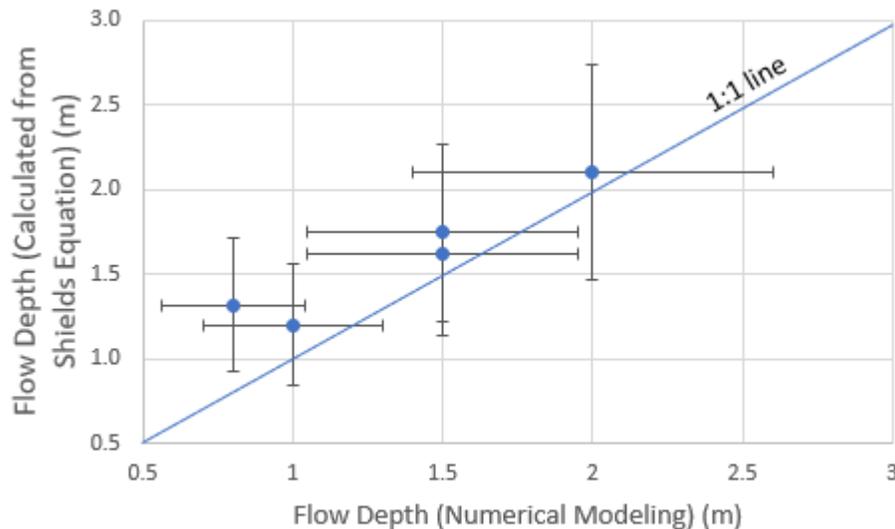
**Figure 6-6. Modeled flow depth vs. calculated flow depth using boulder size as a proxy for flow depth. The plot includes an estimated 30% error for both the numerical modeling flow depth and the calculated flow depth from the Shield’s equation.**
