Ministry of Environment & Climate Change Strategy
#401 - 333 Victoria St., Nelson, BC
V1L 4K3

March 17, 2022

Memorandum: Fish collection permit CB21-625527 Timber Ridge mussel salvage summary

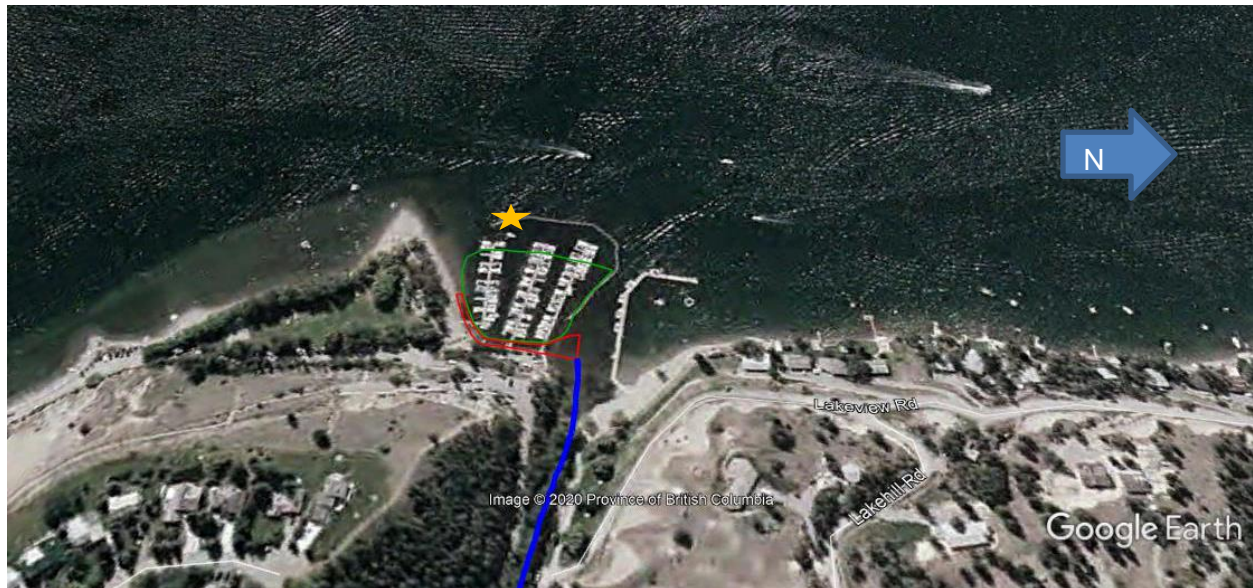
Figure 2. Maximum area to be dredged (green), shoreline excavation buffer zones (red), and mussel translocation areas (yellow star).

- 4) Representative photographs of live samples and habitat conditions were taken.
- 5) Salvaged mussels were returned to similar habitat in Windermere Lake (substrate type, and water depth), and outside of high use areas (e.g., recreation beach). The area for relocation was adjacent to the marina, as depicted in Figure 2.
- 6) Lastly, during the dredge, the environmental monitor (EM) inspected the dredged spoils for any remaining mussels. If found, they were to be salvaged and moved as identified above.

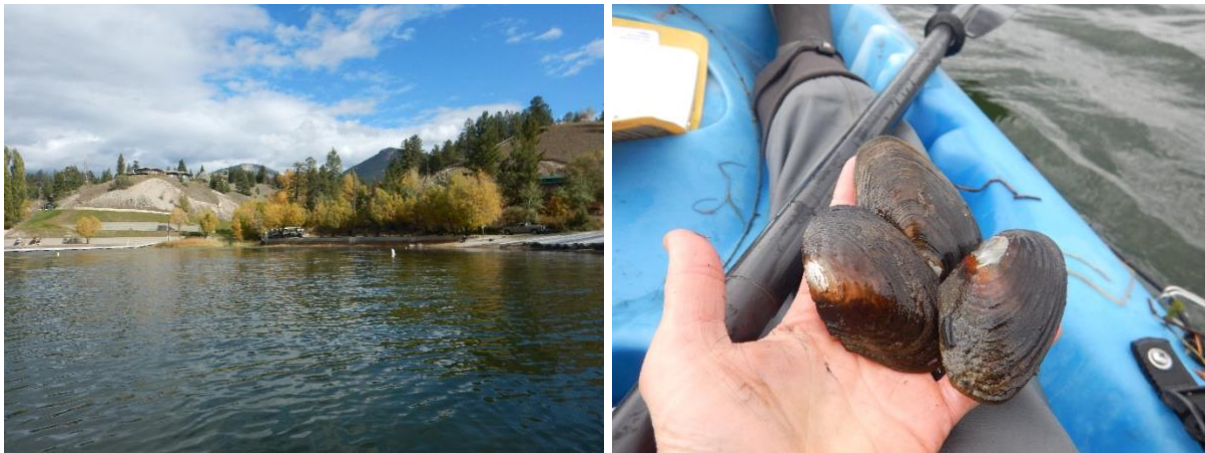
A total of 12 mussels were found during the fall survey. Of these, five were alive and seven were dead/empty shells. The live mussels were found in sand substrate habitat where there was no or little aquatic vegetation (Figure 3, Figure 4). Water depths were approximately 1 m. The mussels were present here because this is where there was improved flow with oxygenated water, as opposed to the heavily vegetated shallow sections of the marina.

Figure 3. View towards shore of Timber Ridge marina and mussels salvaged on Sept 29, 2021.

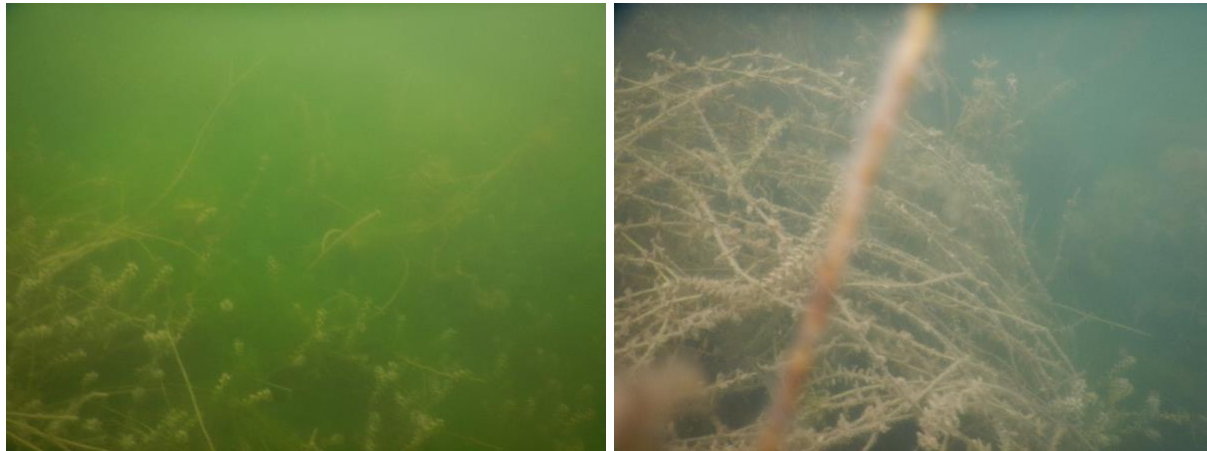
Figure 4. Poor water clarity due to thick aquatic vegetation growth and algae in the shallower areas of the marina (Sept 29, 2021).
