Burges James Gadsden Provincial Park

Wetland Restoration Design Plan

Date: July 24, 2019

Prepared for: BC Parks

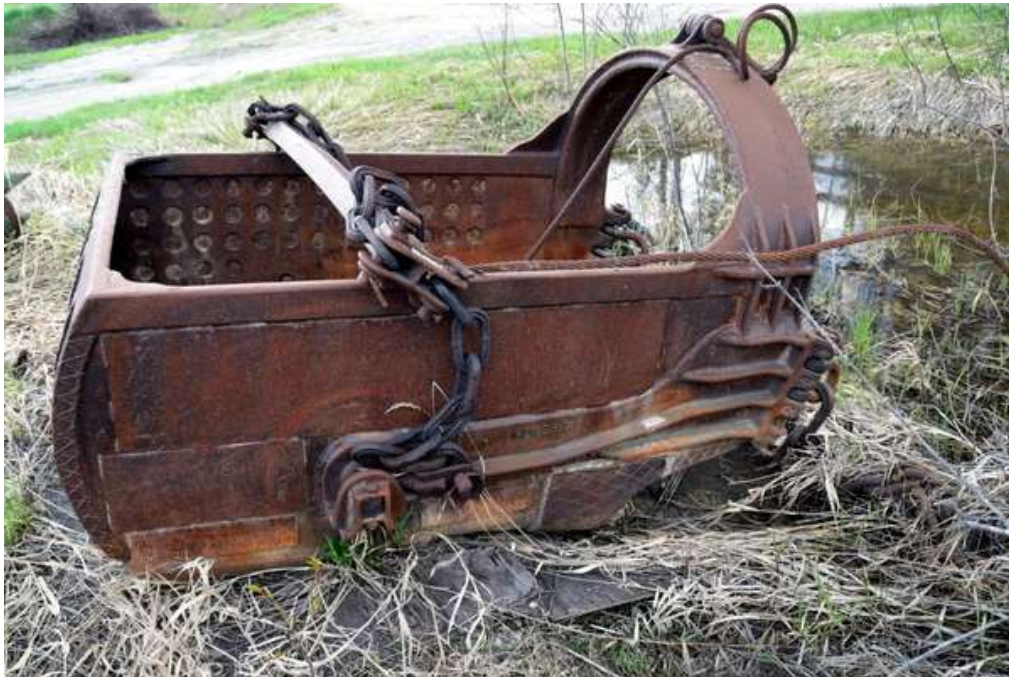
Dragline bucket used to drain Moberly Marsh

A dragline was used to build the dikes. A dragline bucket may be observed on private land adjacent to the Park. The long and narrow areas where soil was removed to build the dams are the main places that contain water within the Park. This is because the excavations were deep enough to expose groundwater.

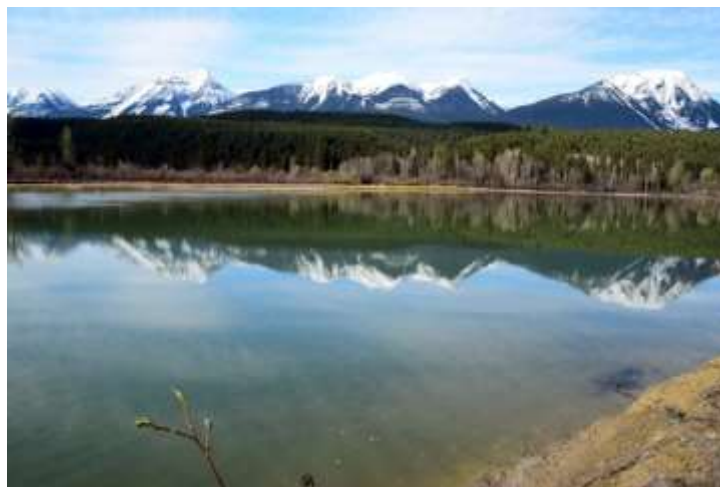
Figure 1. The Columbia River, shown here, once flooded Burges James Gadsden Provincial Park. The seasonal flooding was of critical importance to maintaining natural wetlands, and the animals and plants using them.

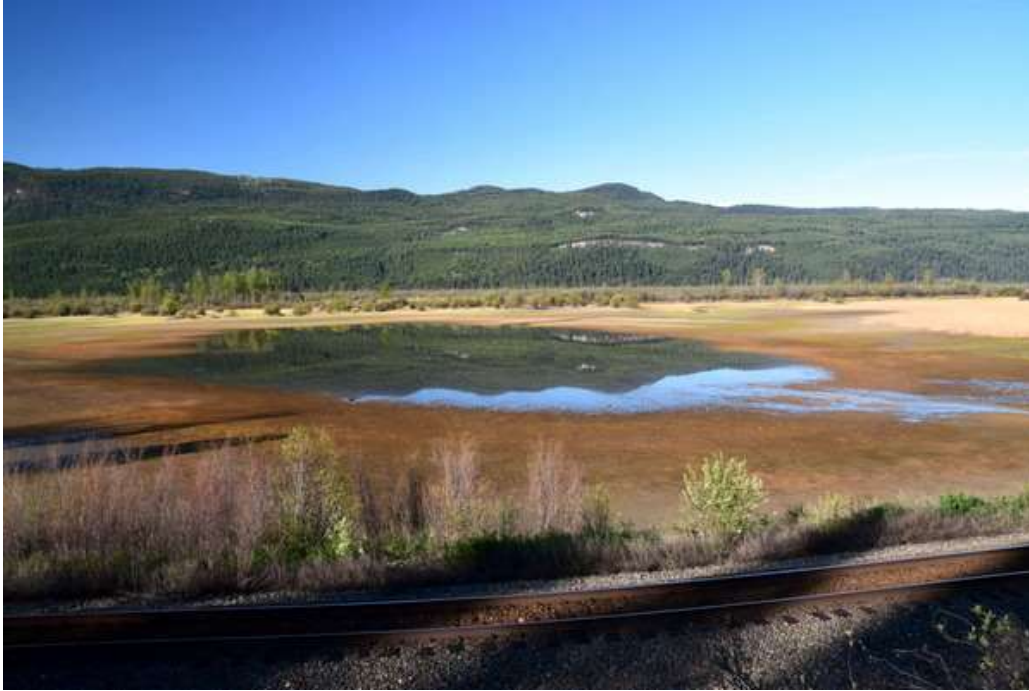
Figure 2. Natural ephemeral wetlands like the one shown may be restored in the Northern portion of Burges James Gadsden Provincial Park.

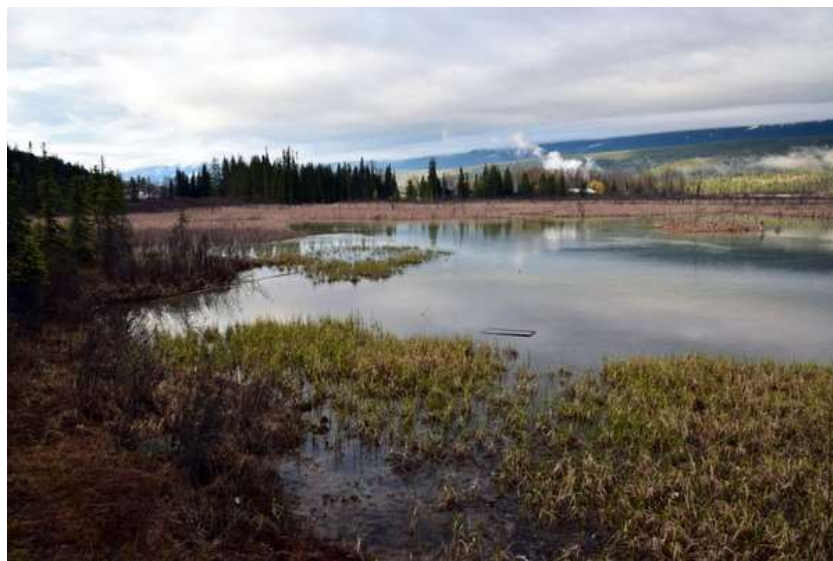
Figure 6. The Southern two-thirds of the Park historically contained large, perennial, shallow open-water wetlands, as shown here. This wetland is located near the town of Golden, BC.

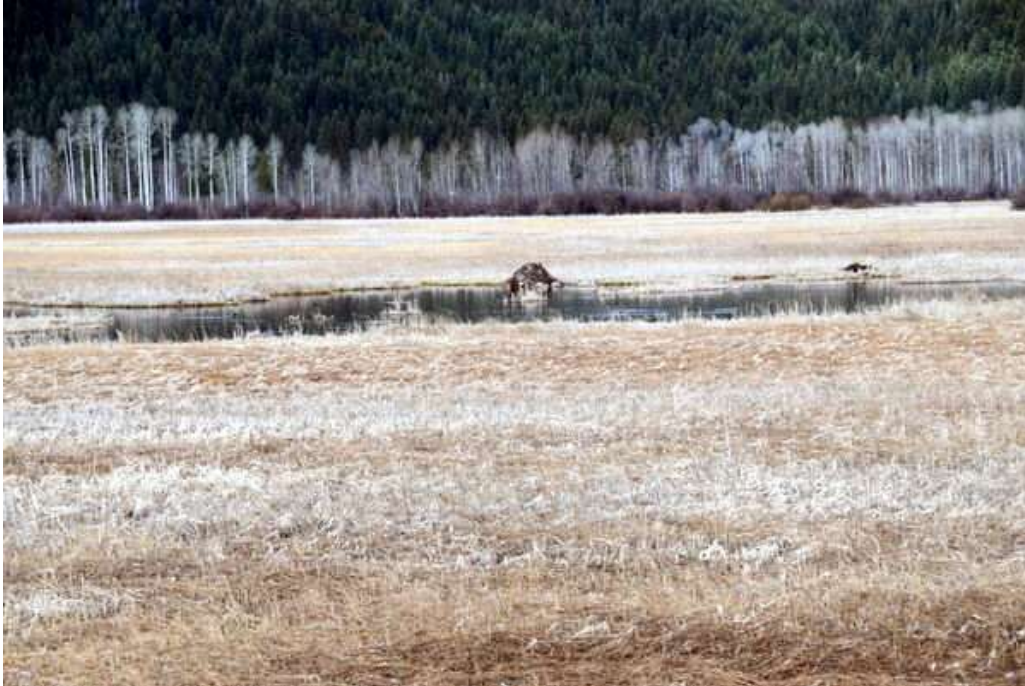
Figure 7a. This open-water wetland containing beaver lodges is the most visible feature in Moberly Marsh when traveling the TransCanada Highway. Beaver made the pond by building a dam across two ditches dug after 1965.

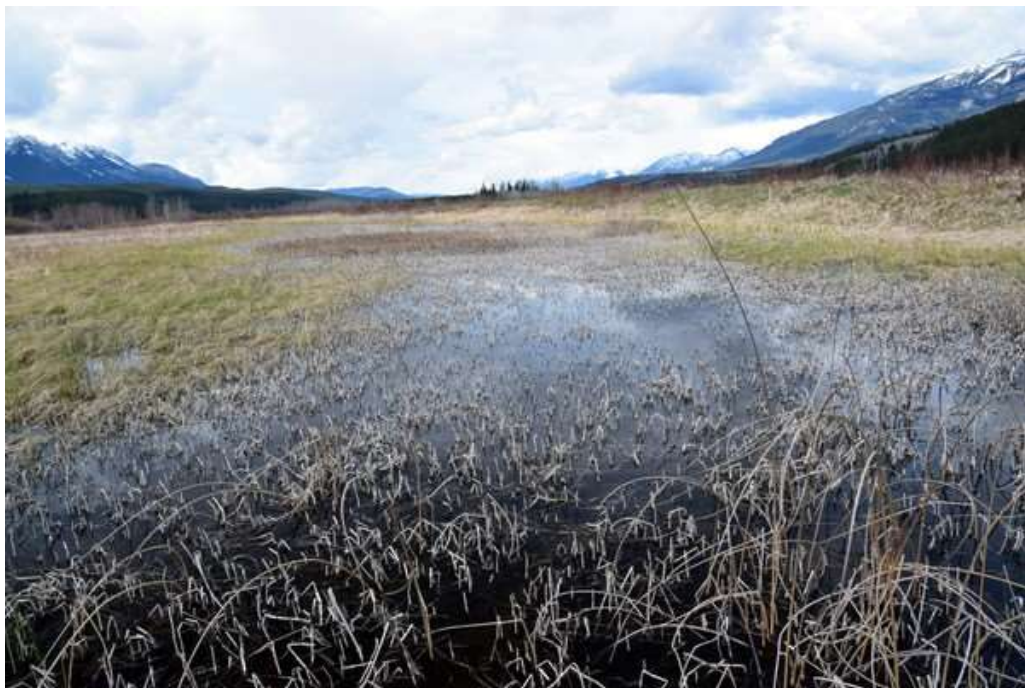
Figure 7b. Few natural streams, like the one shown here, remain in the Park. Most were turned into ditches for draining wetlands.

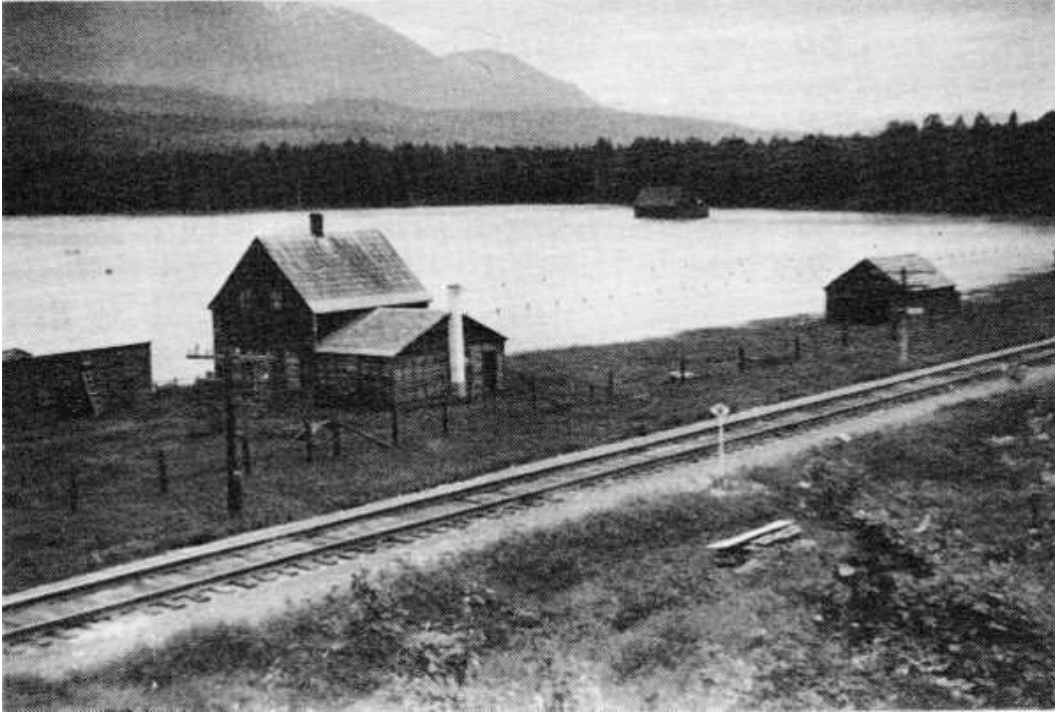
Figure 8. 1948 photo of Moberly Marsh showing the Harry Cooper's home during a flood (Blaeberry Homesteaders book page 85).

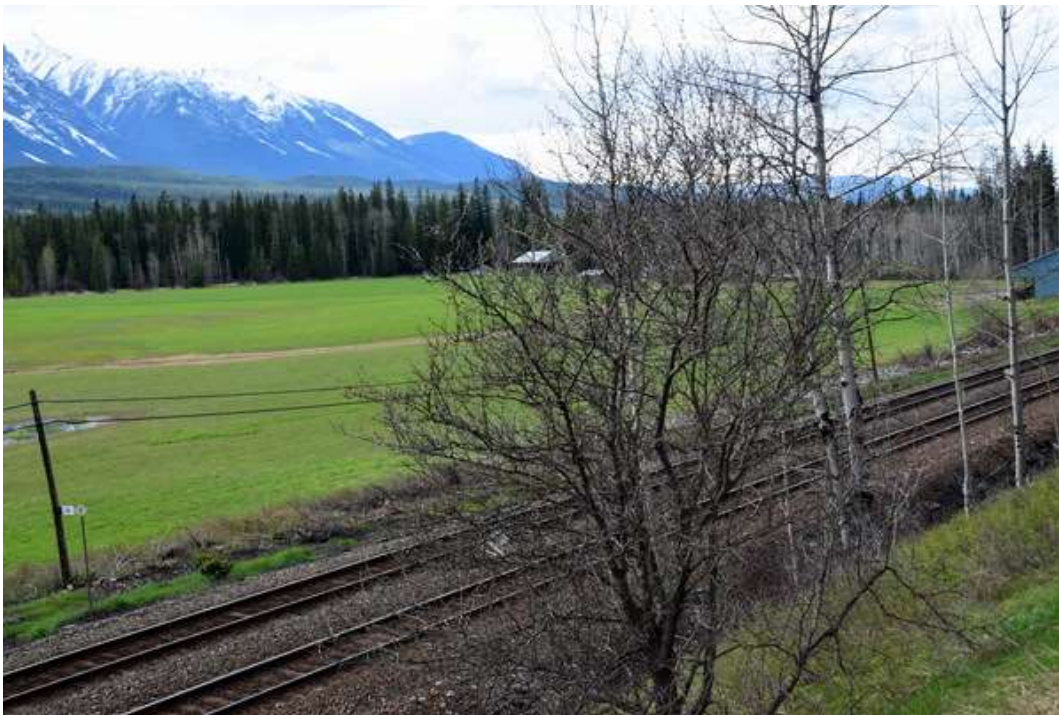
Figure 9. May, 2019 match of Moberly Marsh showing where Harry Cooper's home once stood. Stones were found from the home's foundation.

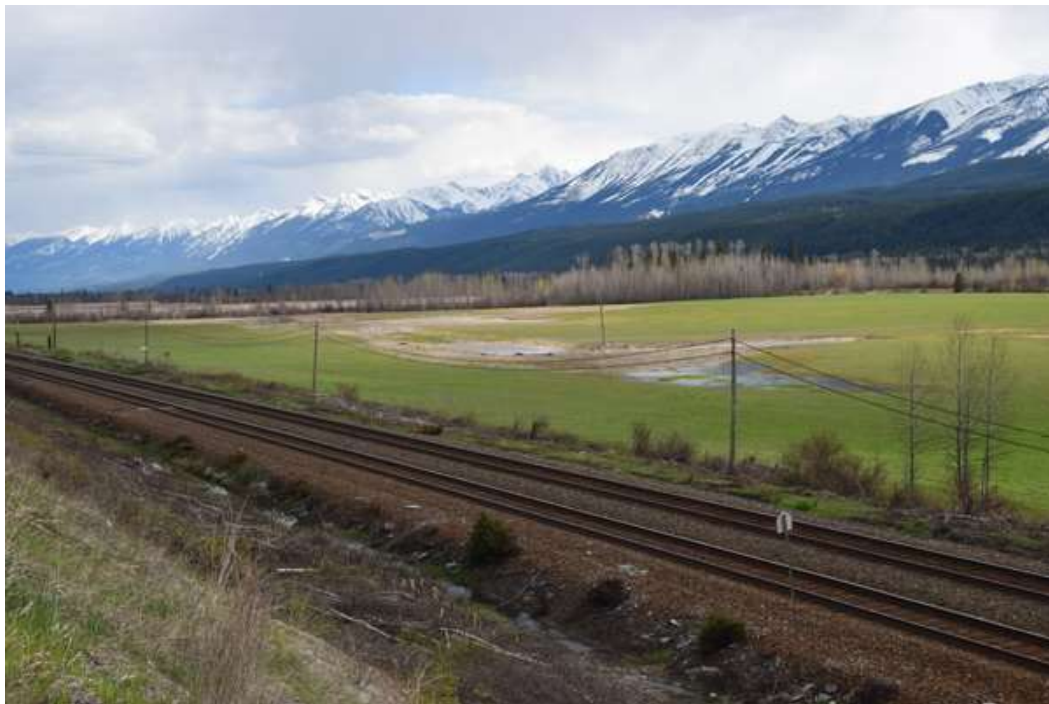
Figure 11. May, 2019 match of the photo on page 85 of the Blaeberry Homesteaders Book. Note the wetlands recently restored in the field.

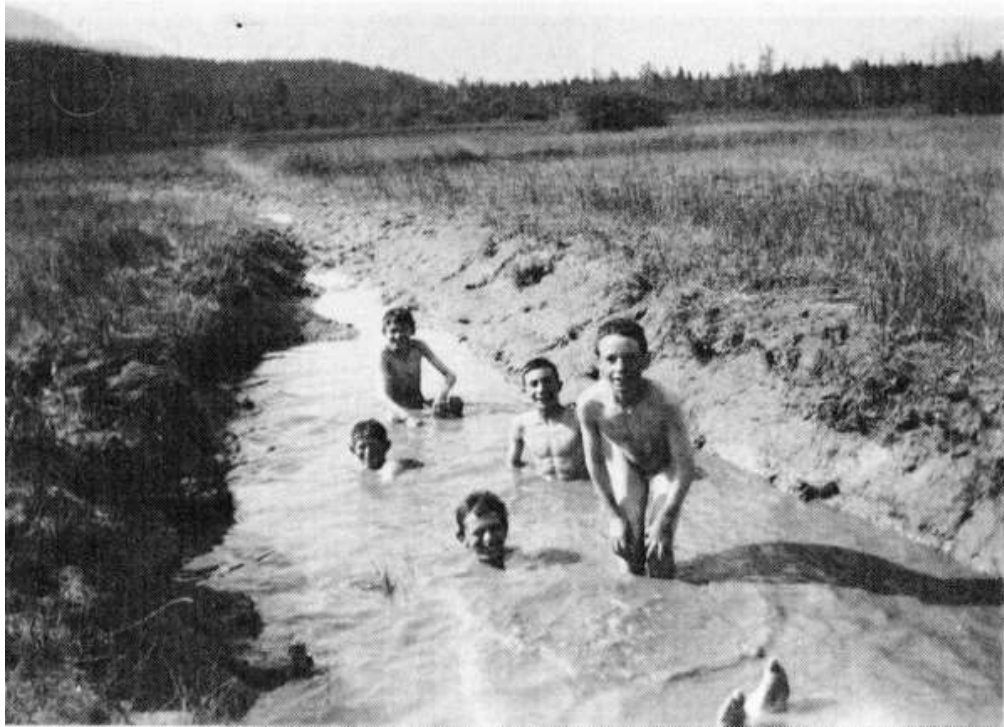
Figure 12. Boys swimming in ditch within Moberly Marsh. Blaeberry Homesteaders Book page 99. The author says the ditch was dug in the 1920's. The photo appears to have been taken in the 1940's.

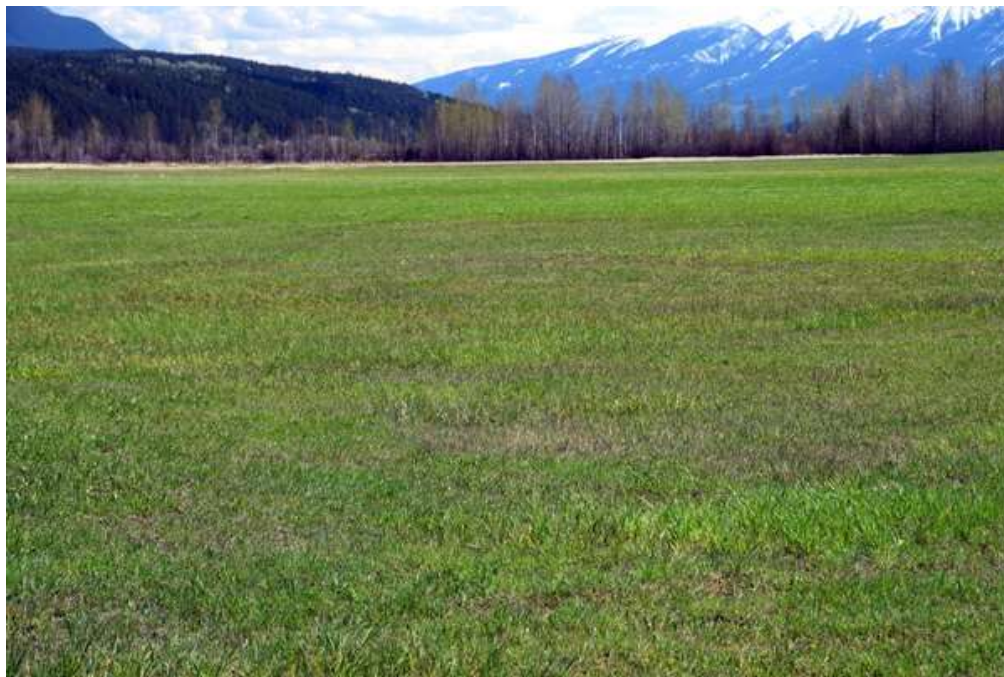
Figure 13. Approximate match of the photo showing the boy's swimming on page 99 of the Blaeberry Homesteaders Book. Photo taken in May, 2019.

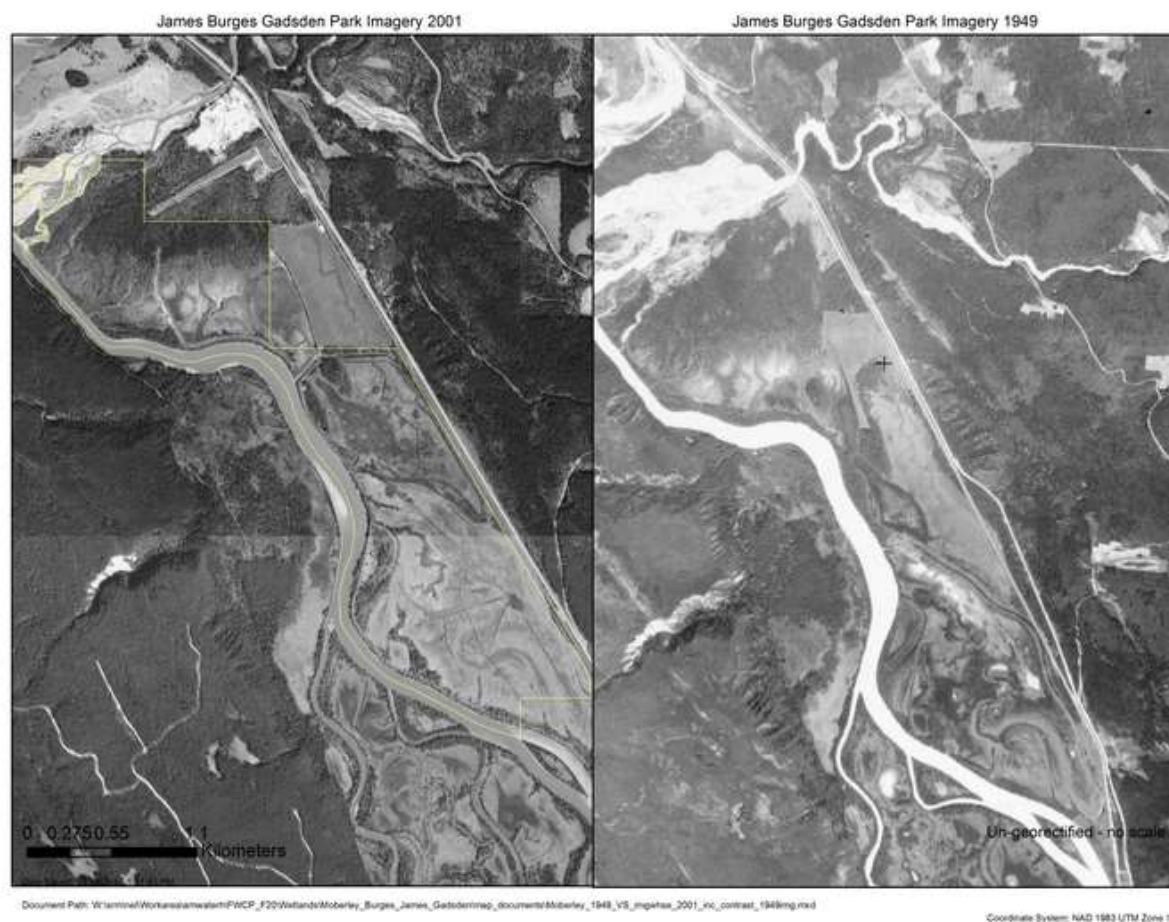
Figure 14. 2001 (left) and 1949 (right) aerial photos showing Moberly Marsh and Burges James Gadsden Provincial Park.

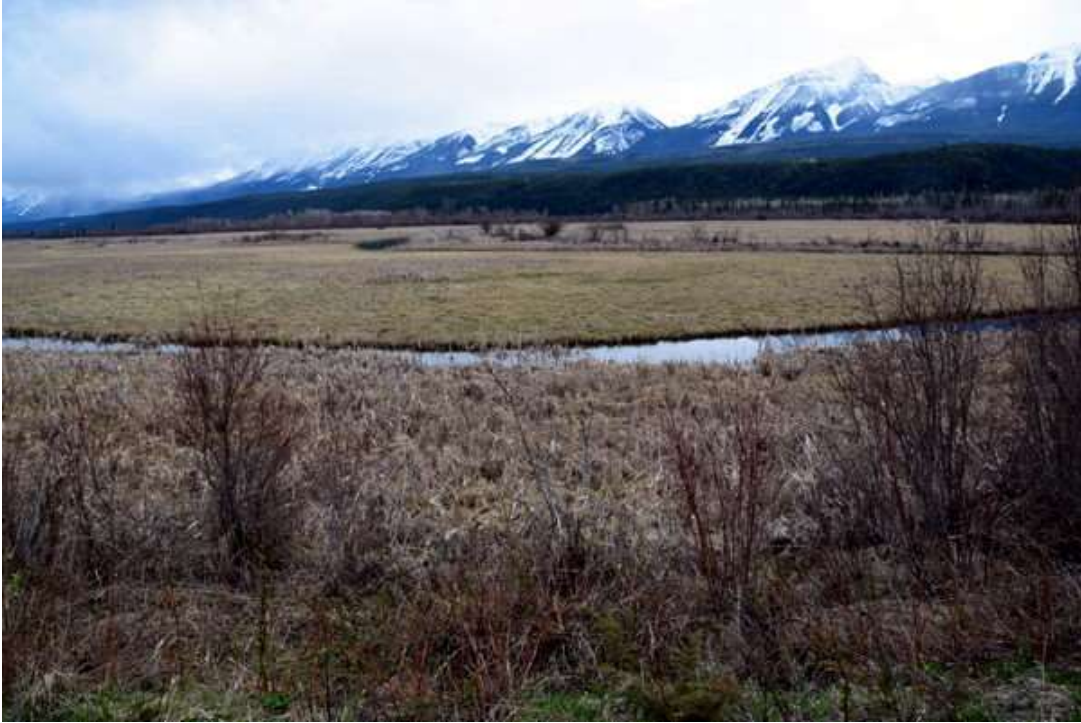
Figure 17. Constructed ditches like the one shown here are draining Moberly Marsh. Note the change in vegetation on either side of the ditch. The cattails growing in the foreground on higher ground show that more water is present compared to sedges and grasses growing on the other side of the ditch. The ditch is moving water out of the wetland.

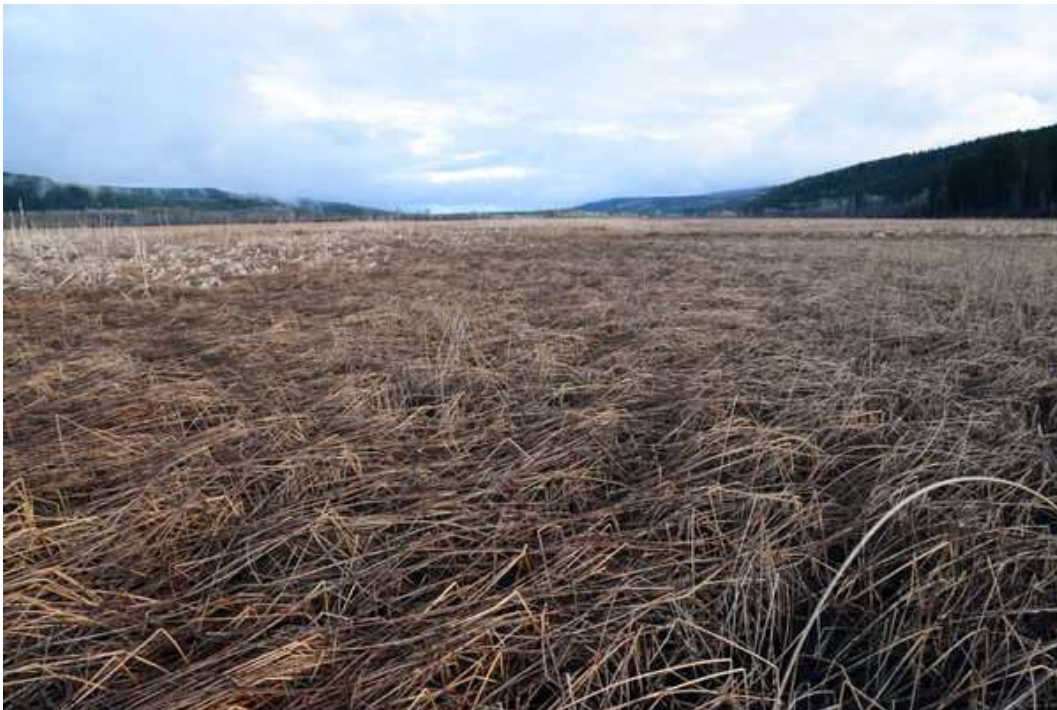
Figure 18. A dense growth of bulrushes grows where there was once a large wetland containing open water within Burges James Gadsden Provincial Park.

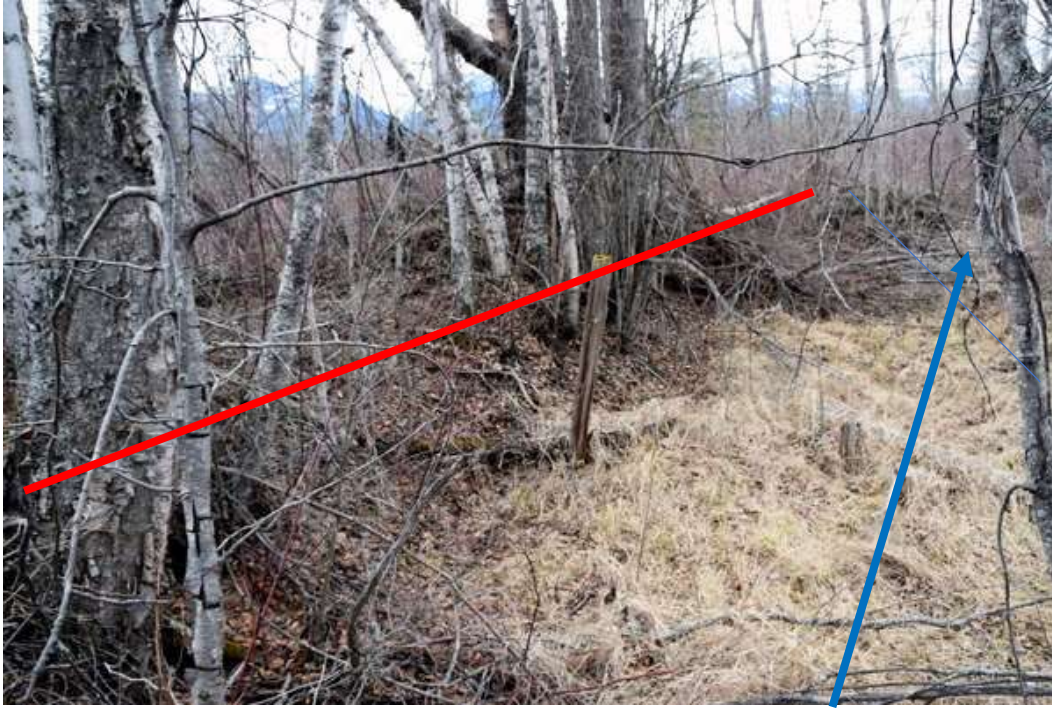
Figure 20. The red line marks a section of a dike built before 1965. The blue arrow marks a ditch dug at the same time. The dike was built using soil removed from digging the ditch, and helped prevent water from the Columbia River from flooding a portion of Moberly Marsh.

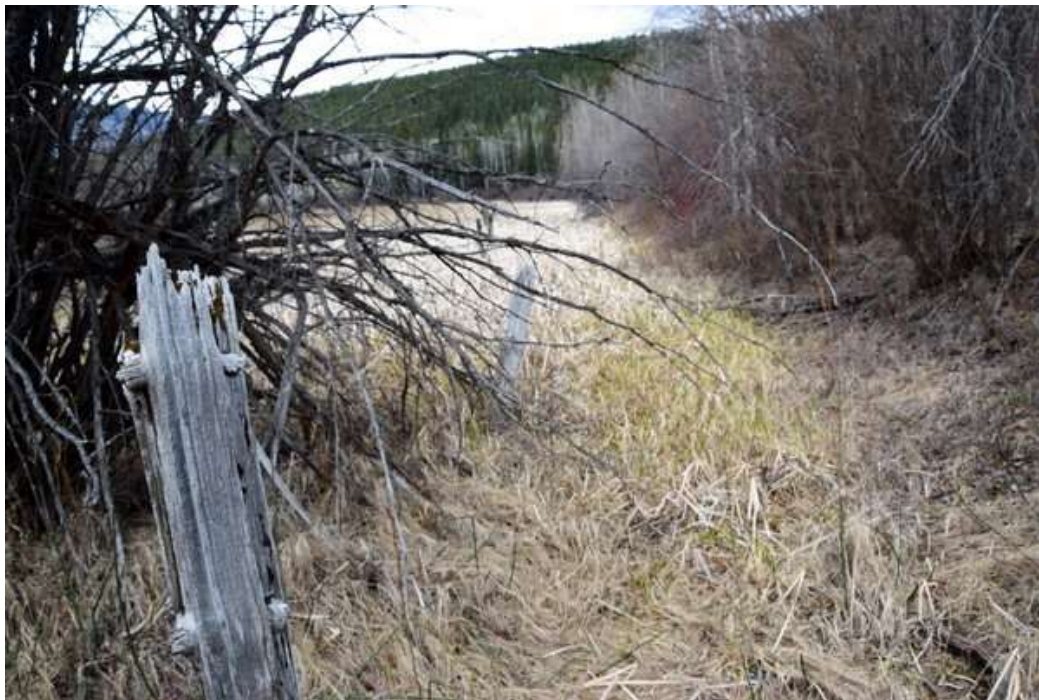
Figure 21. The fence posts show that portions of the Park were farmed and used for pasture. The ridge of trees on the right is a road and dike constructed across Moberly Marsh years ago.

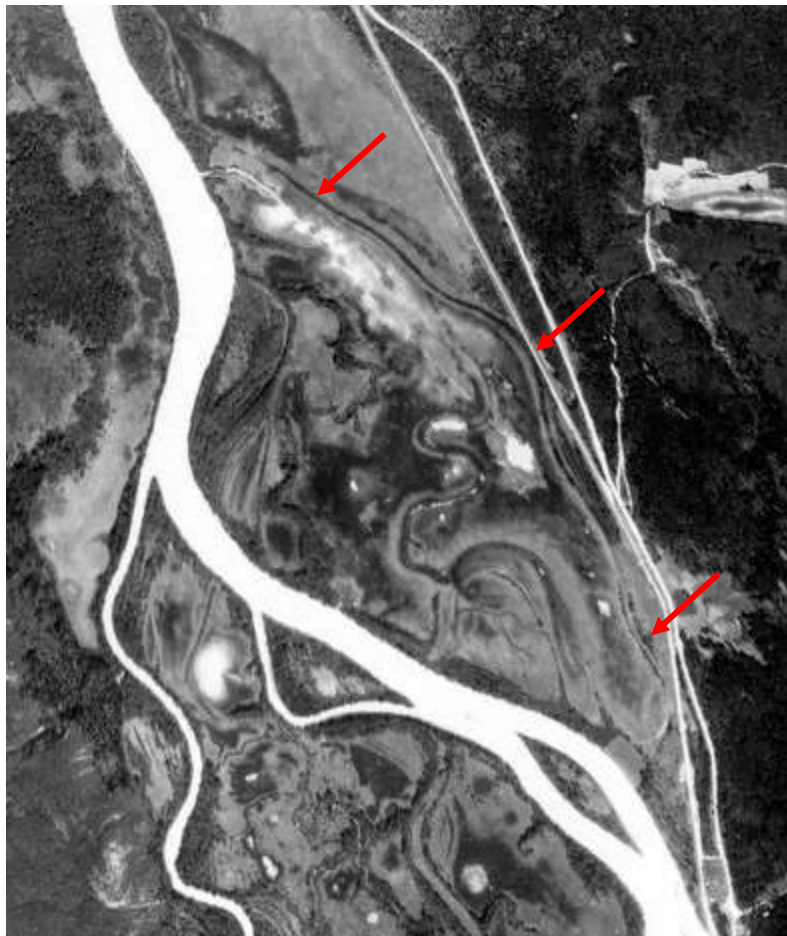
Figure 22. Arrows point to the probable historic channel of Moberly Creek on this 1949 aerial photo (GeoBC, 2019)

Moberly Creek appears to have historically flowed into Moberly Marsh. The stream was likely moved and straightened so that it would flow into the Columbia River at a right angle, and not enter Moberly Marsh. The stream may have been moved and channeled to create farmland, and too facilitate the construction of the railroad and TransCanada Highway 1.

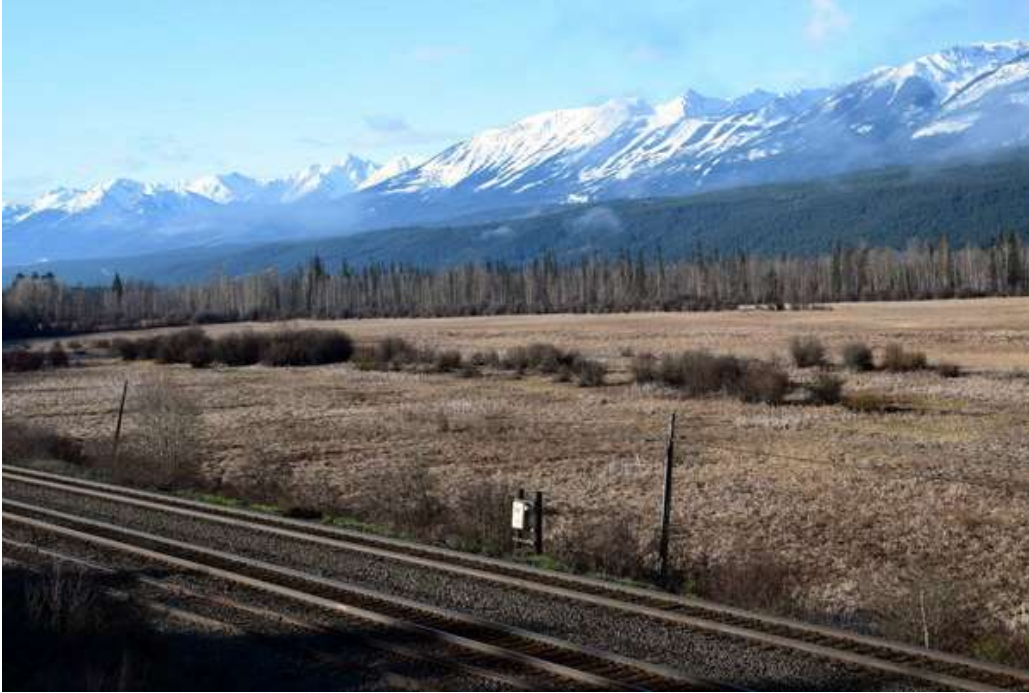
Figure 23. It is very possible the rows of willows are growing on the banks of Moberly Creek, before it was diverted from entering Moberly Marsh.

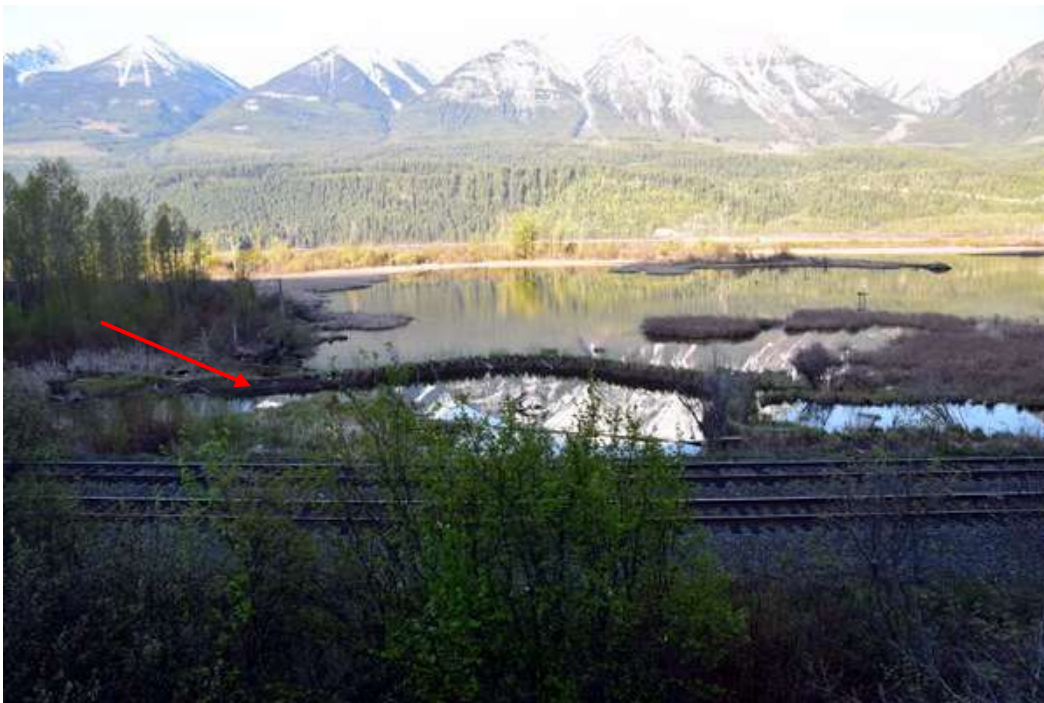
Figure 24. The red arrow points to a beaver dam across a stream entering a natural wetland along the Columbia River, South of Golden. The stream flows through a culvert under the railroad tracks. Moberly Marsh may have appeared like this when Moberly Creek entered the large wetland.

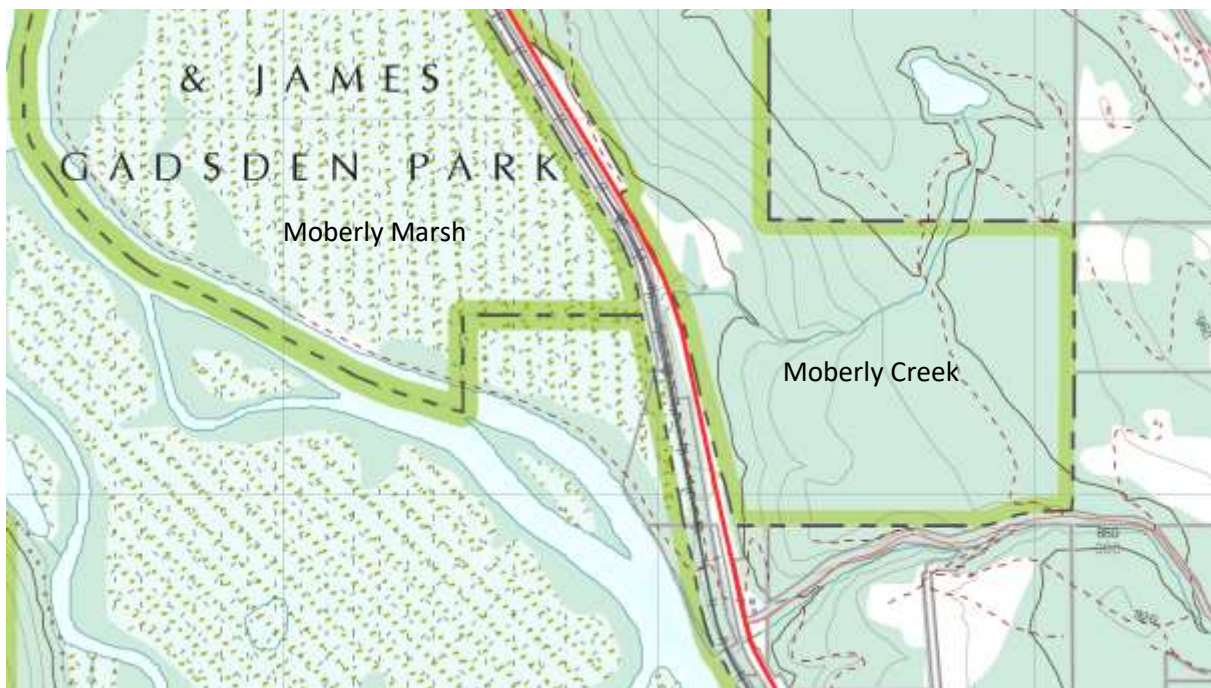
Figure 25. This topographic map shows that Moberly Creek once flowed into Moberly Marsh. (GeoBC, 2019)

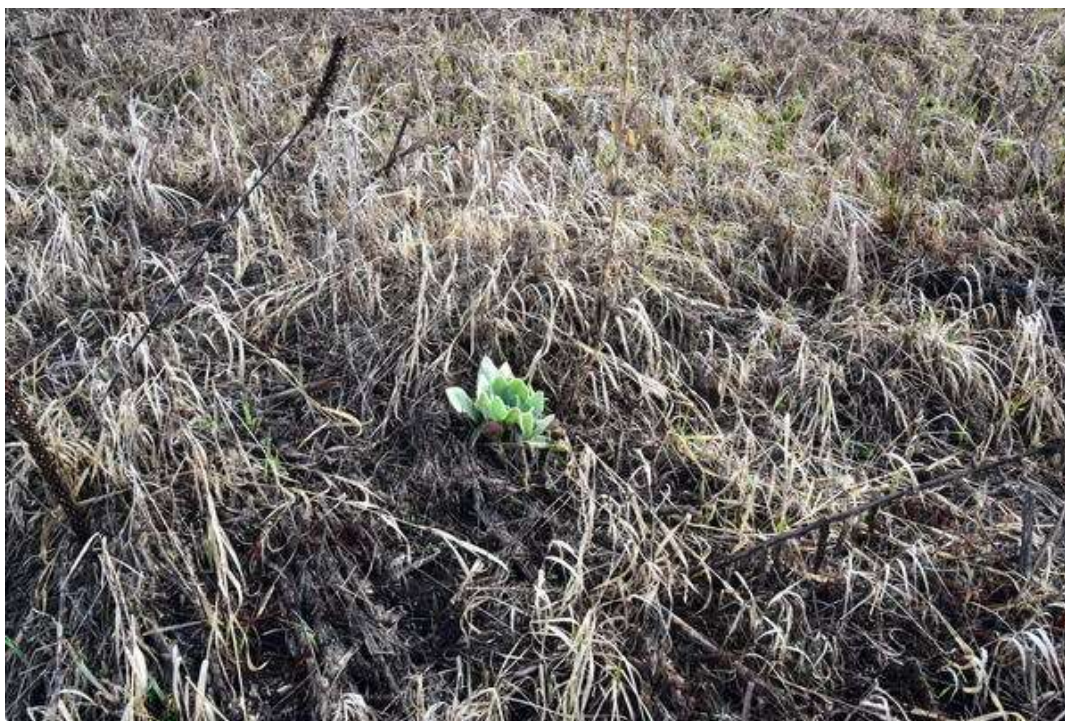
Figure 28. Mullein and reed canary grass grow in old fields once part of Moberly Marsh.

Reed canary grass and the nonnative plant Mullein was found growing on the land that was once farmed. A livestock feeder was found in the Northern part of Burges James Gadsden Provincial Park, showing the wetlands were used for pasture.

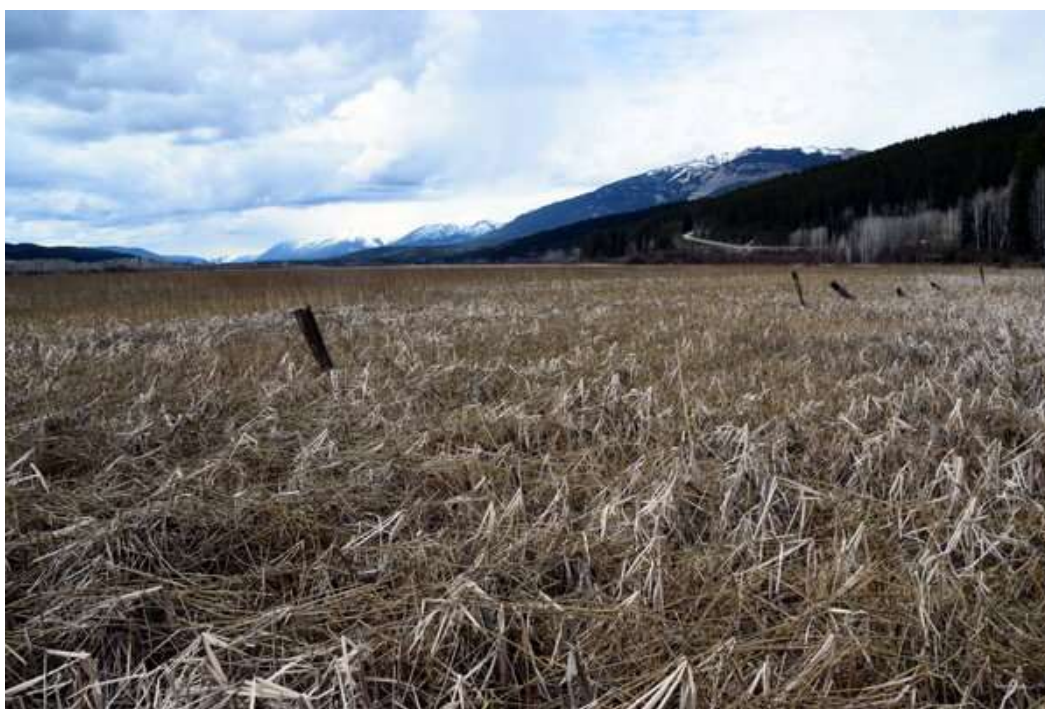
Figure 29. Wood fence posts and woven wire once bordered farmed fields within Moberly Marsh.

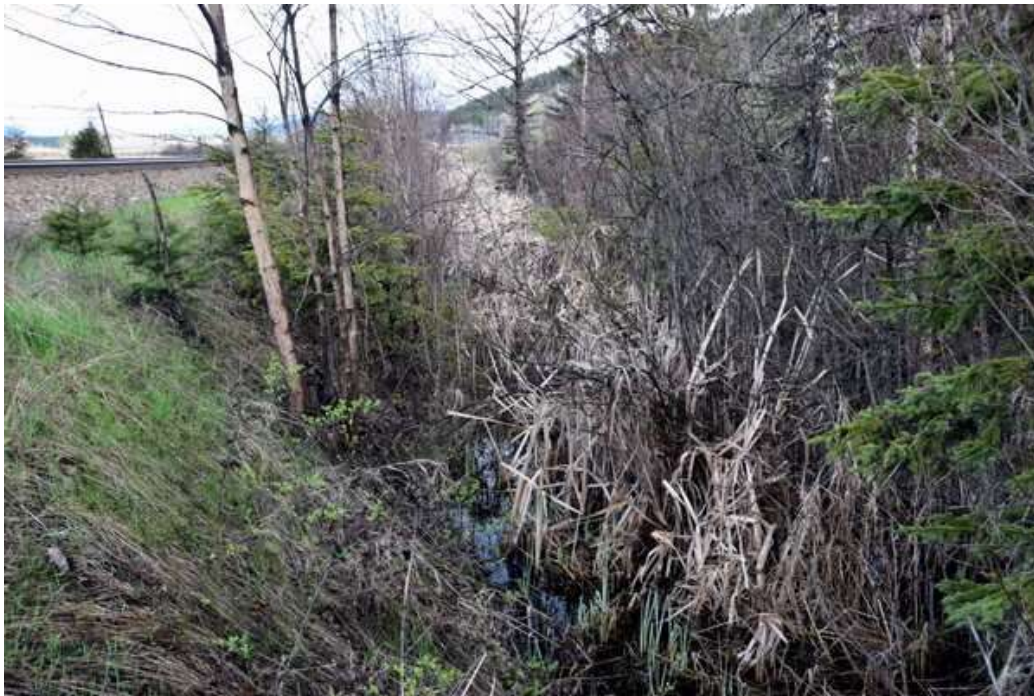
Figure 30. Ditches located between the TransCanada Highway 1 and The Canadian Pacific railroad divert runoff from entering Burges James Gadsden Provincial Park.

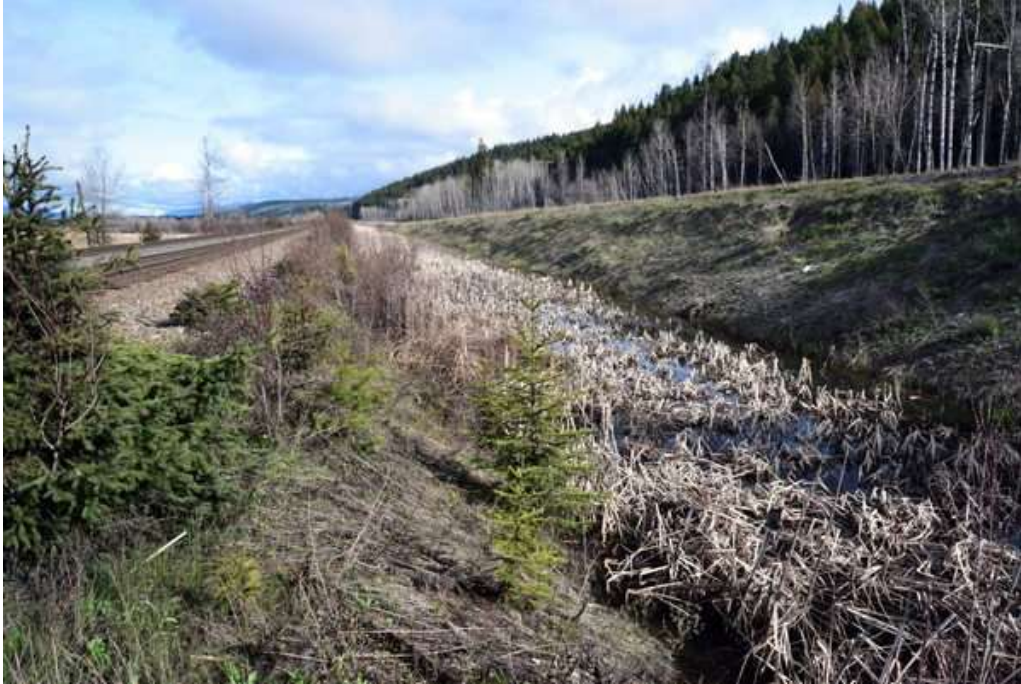
Figure 31. The majority of runoff that once entered Moberly Marsh is being diverted by ditches along the TransCanada Highway 1 and the Canadian Pacific railroad. This is why restoring floodwaters from the Columbia River and filling ditches is especially important to the health of Moberly Marsh.

The construction of the Canadian Pacific Railroad impacted Moberly Marsh by diverting runoff and by filling the Eastern edge of the wetland. Long sections of the railroad bed were built by filling portions of Moberly Marsh. Deep and long ditches were dug along the upper and lower sides of the tracks. These ditches captured runoff and intercepted groundwater. The ditches contain standing and flowing water. Few culverts were installed in the railroad bed. The author observed where a number of the culverts are plugged. A large amount of the water in the ditches along the railroad is being diverted into a deep ditch dug in the Park to drain the large field on private land. The runoff from the railroad is generally down the ditch into the Columbia River, and is not supplying Moberly Marsh. The water in the ditches along the railroad tracks does not appear clean. Coal dust and oil covers the ground, and the air near the track's smells like creosote.

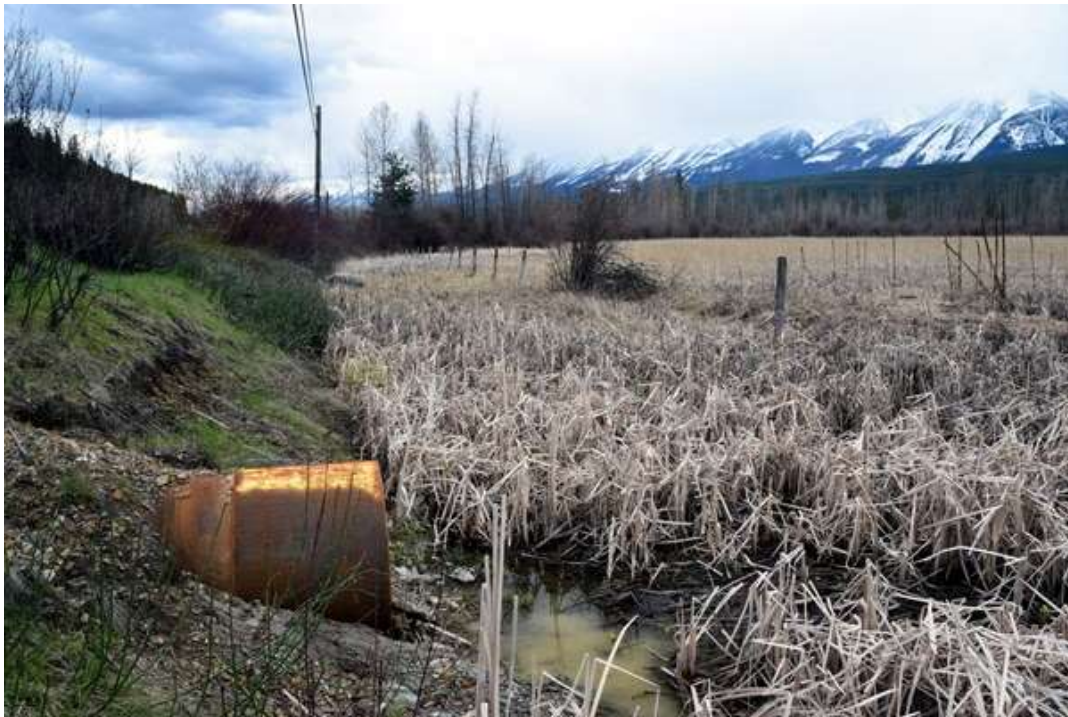
Figure 32. Few culverts are located along the Canadian Pacific railroad to carry runoff into Moberly Marsh. None were flowing water at the time of the survey.

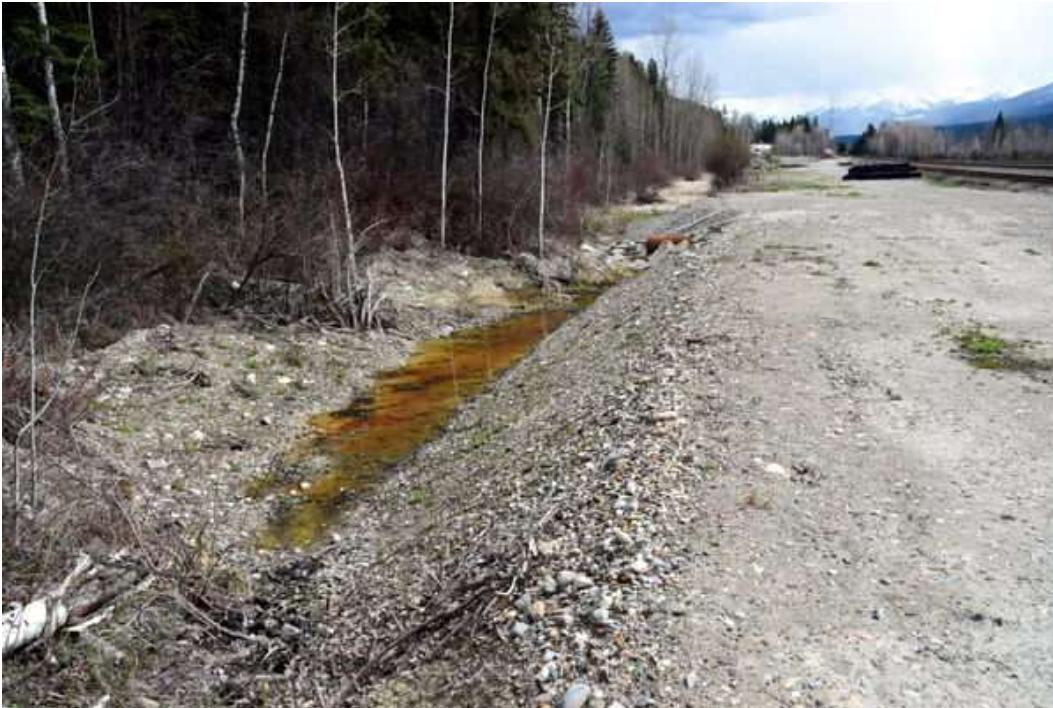
Figure 33. The railroad and associated access roads block the majority of runoff from entering Moberly Marsh.

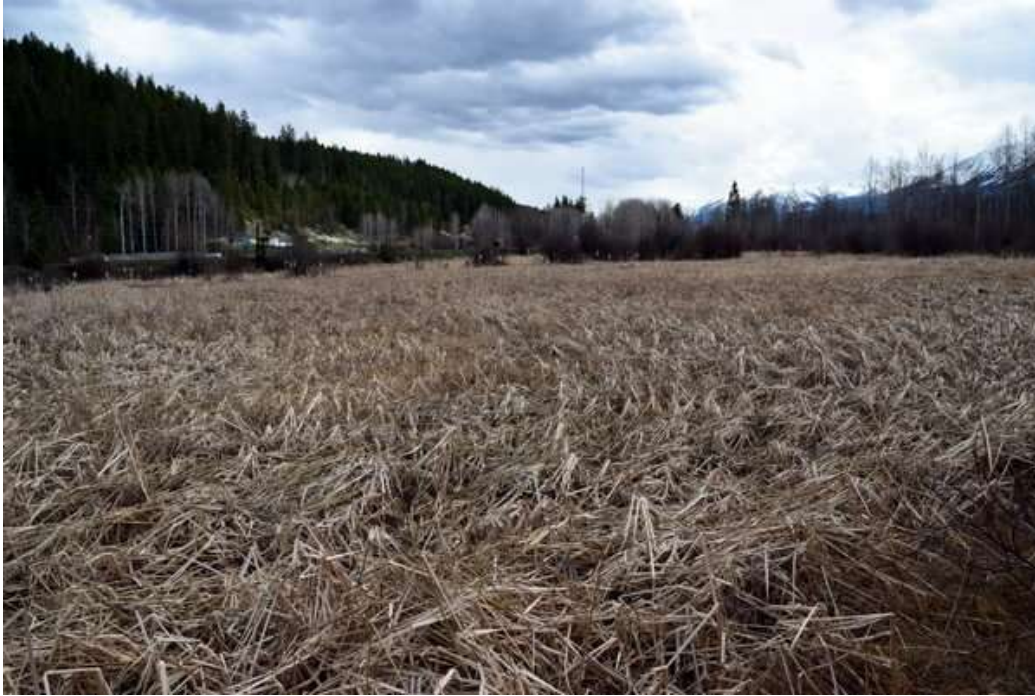
Figure 38. Large areas of Burges James Gadsden Provincial Park are covered by dense growths of cattails. Historical aerial photos show these areas containing large wetlands with open water.

The impoundments are now dominated by cattails with little open water.

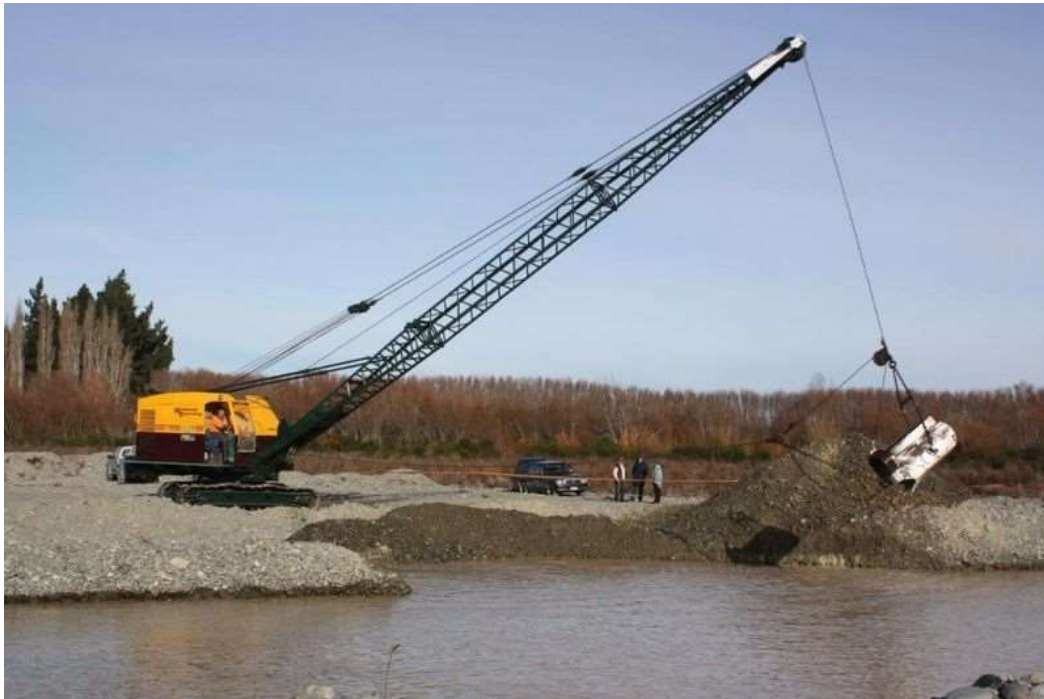
Figure 39. This photo shows a dragline working to move soil. Draglines were used to dig the ditches and build the dikes in Moberly Marsh.

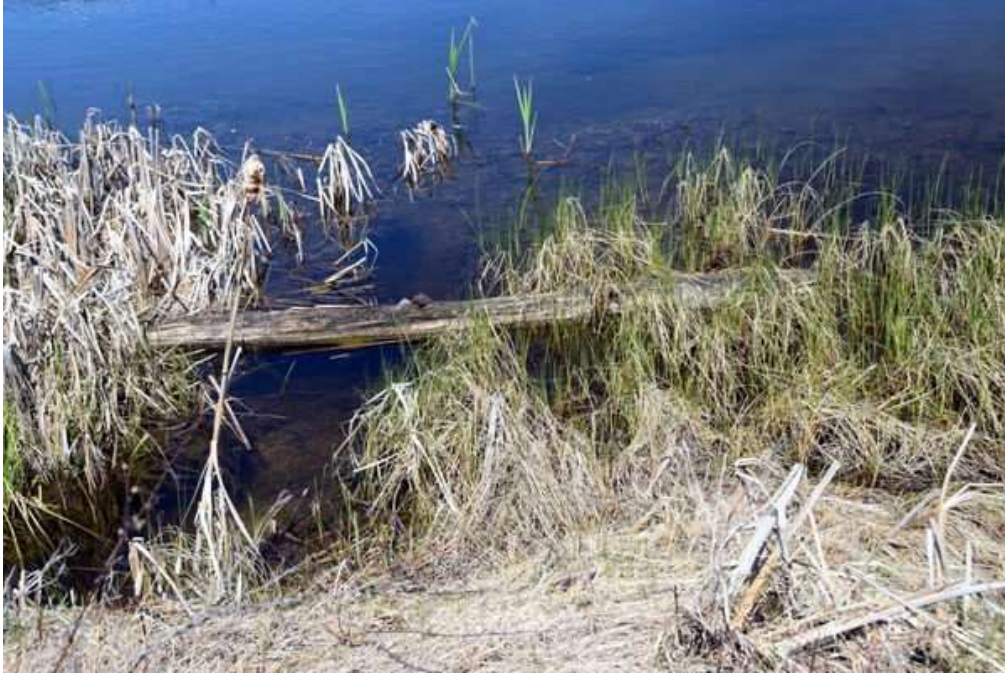
Figure 40. The dikes greatly reduced the quantity of large woody debris entering Moberly Marsh. The logs are of great importance to waterfowl for loafing.
