Burges James Gadsden Provincial Park

Wetland Restoration Design Plan

Date: July 24, 2019

Prepared for: BC Parks

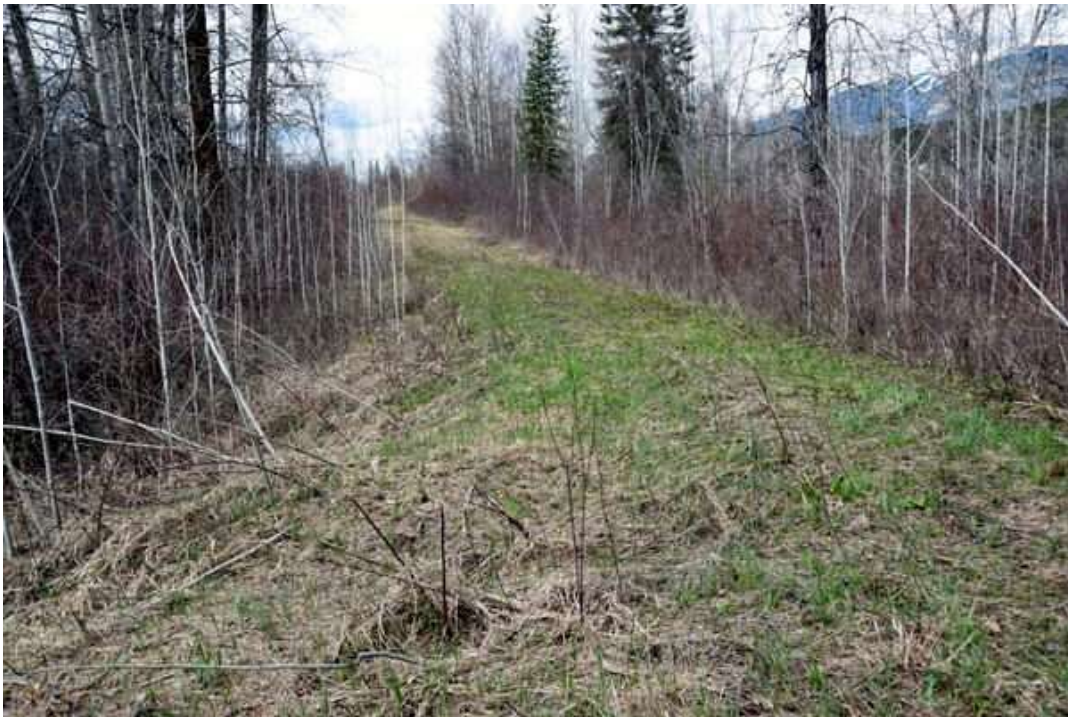
Figure 41. Dikes were built on the banks of the Columbia River to prevent seasonal flooding of Moberly Marsh. This dike was built for the Bergenham Compartment. The top of the dike is being mowed by a volunteer.

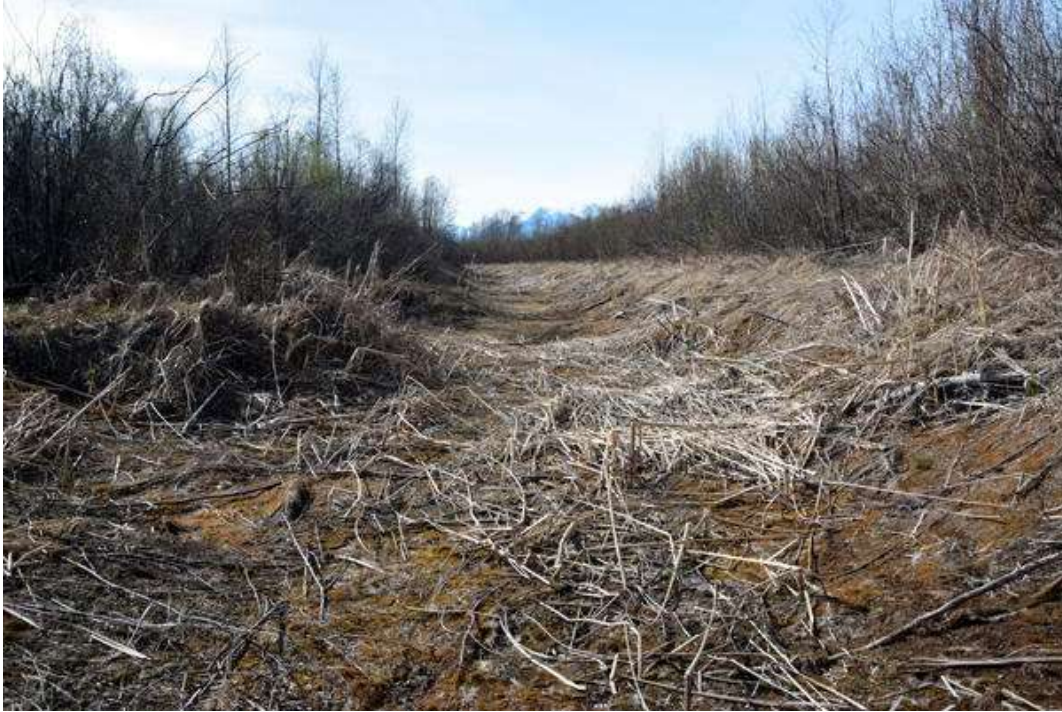
Figure 42. This deep and wide ditch was formed by the dragline when it removed soil for building the adjacent dike. The area where soil was removed is called a borrow pit, and this is a borrow pit ditch. The ditch moves surface water and groundwater downhill towards the water control structure. Water also soaks into the ground and flows under the dike into the Columbia River.

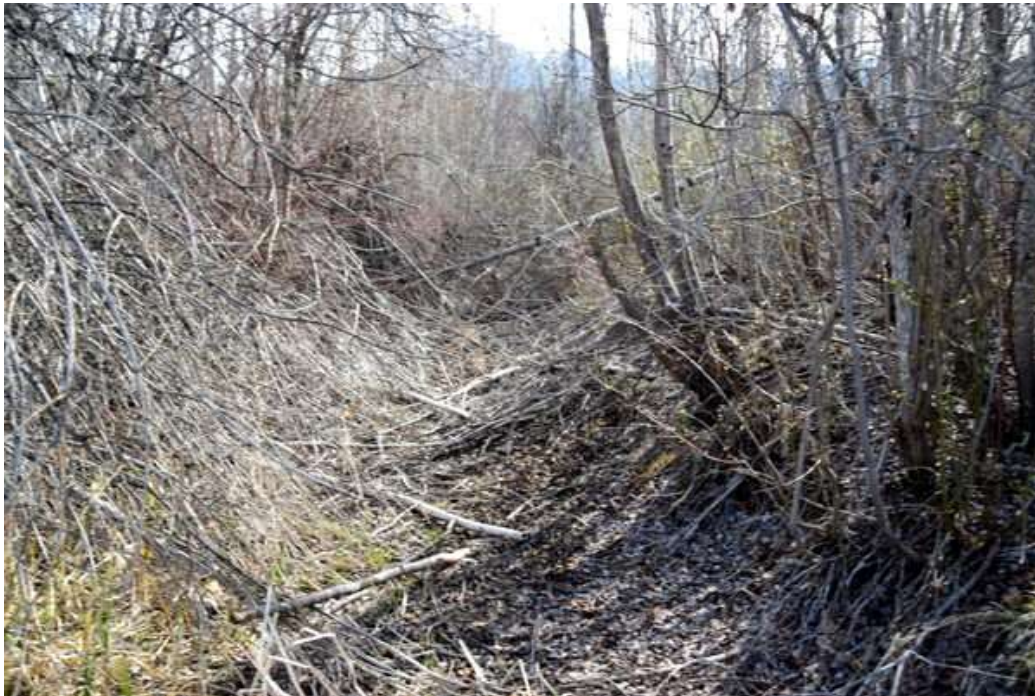
Figure 43. Many of the borrow pit ditches are dry like the one shown.

The water entering the borrow pit is drawn in from surrounding saturated soils. The dikes were not built on level ground, and neither were the borrow pits. Therefore, the borrow pits inadvertently became large drainage ditches by collecting and moving groundwater out of the wetland. The groundwater moved downhill in the borrow pit ditches until it disappeared in a gravel layer, flowed under the dike in a permeable layer, or entered the Columbia River via a leaking water control structure.

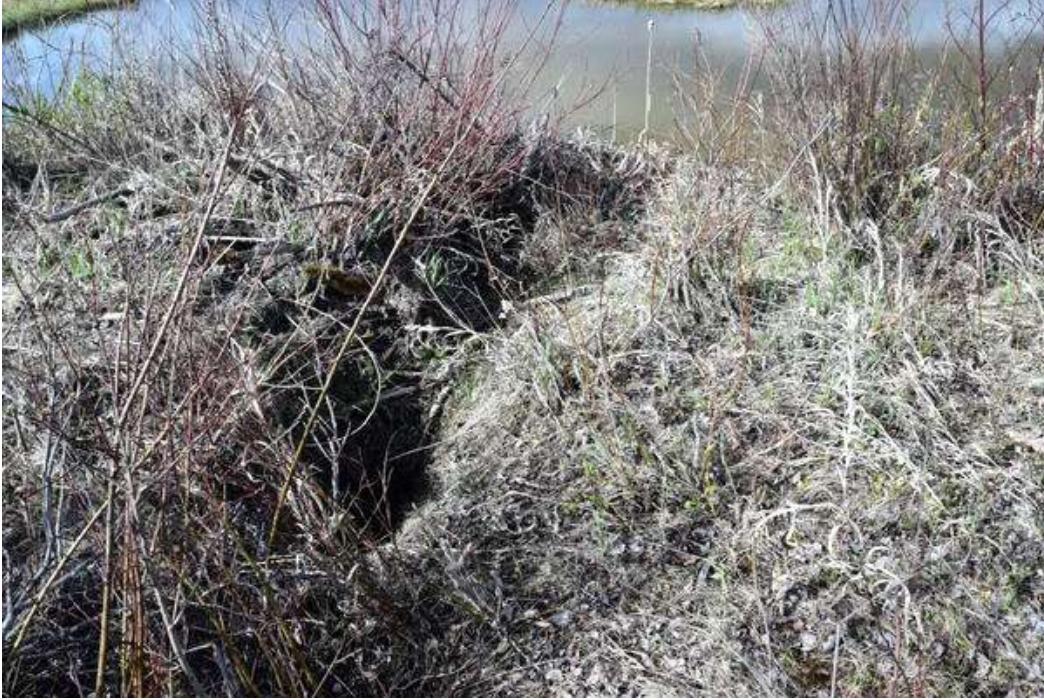
Figure 44. Interior dikes within Burges James Gadsden Provincial Park are riddled with beaver burrows. This photo shows a typical section of the dam on the Sime Compartment breached by a beaver.

1. Water flows under the dikes via permeable layers of organic soil, tree roots, sand, and gravel layers.
2. Water flows through and under the dikes via muskrat and beaver burrows.
3. Moberly Creek does not enter the impoundments.
4. Water control structures were leaking.

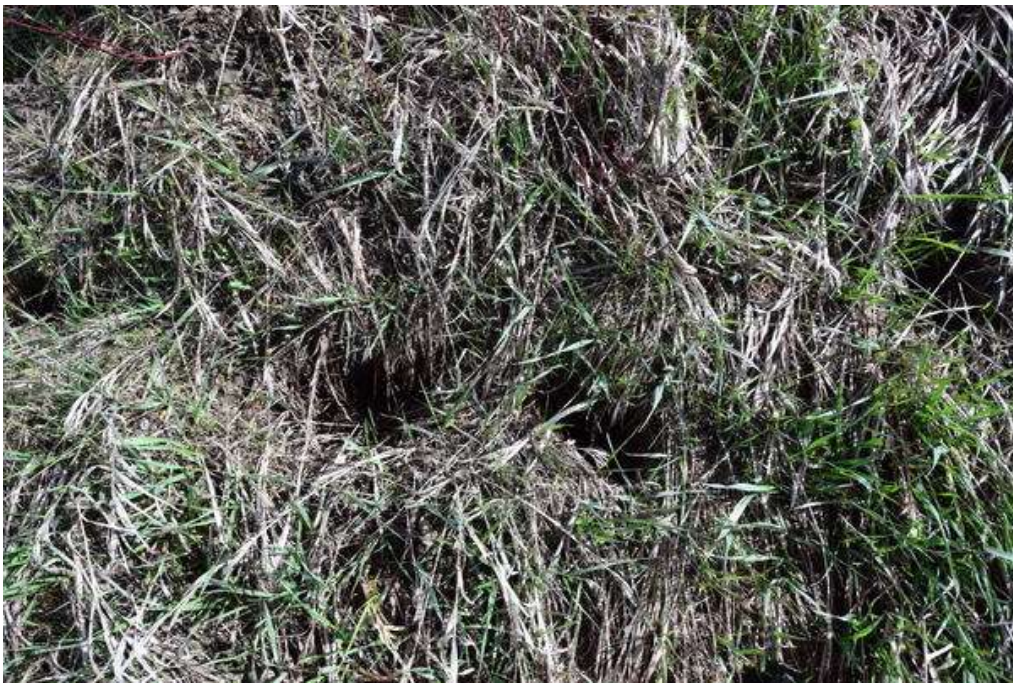
Figure 45. The holes are collapsed muskrat burrows in an interior dike on the Sime Compartment. Muskrat and beaver burrowing activity have caused breaching and failure of interior dikes.

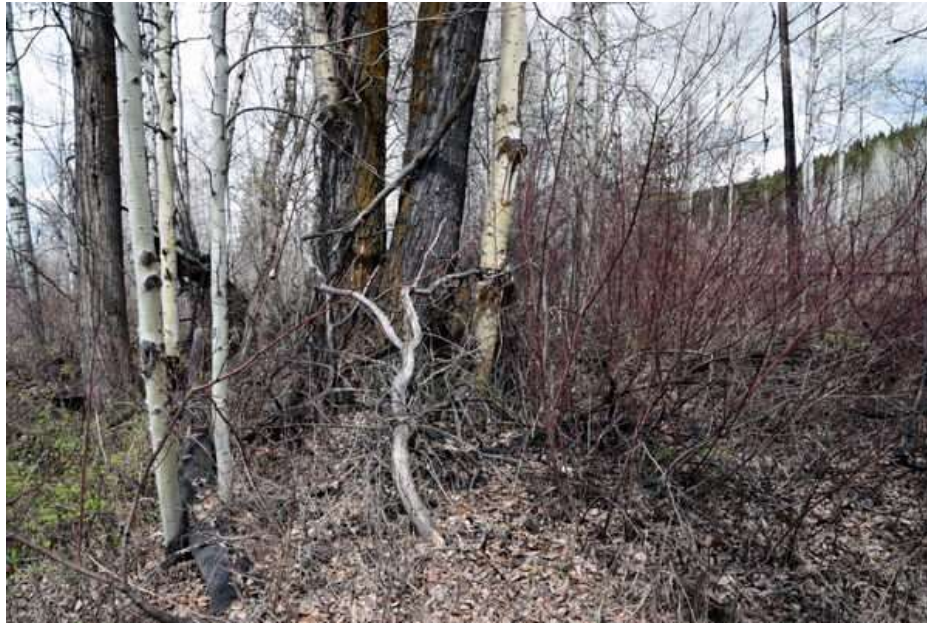
Figure 46. This photo shows the Southern end of the dike built for the Bergenham Compartment. Sections of dike that are growing desirable plants would not affect restoration of the wetlands would not be disturbed or removed by the project.

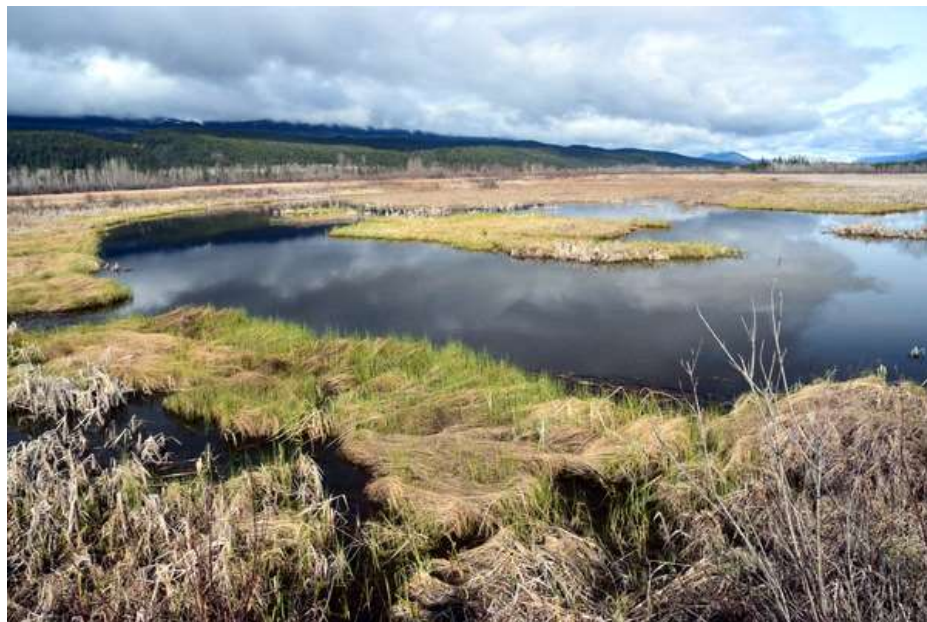
Figure 47. Restoring Moberly Marsh will return a diversity of wetlands to Burges James Gadsden Provincial Park similar to what is shown here. These wetlands are located within the Sime Compartment. Water in the wetlands is not being maintained by the constructed dikes, and the wetlands would not be dried by removing the dikes. The author knows this based on removing over 300-dams to restore wetlands across North America.

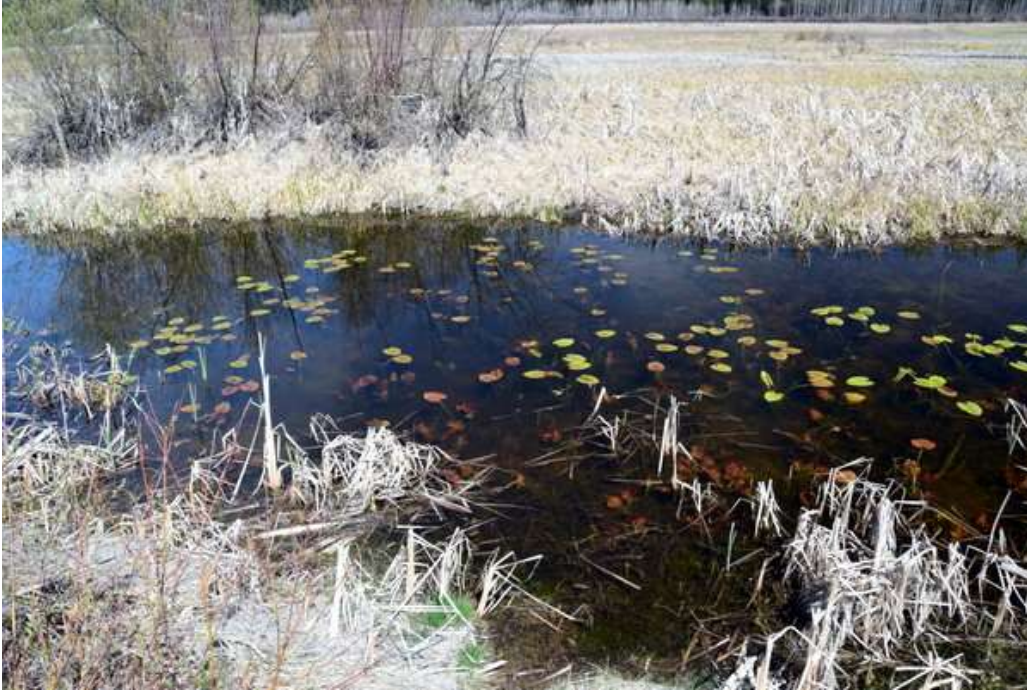
Figure 48. Numerous small wetlands like the one shown may be restored by removing the dikes and associated borrow pit ditches.

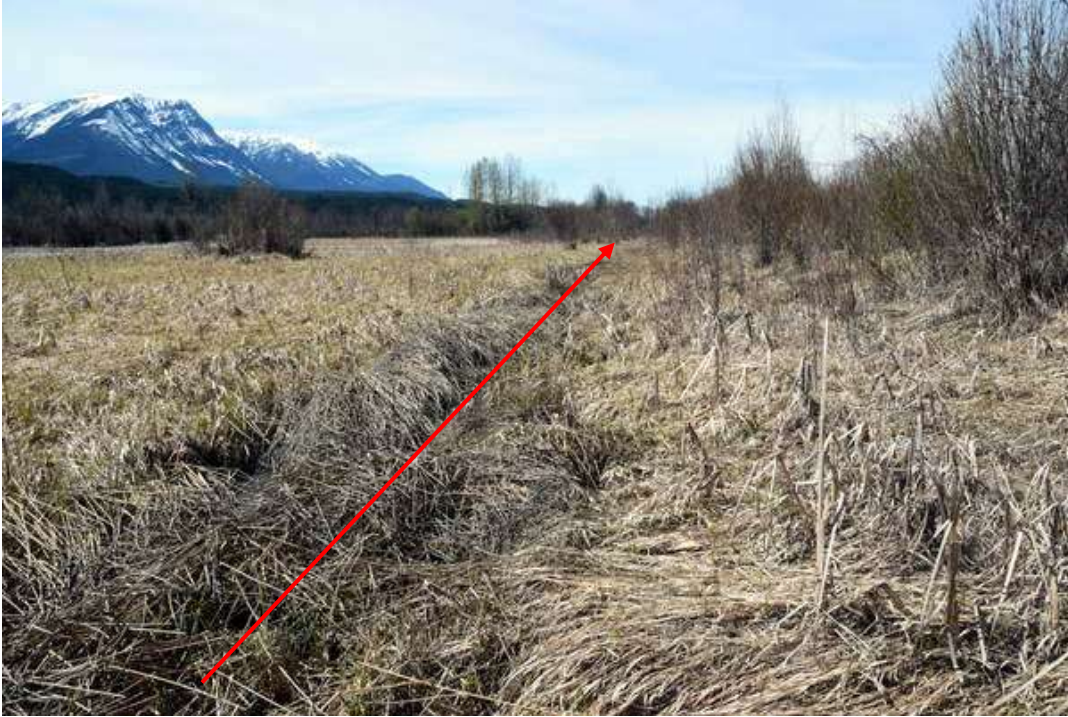
Figure 49. The red arrow shows a long and narrow ditch dug to dry natural wetlands and a stream within the Park. Notice the difference in vegetation on either side of the ditch.

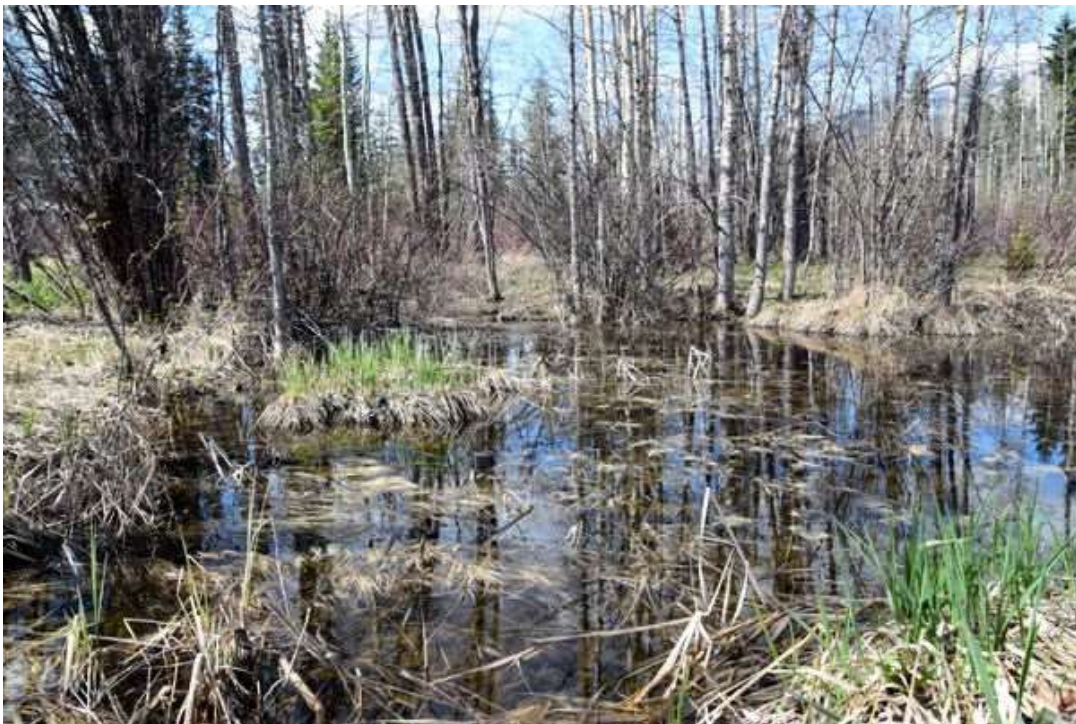
Figure 50. Ditches may be filled to restore small wetlands surrounded by trees like the one shown. This wetland is located on private land within Moberly Marsh.

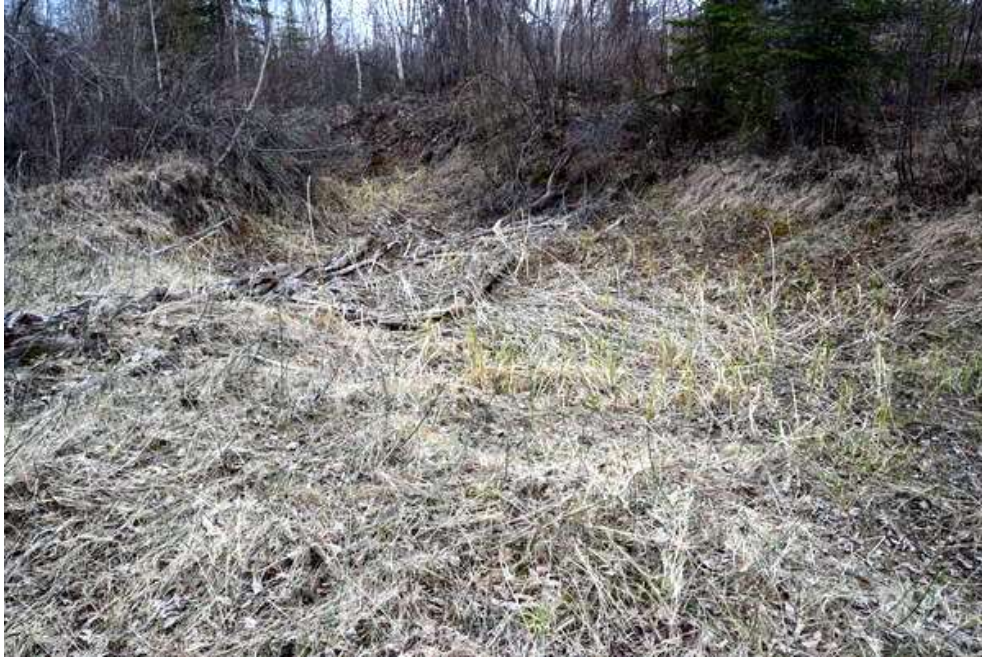
Figure 51. This drainage ditch was dug prior to 1965 near the Southern end of Moberly Marsh. The ditch was blocked by a dike built for the Bergenham Compartment. Water is soaking into the ground and flowing under the dike.

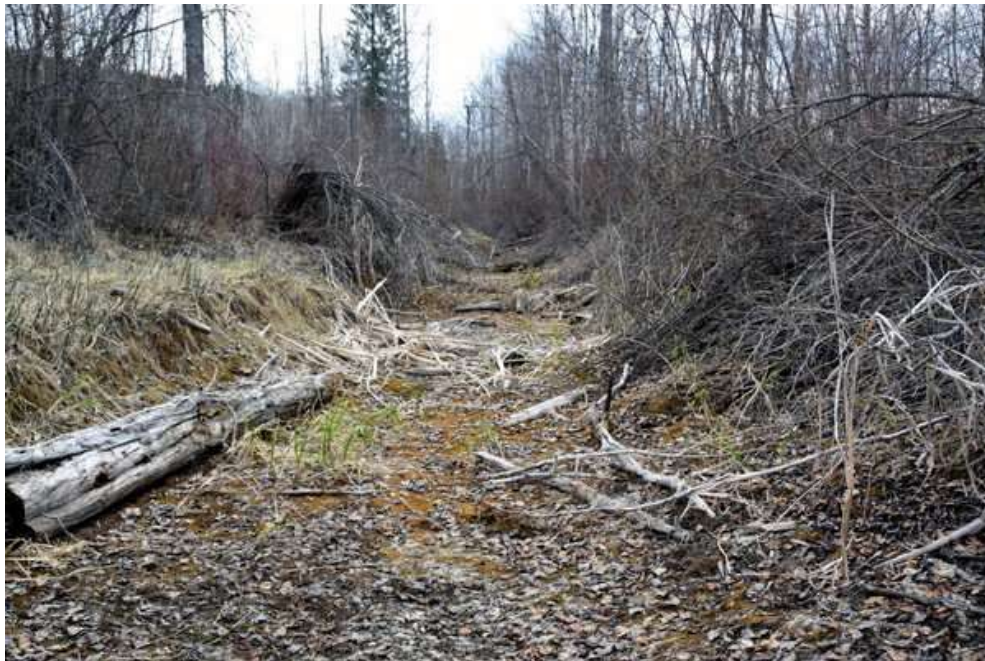
Figure 52. This photo shows where soil was removed to build a dike for the Bergenham Compartment. The area where soil was removed is called a borrow pit. Borrow pits parallel dikes, and slope downhill towards water control structures and pipes. The borrow pits formed ditches that are draining Moberly Marsh.

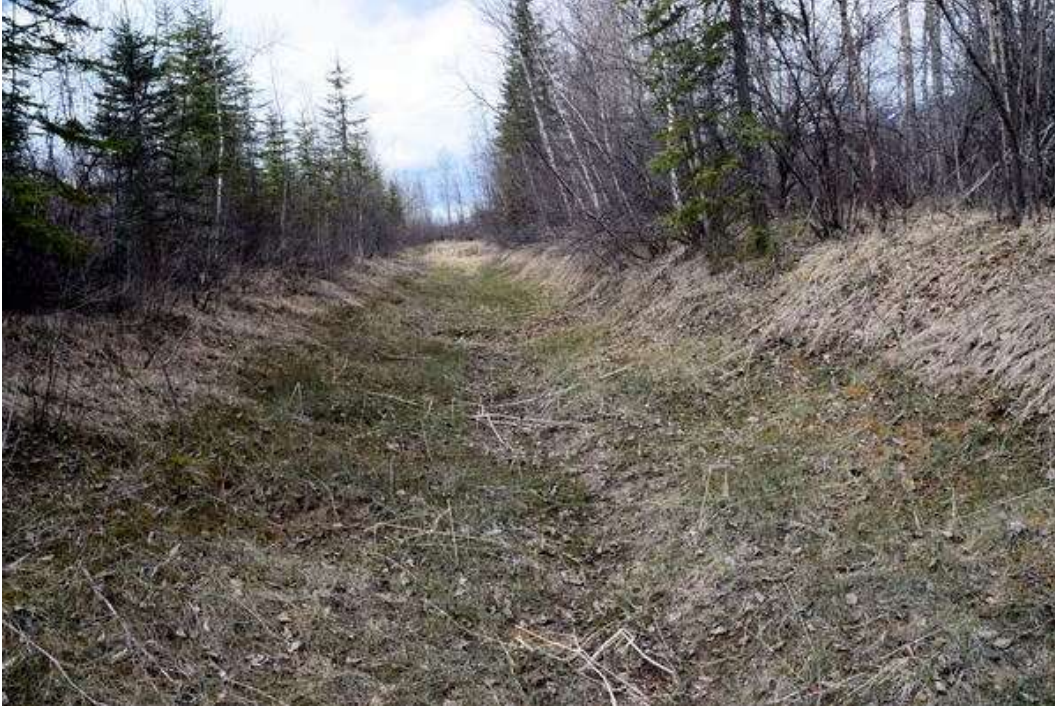
Figure 53. Here is another borrow pit ditch located along a constructed dike. The majority of the borrow pit ditches are dry because water is soaking into the ground and flowing under the dike towards the Columbia River in organic, sand, and gravel layers. The borrow pit ditches remove standing water and lower the elevation of groundwater over the entire Burges James Gadsden Provincial Park.

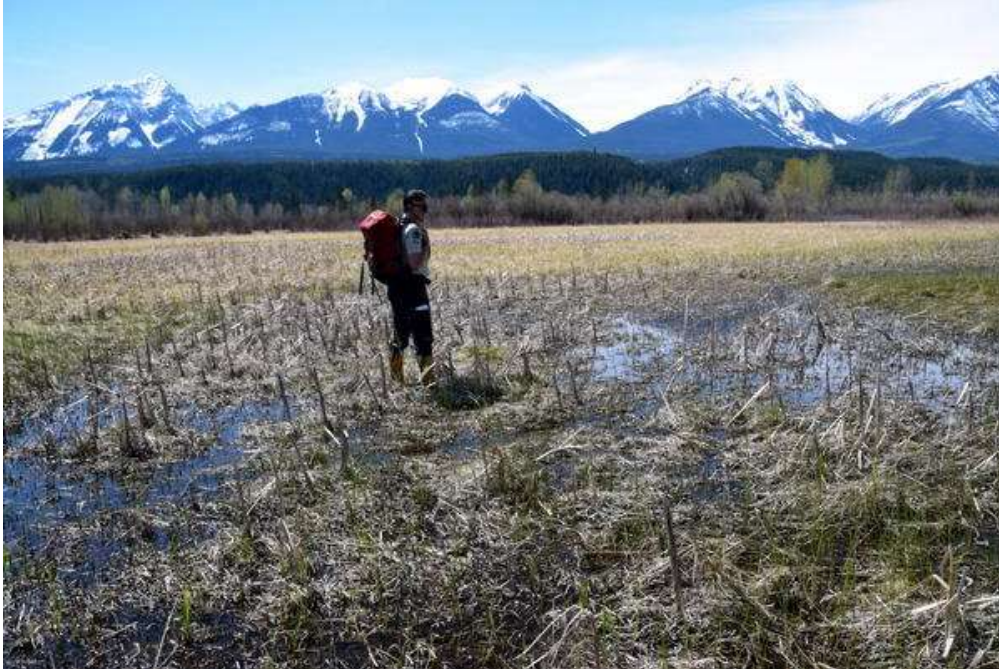
Figure 54. Natural streams were wide and shallow, like the one shown here in the Park. Many were dug into wide and deep ditches with curves in them after 1965, using the “level ditch” technique.

Level ditches were built with throughout Moberly Marsh. Level ditches are designed to provide standing open water in dense cattails, and not drain. However, field examination by the author finds that the majority of level ditches are draining, removing water from Moberly Marsh. Because the ground surface in Moberly Marsh is sloped, ditches that were dug for any purpose remove water from a wetland unless they are successfully blocked at their outlet. Some of the level ditches in Moberly Marsh have been dammed by beaver, creating small open water wetlands. Many of the level ditches are not blocked at their end. Surface and groundwater are being drawn into the level ditches, moving downhill, and then leaving the wetland by traveling under the dam and past water control structures. The level ditches were also built across and in natural streams, interrupting and diverting their flow.

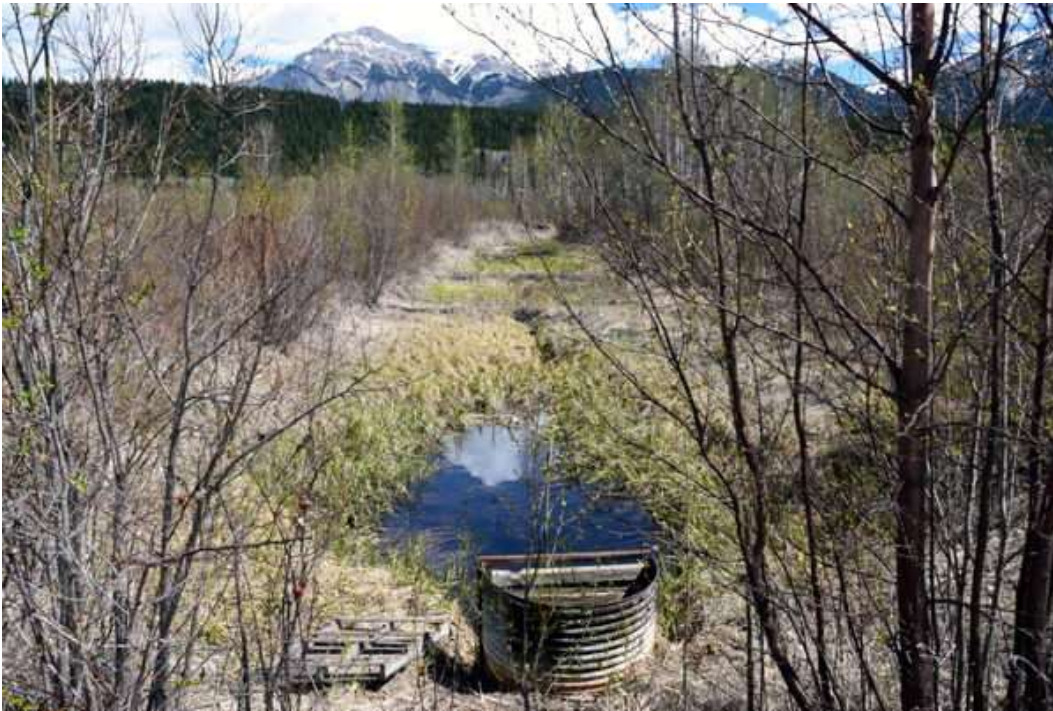
Figure 55. This long ditch was dug for the Bergenham Compartment as part of the 3-Way Control Structure. A flashboard riser water control structure was installed at the end of the ditch. The ditch was started before 1949, then deepened, widened, and lengthened after 1965. The flashboard riser and surrounding dike are leaking and not holding water. The elevation of water in the flashboard riser water control structure was the same as the elevation of water in the river. Removing water control structures, filling ditches, and restoring the elevation of natural levees along the Columbia River would restore water levels in Moberly Marsh.

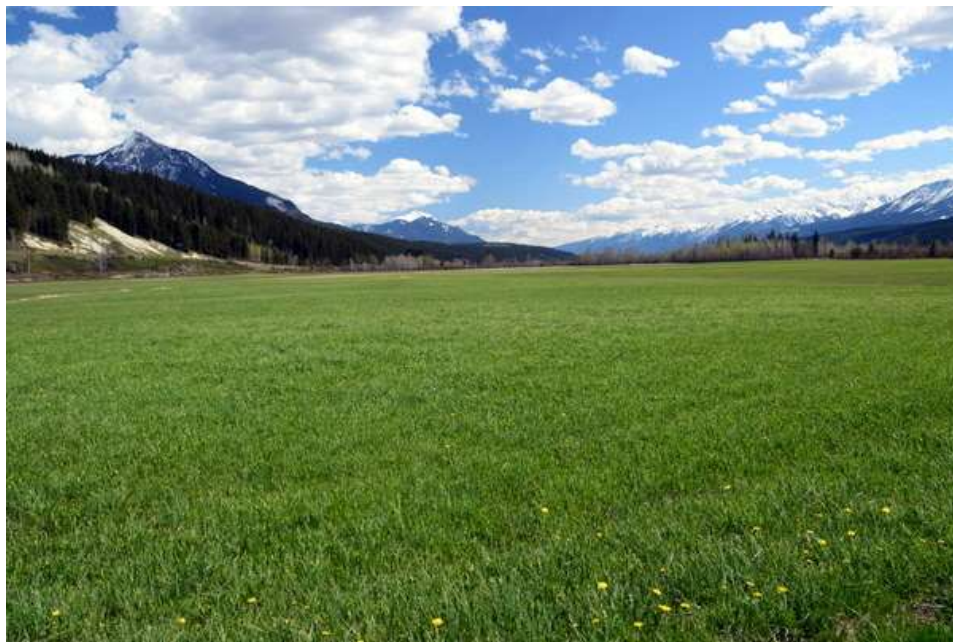
Figure 56. This large 81-acre hayfield on private land was made by draining a significant portion of Moberly Marsh after 1965. The field was surrounded by a high dike to keep out the Columbia River. Numerous ditches were dug and water control structures with a pump were installed within the Burges James Gadsden Provincial Park to keep the field from flooding. The field receives use by a high diversity and number of bird species during migration.

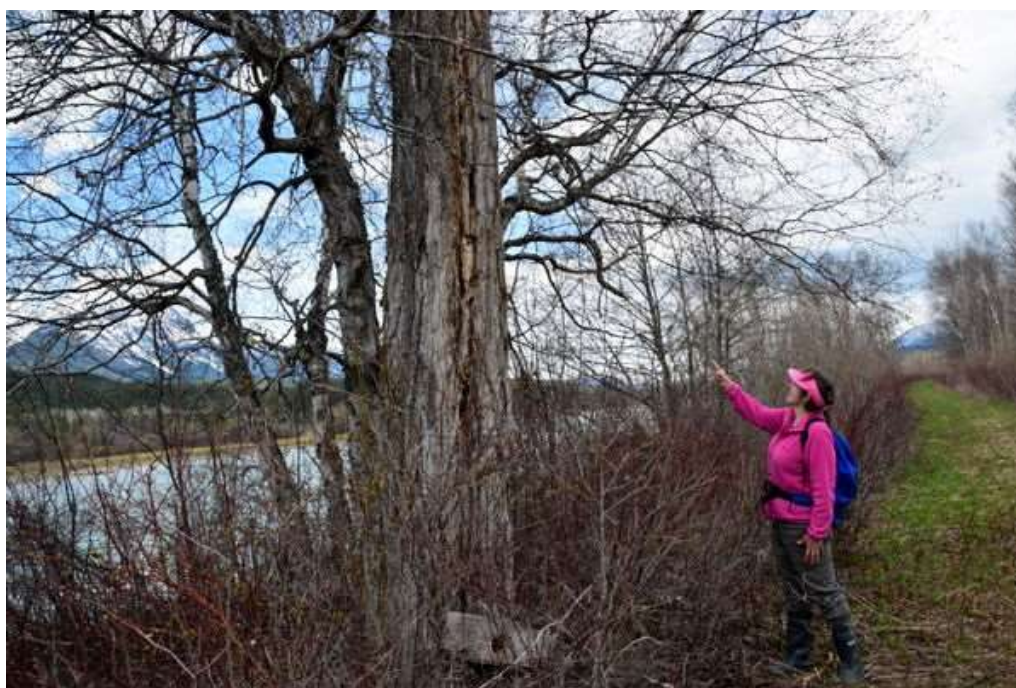
Figure 63. The elevation of dikes would be lowered to approximately the same elevation as the base of large old cottonwood trees growing between the dike and the Columbia River.

The elevation of dikes will be lowered to approximately the same elevation as the base of the closest old cottonwood tree growing between the river and the dike. The elevation of the top of the restored levee can be expected to change along the Columbia River. The Contract Representative will monitor and mark planned elevations along the length of the dike being removed as construction is taking place. The goal is to restore a naturally appearing levee along the banks of the river containing dips, ridges, and loosened soil for trees and shrubs to grow.

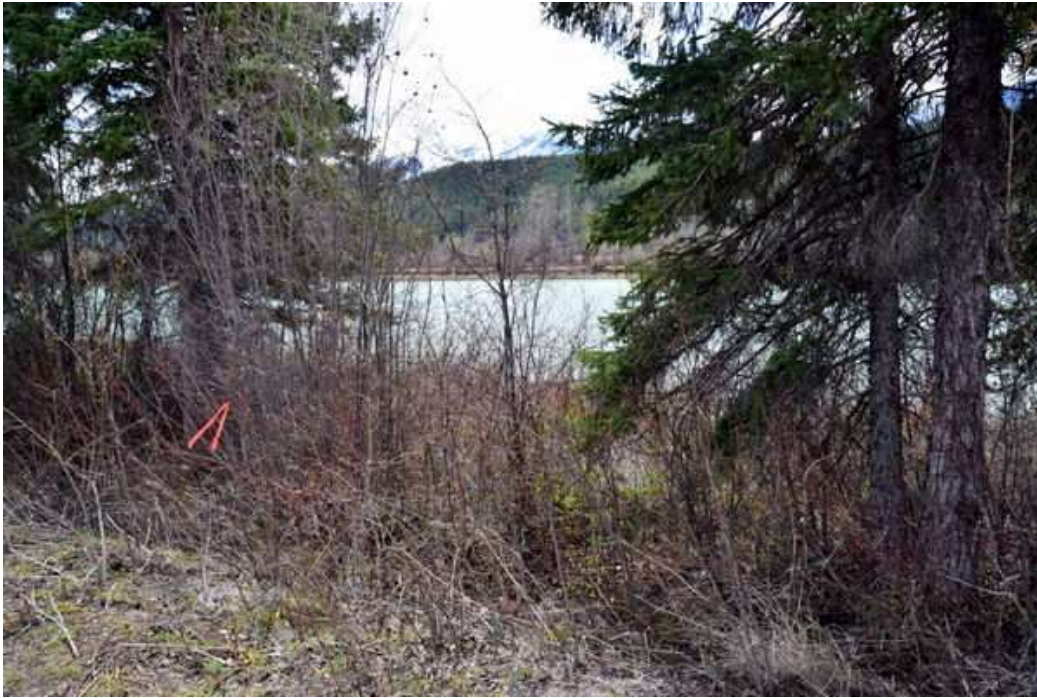
Figure 64. The orange ribbon shows a typical location for building an inlet. The inlet would be built between the trees at an elevation slightly lower than the elevation of the base of old cottonwood trees growing between the dike and the Columbia River.

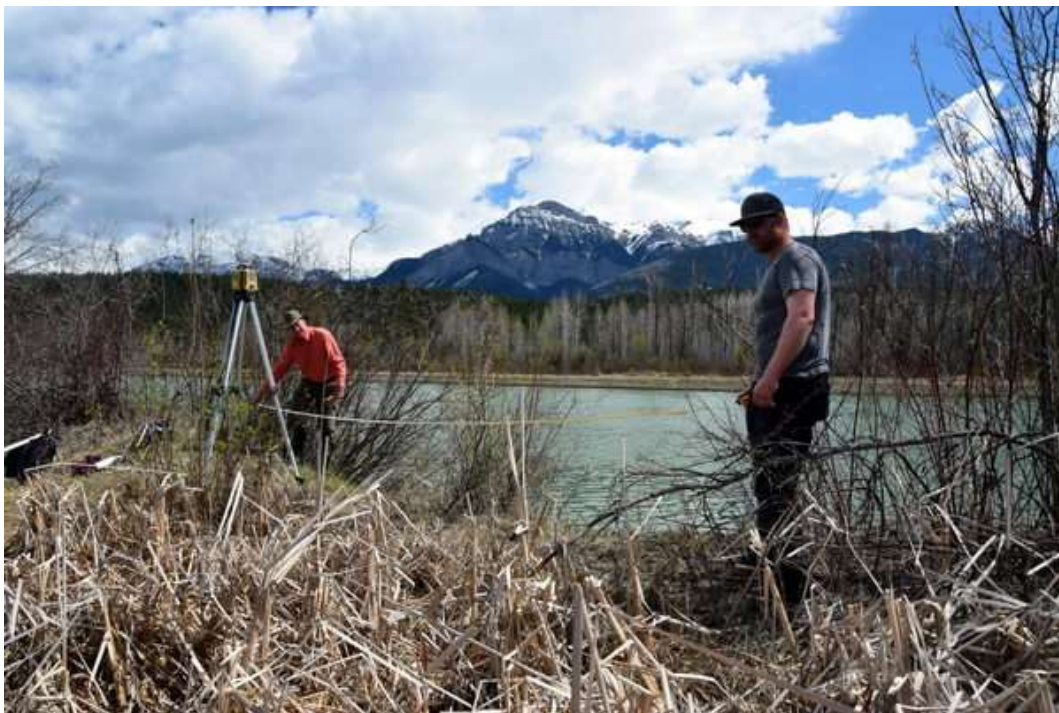
Figure 65. The tape measure spans the width of a natural inlet to a wetland opposite Moberly Marsh. Note the narrow and low ridge of grass between the river and cattails.

A natural inlet to a wetland was identified and measured on the West side of the Columbia River, opposite Burges James Gadsden Provincial Park. The elevation in the bottom of the inlet was approximately 27cm lower than the bank on either side. The high bank on either side of the inlet was the same as the elevation found at the base of large old cottonwood trees growing on the natural levee. The inlet was located in an outside bend of the river, and entered the wetland at a shallow angle to the river. The inlet directed water from the river into a wetland containing open water, cattails, sedges, and willow. The total width of the inlet was

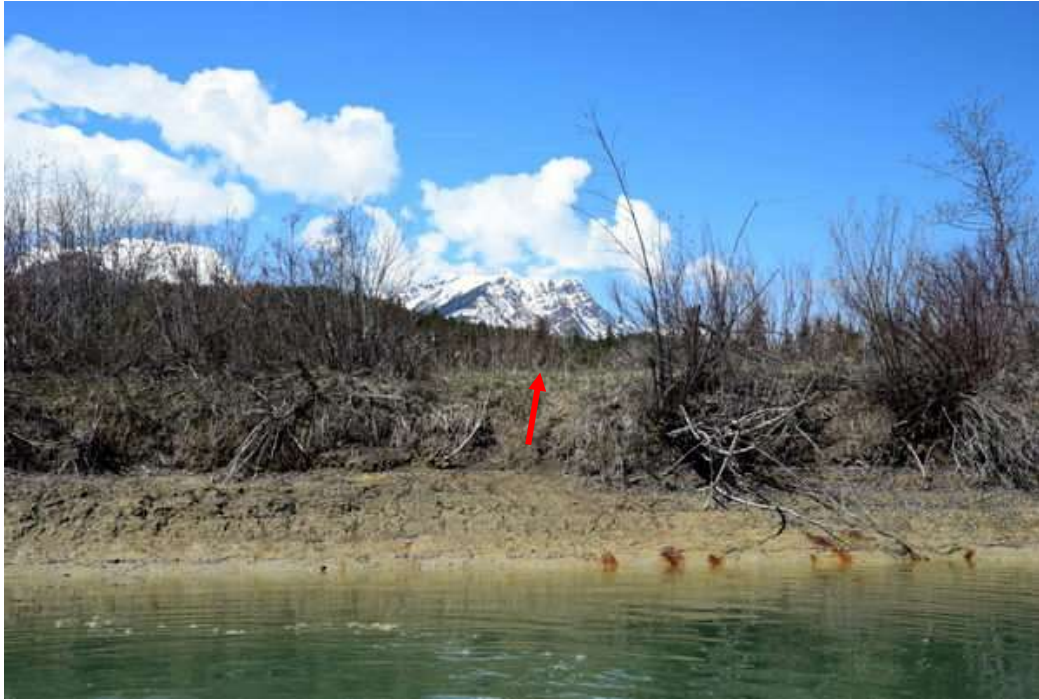
Figure 66. The red arrow marks the center of a natural inlet to a wetland along the Columbia River opposite Moberly Marsh. The green grass with cattails growing in the background are typical of natural inlets.

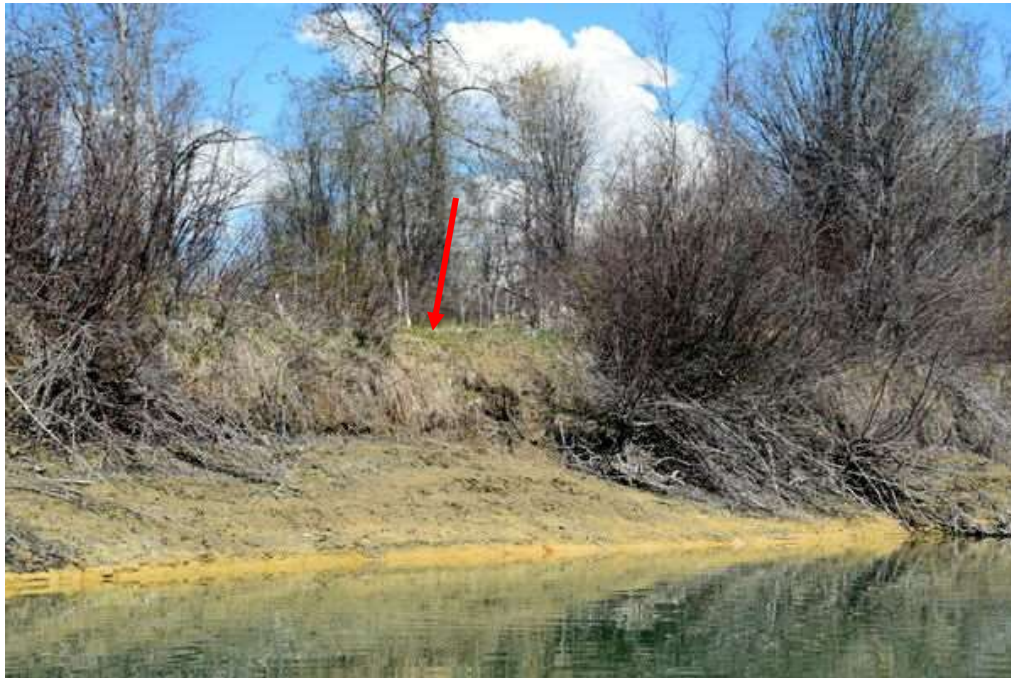
Figure 67. The red arrow marks the center of a natural inlet to a wetland along the Columbia River opposite Moberly Marsh. The green grass with cattails growing in the background are typical of natural inlets. Note the high elevation of the inlet, and that there is no gully between the wetland and the river.

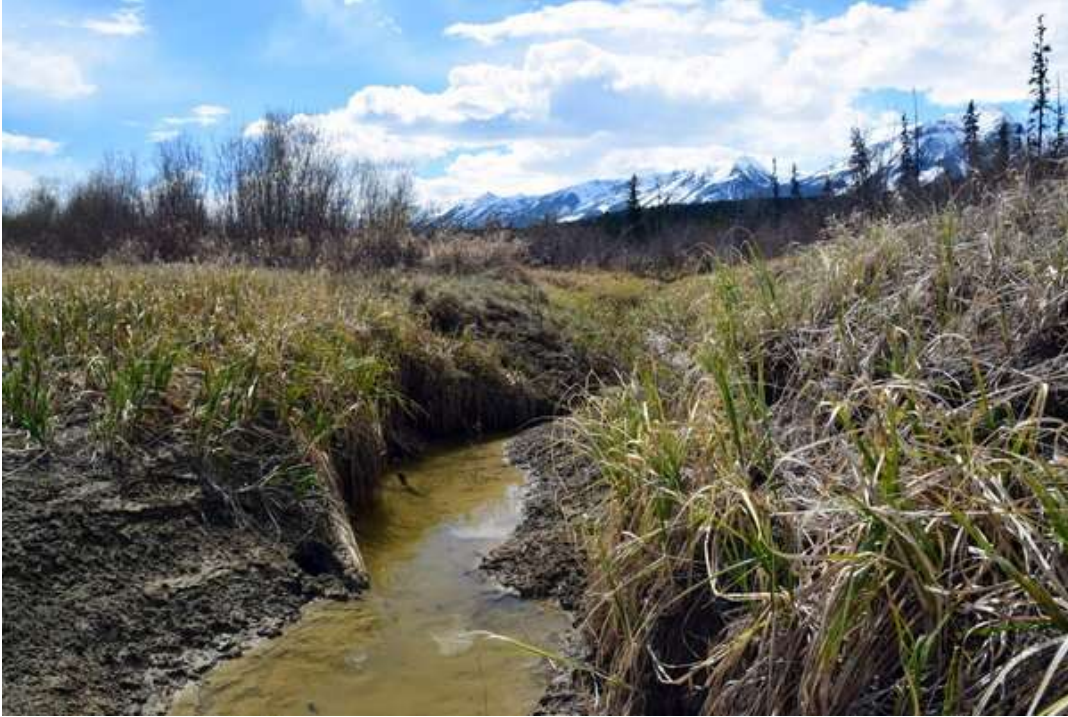
Figure 68. Natural outlet draining from a natural wetland along the Columbia River opposite Moberly Marsh. A stream is flowing in the outlet from the wetland.

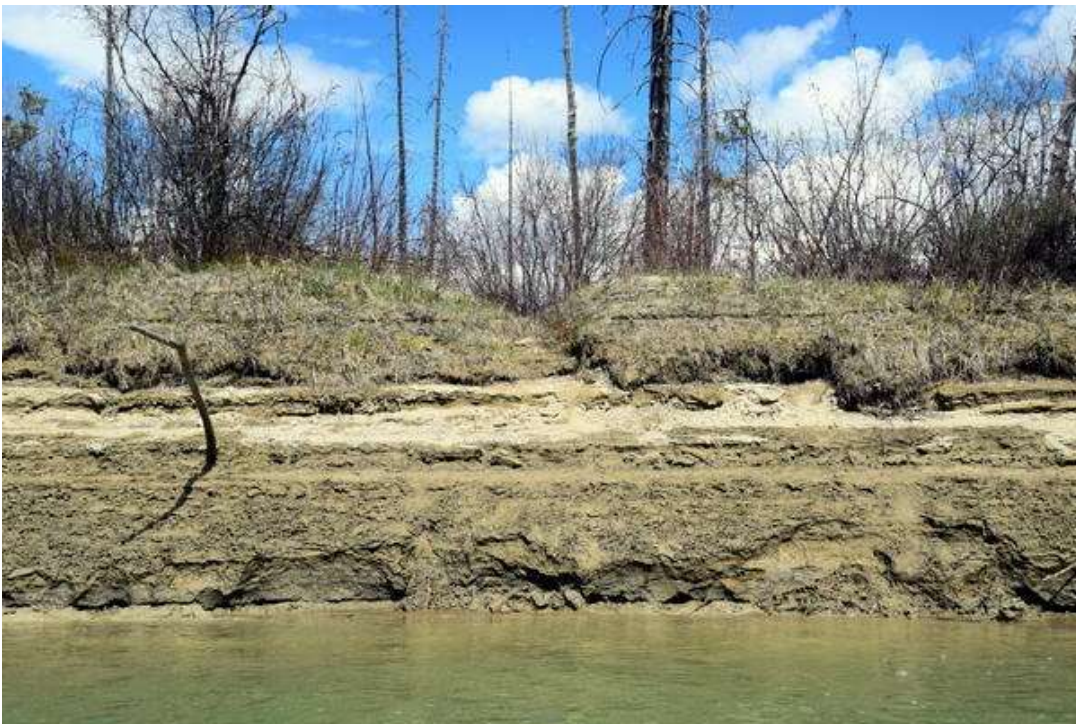
Figure 69. Natural outlet draining from a natural wetland along the Columbia River opposite Moberly Marsh. No stream is flowing in the outlet.

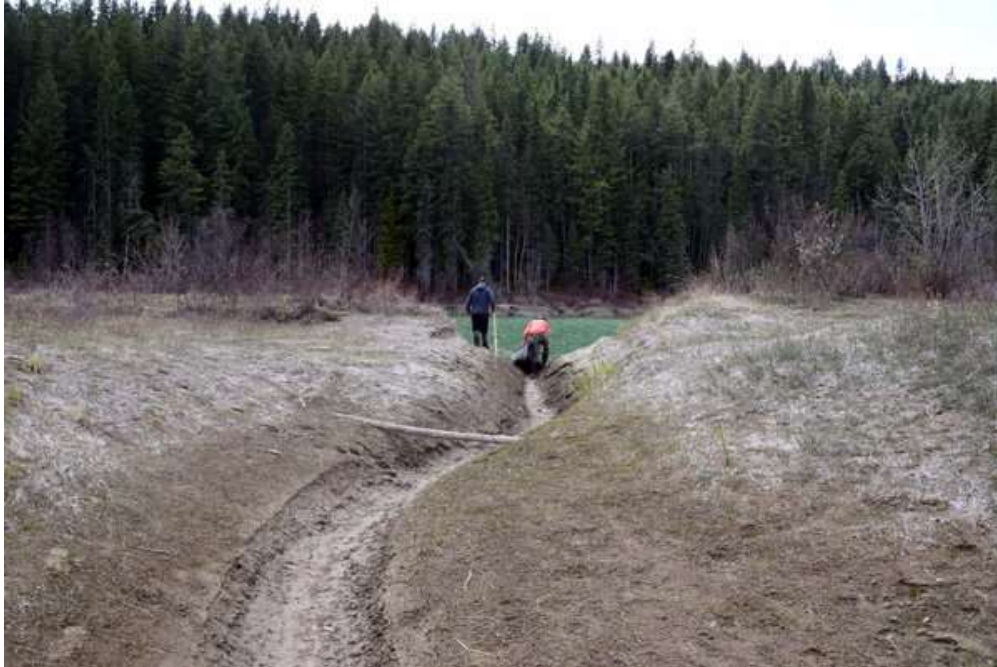
Figure 70. Planned Outlet #2 for Moberly Marsh. This natural outlet has become dry from the construction of dikes and ditches that have drained the wetlands it once served. Beaver have dug a channel up the bottom of the outlet.

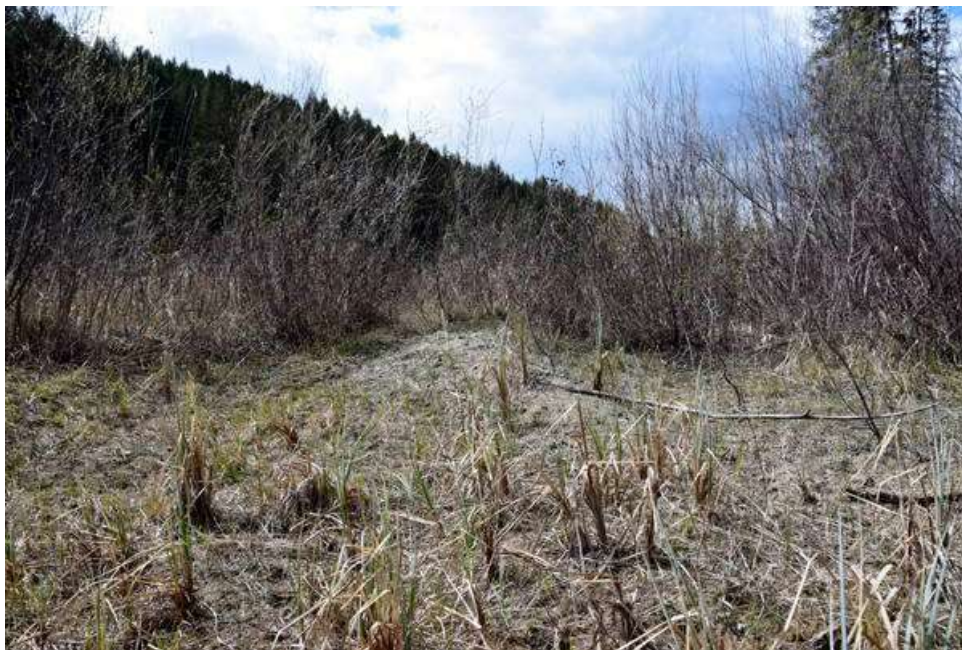
Figure 71. Wetland adjacent to natural outlet along the Columbia River opposite Moberly Marsh. Beaver built a dam across the outlet just before it drops to the river. The elevation of the outlet controls the depth of water in adjacent wetlands. The natural elevation of outlets is the same as the water level in wetlands along the floodplain, which is significantly higher than the river.

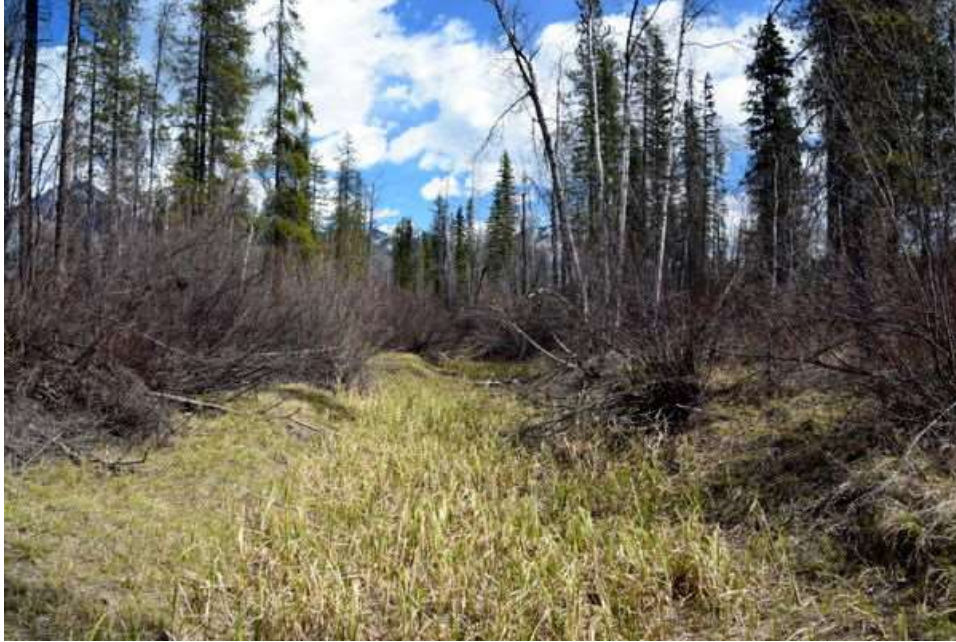
Figure 72. Natural stream as it approaches a natural outlet along the Columbia River, opposite Moberly Marsh. The stream is wide, level, and at a high elevation above the river. A short and steep valley exists where the stream drops to the river.

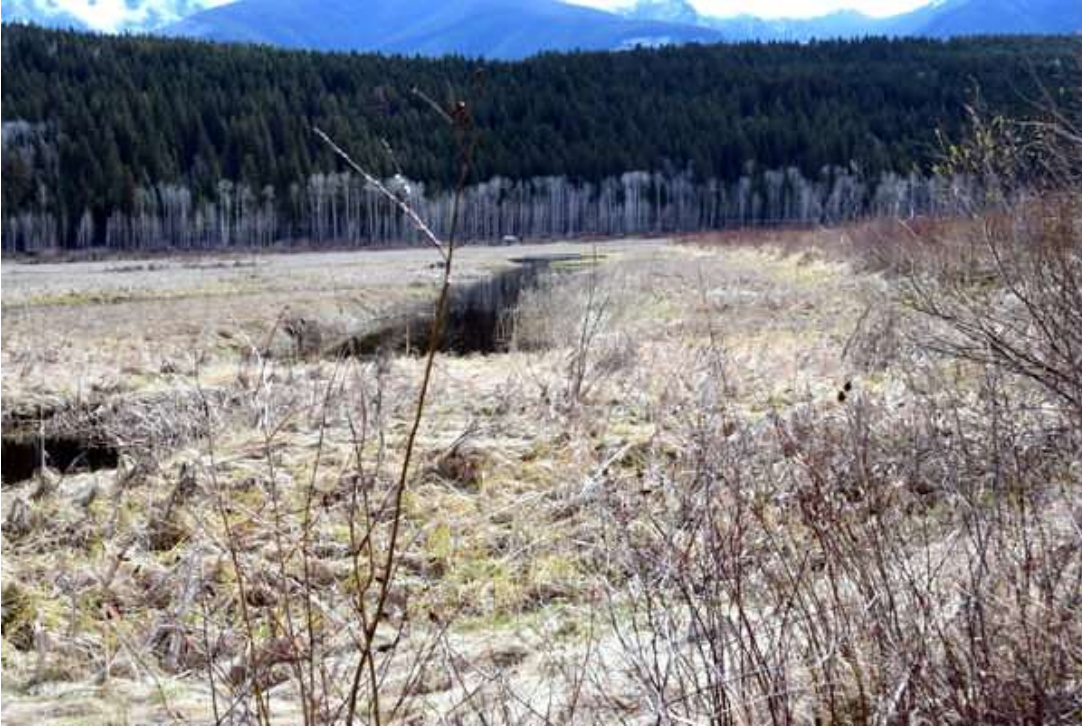
Figure 79. Straight borrow pit ditches like the one shown may be restored to naturally appearing and functioning wetlands.

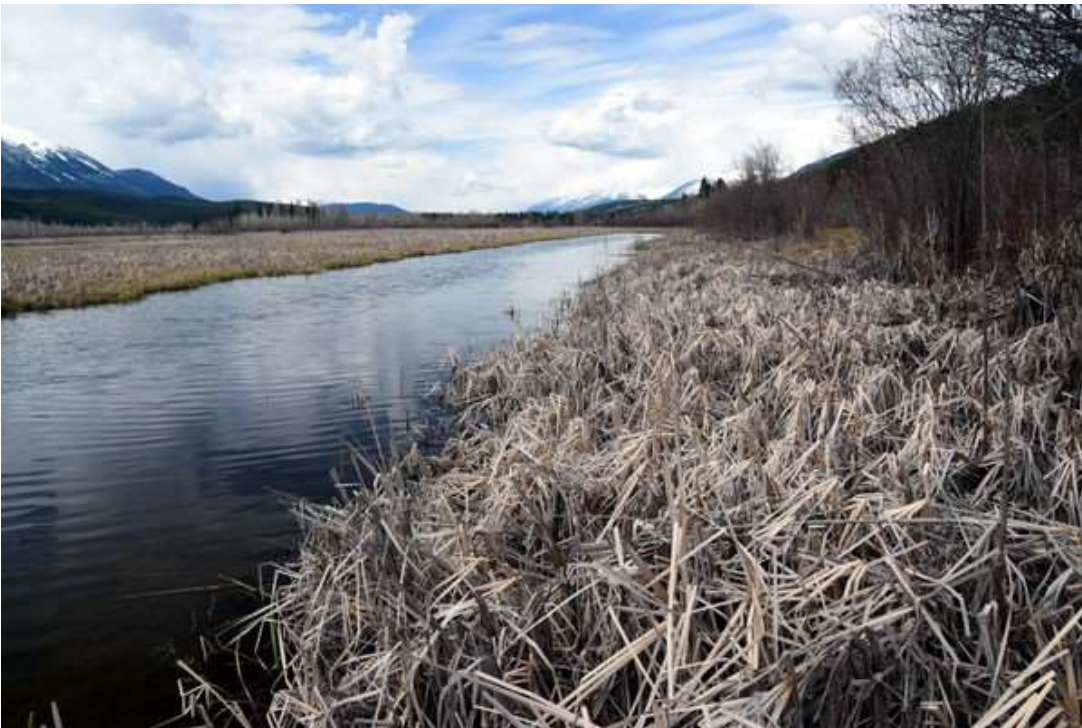
Figure 80. This canal on the Sime Compartment would be transformed by giving it natural irregular edges including points, peninsulas, ridges, bays, and islands, with large woody debris.
