Burges James Gadsden Provincial Park

Wetland Restoration Design Plan

Date: July 24, 2019

Prepared for: BC Parks

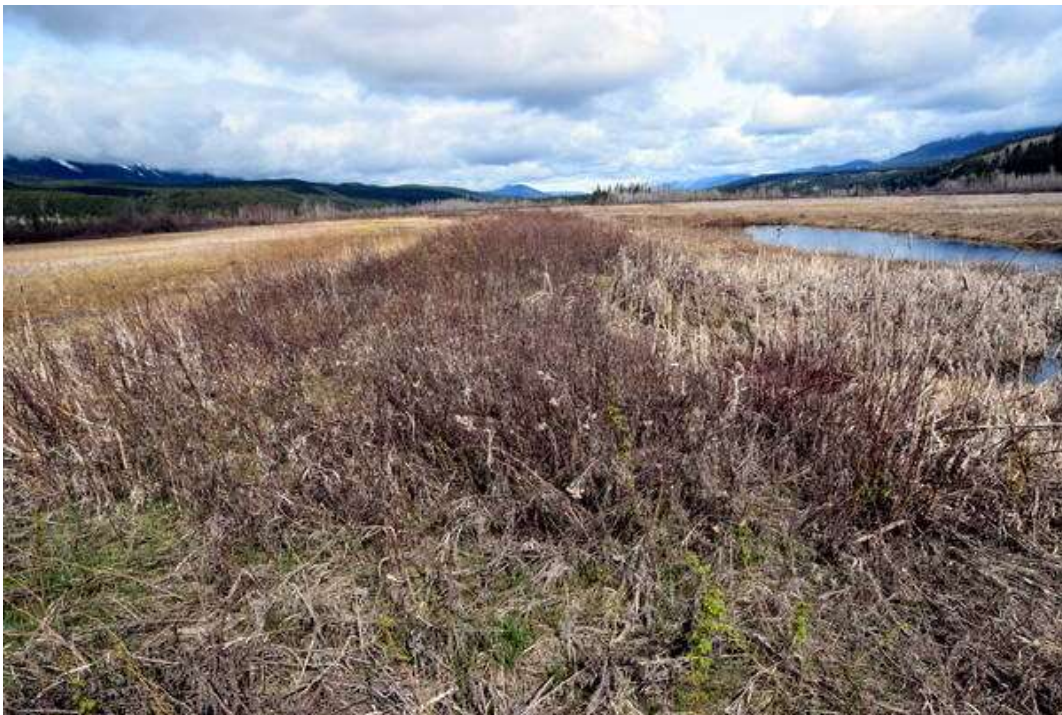
Figure 82. Interior dikes including this one on the Sime Compartment may be removed to restore floodwaters from the Columbia River over all of Moberly Marsh.

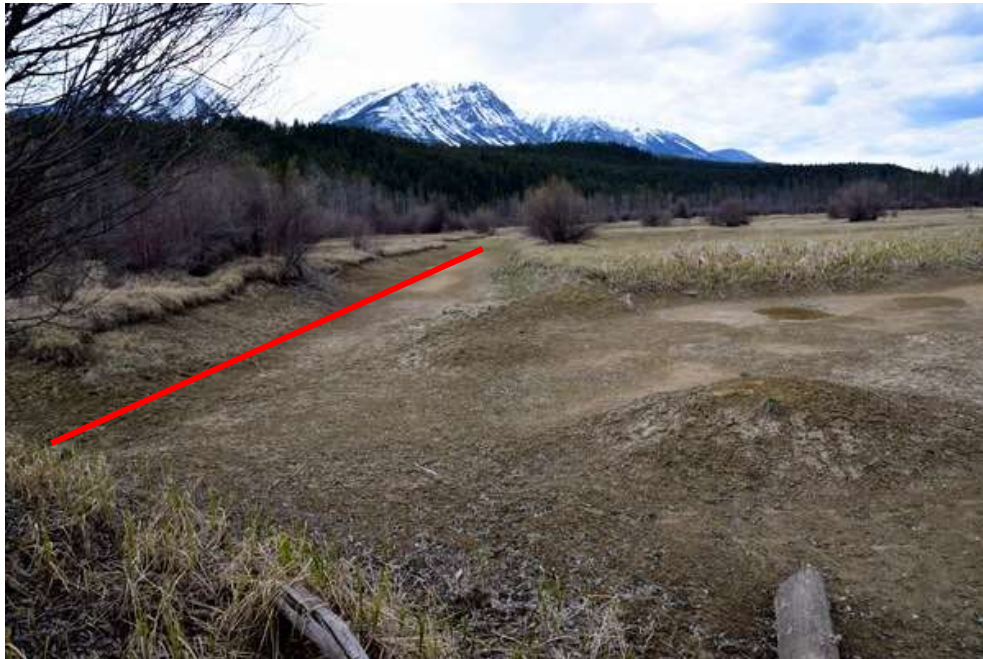
Figure 90. The borrow pit created by building the dike (red line) is draining the entire Northern portion of Moberly Marsh. Gravel lenses exposed in the ditch are carrying water under the dike into the Columbia River.

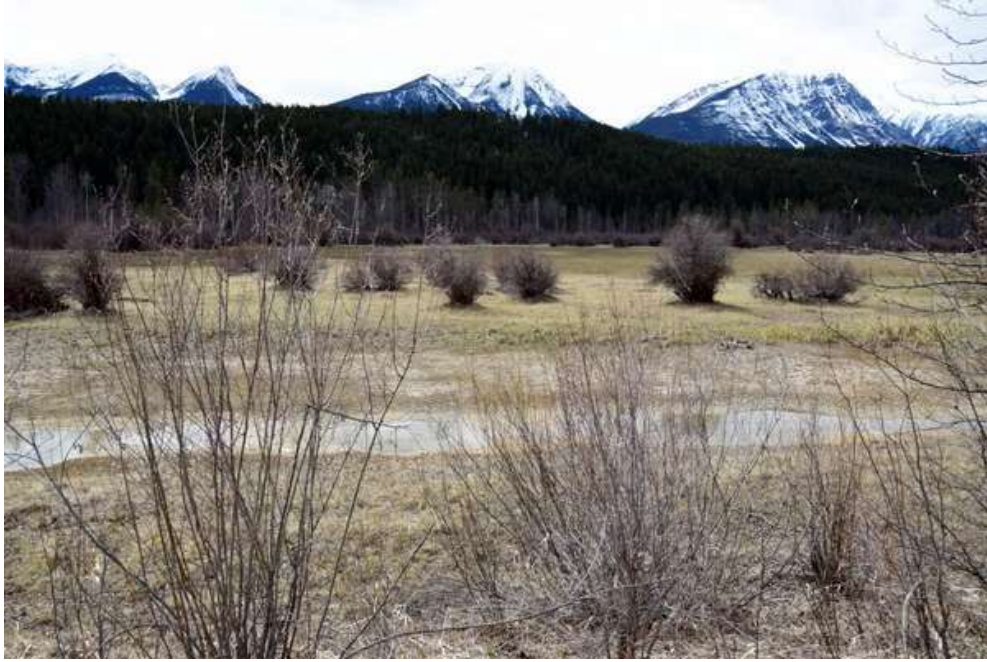
Figure 91. Willows are beginning to grow in the drained wetland basin. The borrow pit created by building a long dike is draining the wetland. Water is flowing down the borrow pit ditch, into exposed gravel layers, and then into the Columbia River.

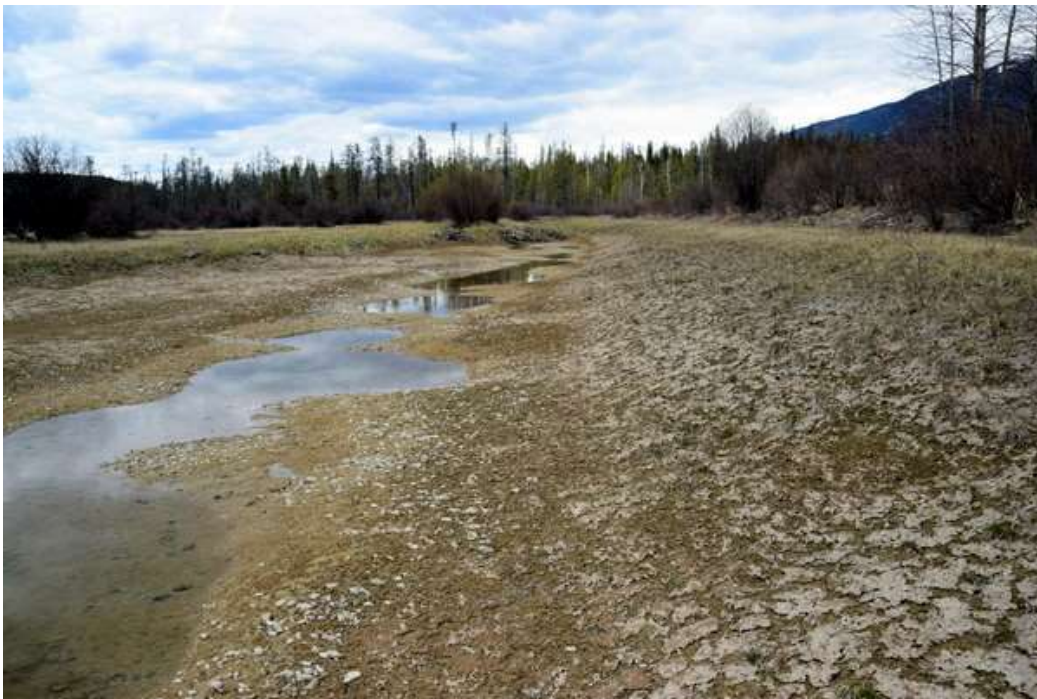
Figure 92. Note the gravel in the ditch that is draining the large wetland.

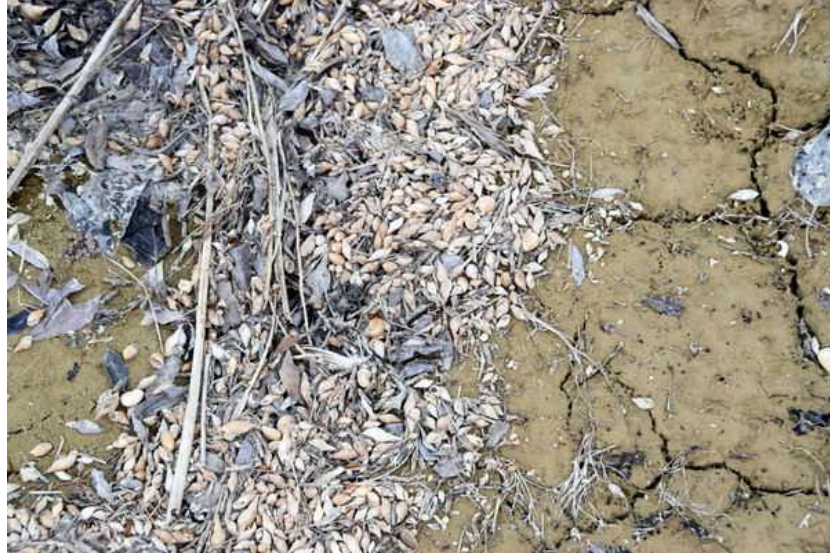
Figure 93. The construction of dikes and ditches in the Braul Compartment has greatly shortened the hydroperiod of natural wetlands within Moberly Marsh. The crustaceans shown in this photo died because the wetland dried prematurely due to drainage.

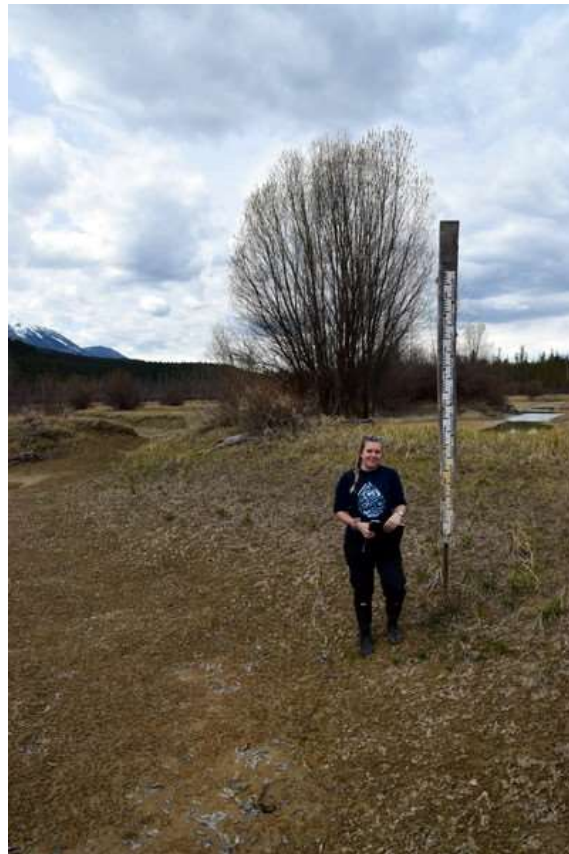
Figure 94. This ditch was constructed to move water into and out of a large natural wetland within the Braul Compartment. The ditch now only drains the wetland. The wetland no longer holds water due to the permeable substrate exposed in the ditches.

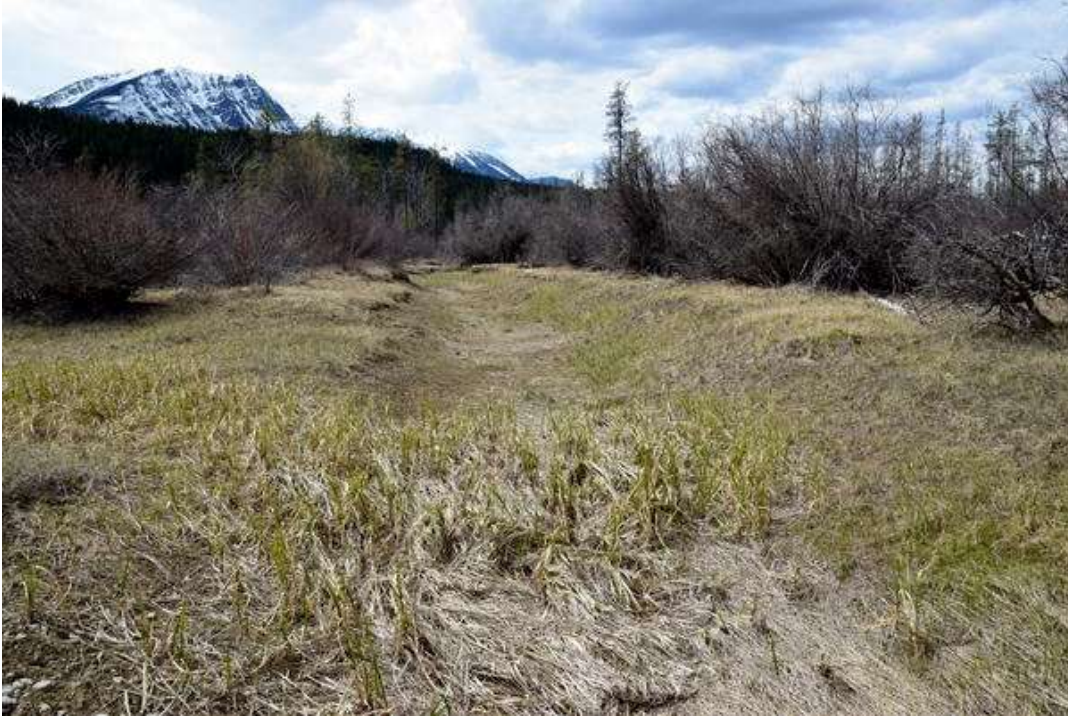
Figure 105. This photo shows the transition where a natural stream was turned into a drainage ditch within the Braul Compartment after 1965.

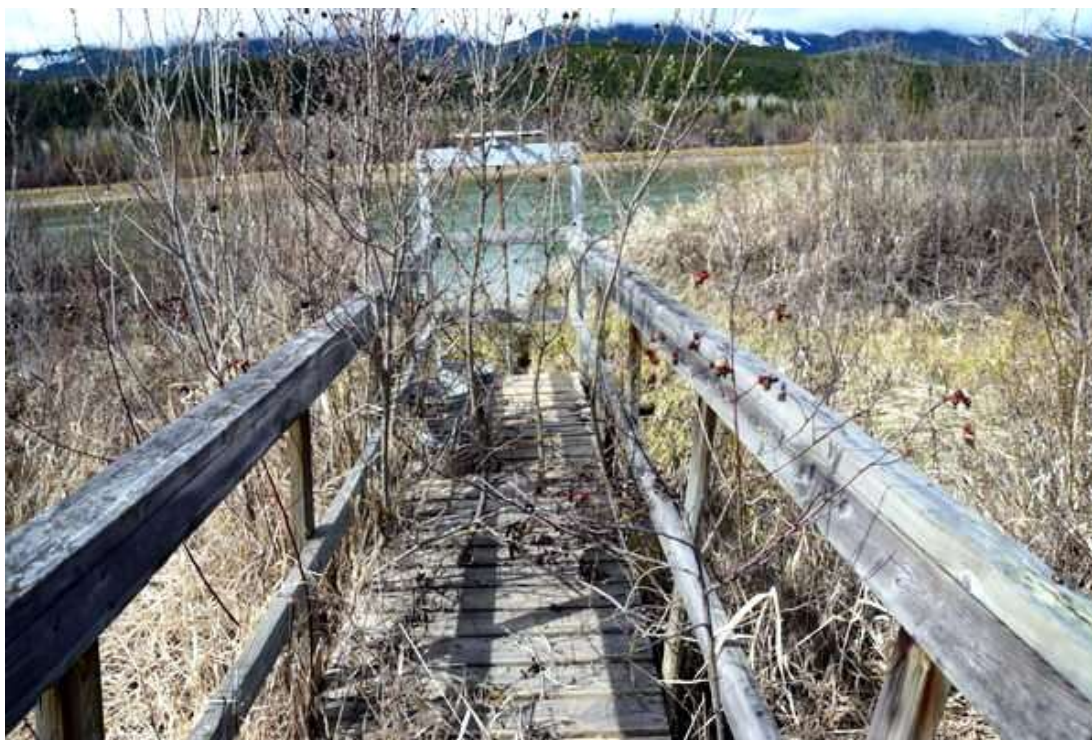
Figure 118. The walkway for the 3-Way Control Structure may be removed.

A large excavator will be needed to remove the water control structures and pipes. A cutting torch will be needed to cut long pipes. A pump may be needed to remove water from holes being dug to ensure all pipes are found. An attempt should be made to block ditches with compacted soil to prevent water from rushing in the holes being dug.

The pipe and water control structures are to be hauled off site. The site where the 3-way control is located will be modified to a naturally appearing outlet with an entrance at a higher elevation.

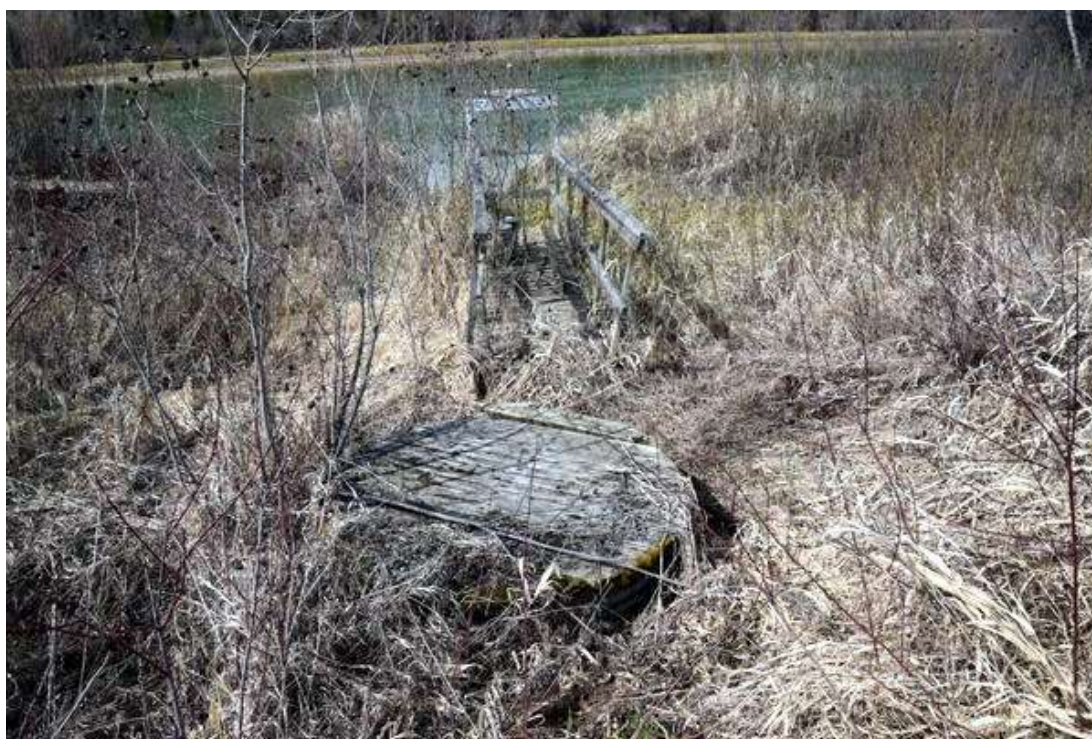
Figure 119. All pipes associated with the 3-Way Control Structure may be removed.

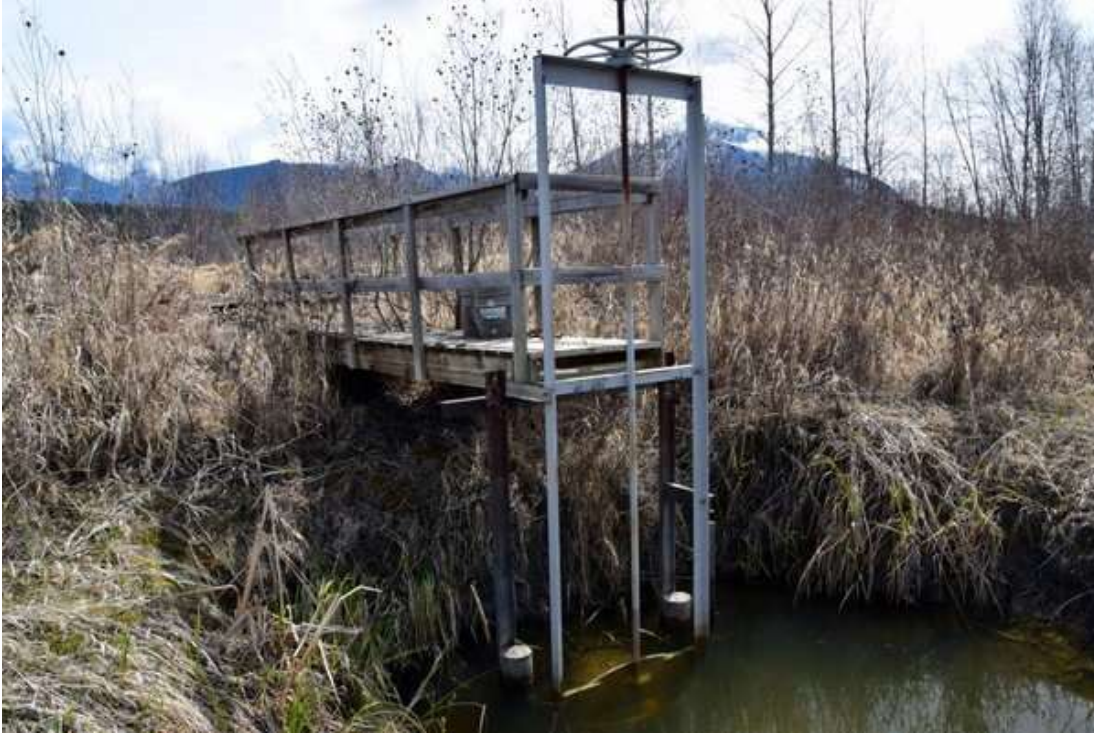
Figure 120. The ditch leading to and from the 3-Way Control Structure would be changed to a naturally appearing and functioning outlet at a much higher elevation for Moberly Marsh.

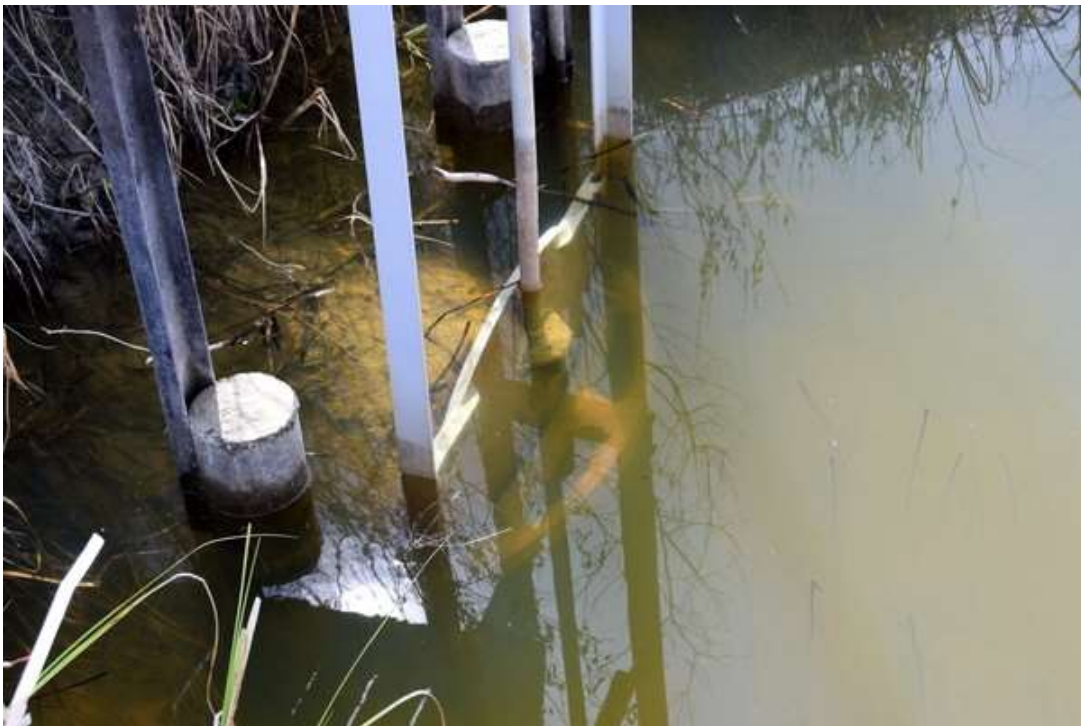
Figure 121. Leaking valves on water control structures are draining Moberly Marsh.

Beaver and muskrat have dug burrows into the dikes surrounding flashboard riser water control structures. The water control structures are leaking, and water is likely leaking around the pipes connecting the water control structure. The flashboard riser type water control structures are not holding water. The leaking can be expected to be much worse when water levels are higher in Moberly Marsh due to greater hydraulic pressure.

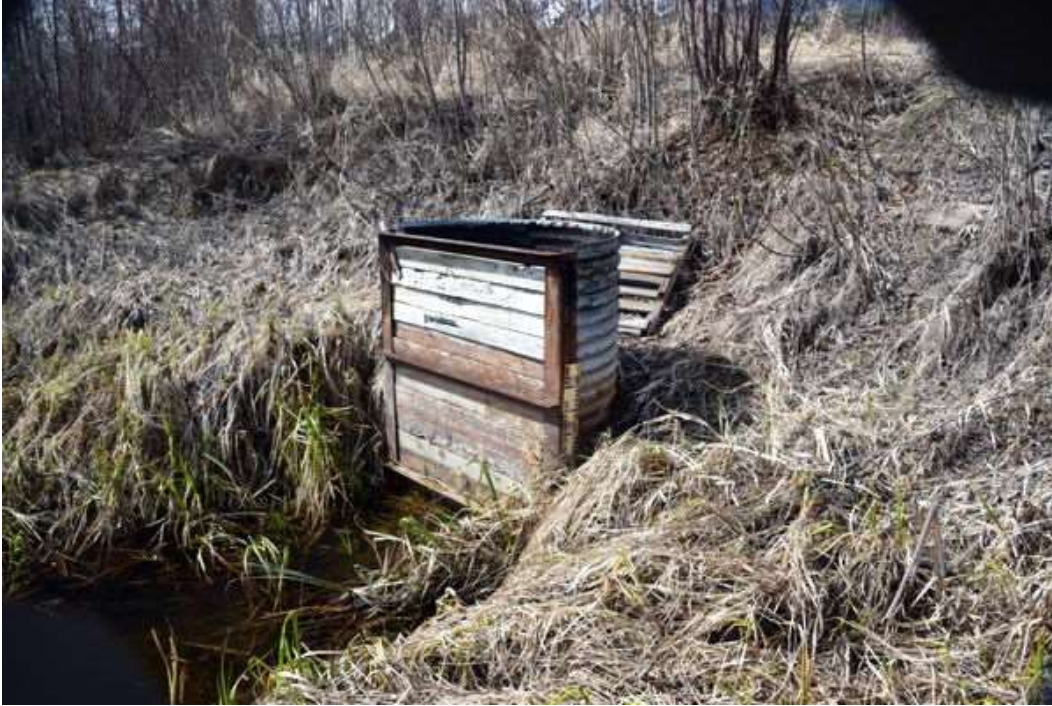
Figure 122. The flashboard riser and pipes for the Bergenham Compartment may be removed. Water levels would be near the top of the structure if the dike and water control structure were holding water.

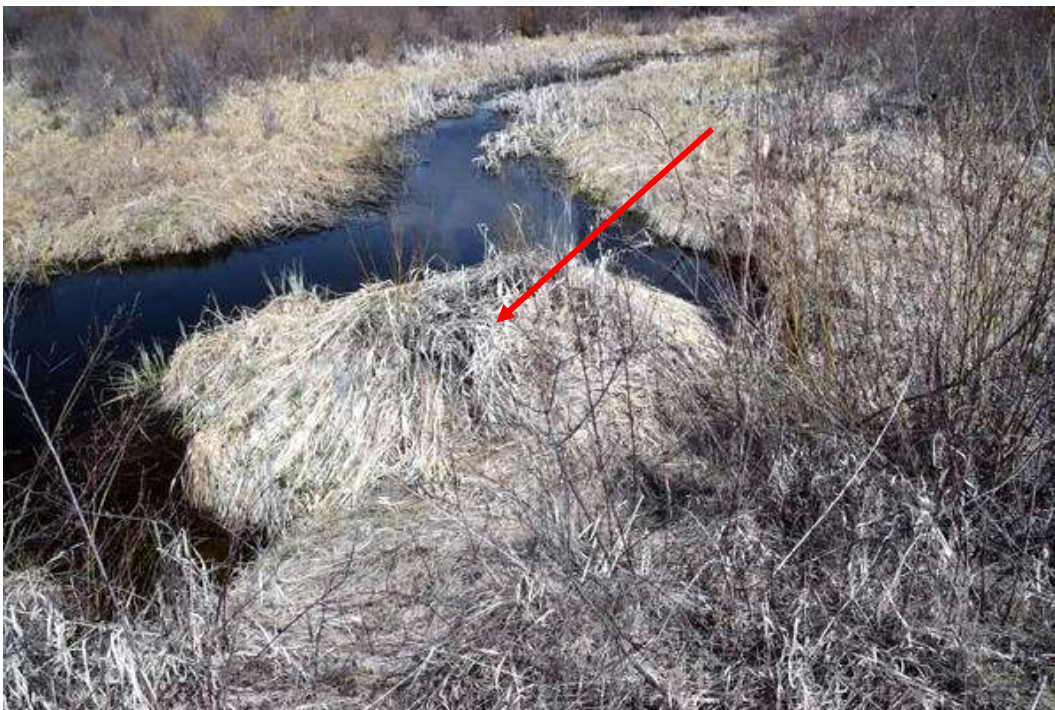
Figure 123. The red arrow points to the flashboard riser and pipes for the Sime Compartment that may be removed. The water control structure has been covered by beaver.

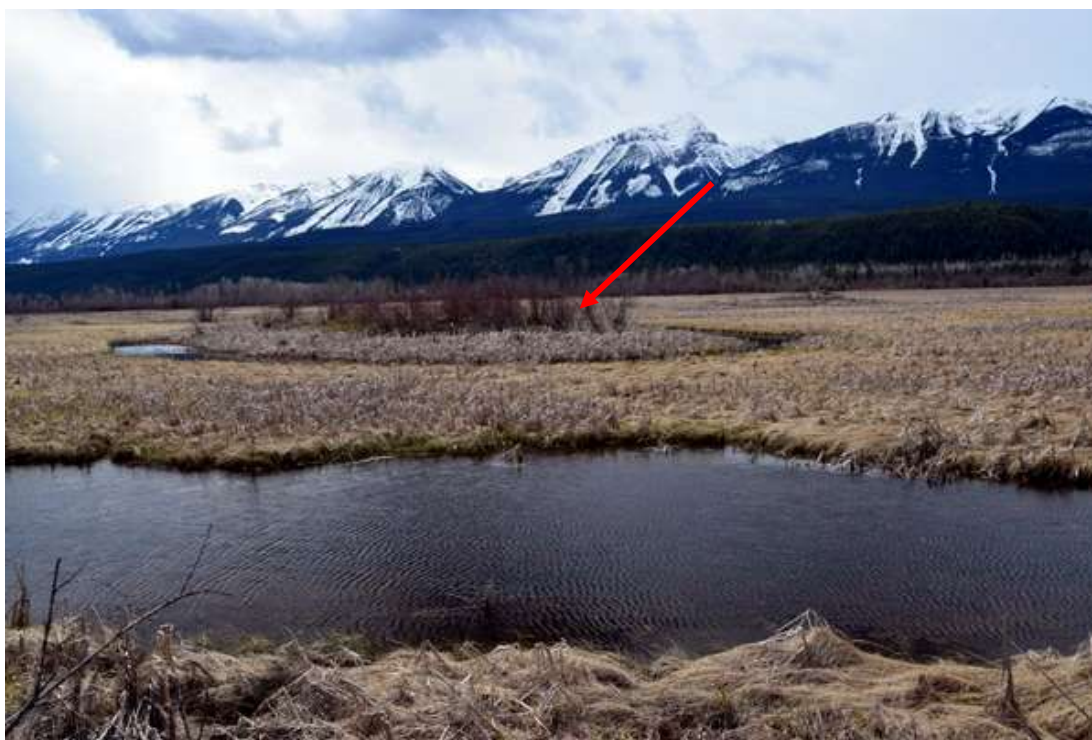
Figure 124. The red arrow points to one of 28 constructed islands.

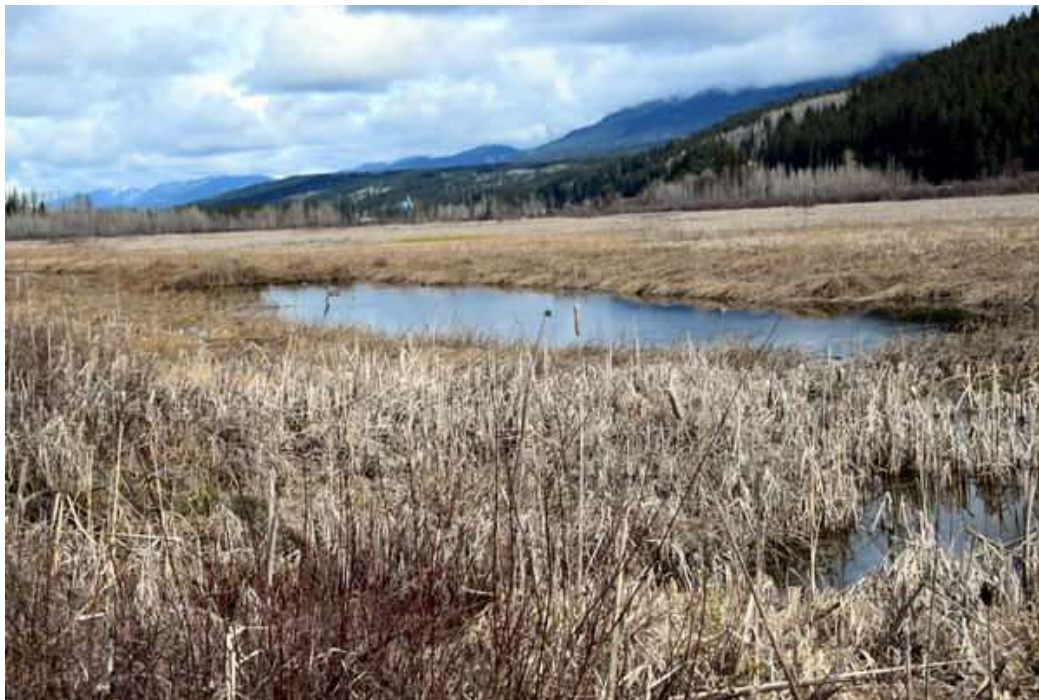
Figure 128. Nesting islands may be reshaped to restore naturally appearing areas of open water like what is shown here.
