# Summary of Columbia Lake Stewardship Society's 2016 Water Quantity Monitoring Program

Prepared by W. Thompson January, 2017

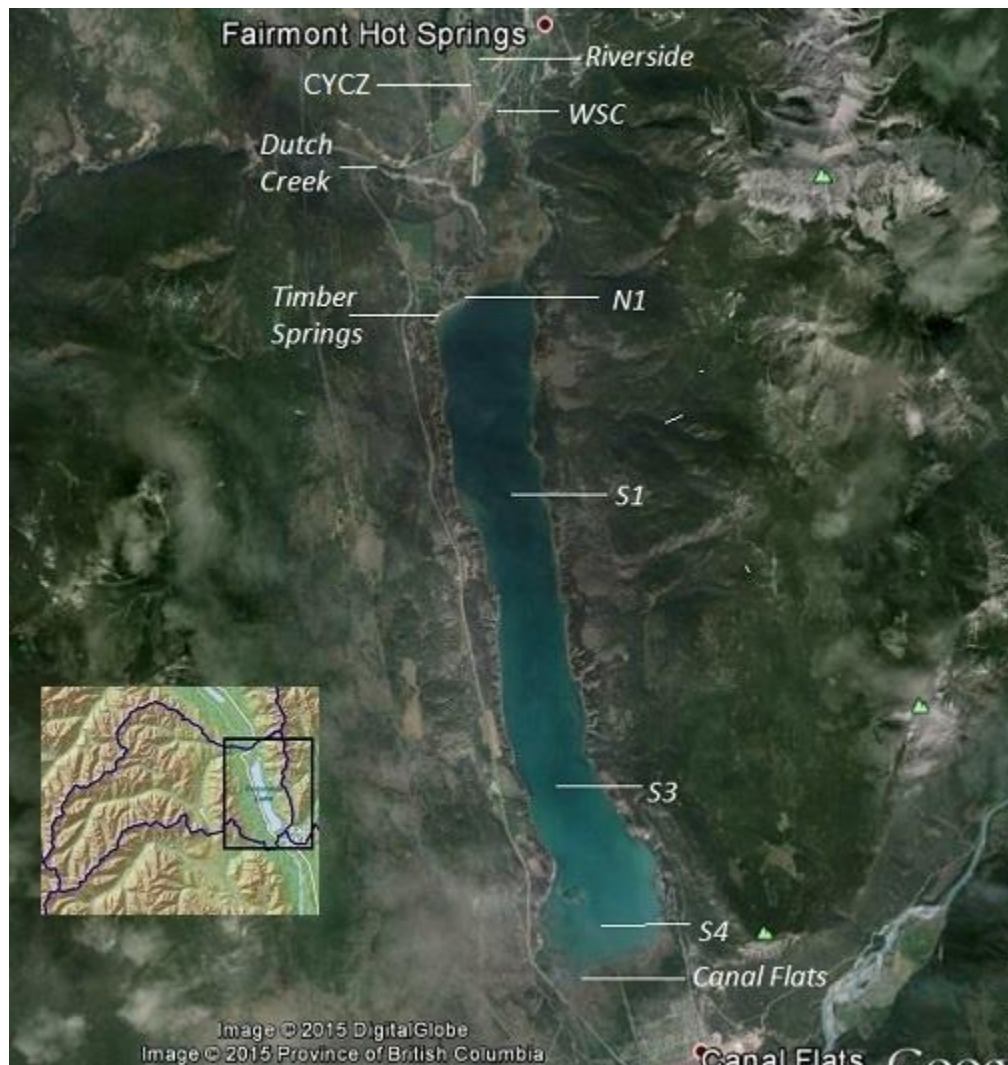
Figure 1 – Map showing station locations. Entire watershed boundary is shown in inset.

Most investigators consider the outflow point of the Columbia Lake Watershed to be on the Columbia River at the Highway 93/95 crossing near Fairmont Hot Springs. The area above that point is 881 square kilometres. The bulk, 696 square kilometres, is contained in the Dutch Creek sub-basin. Not all of the water from Dutch Creek enters the Lake, some by-passes to the north and flows directly into the Columbia River. The proportion flowing into the Lake has varied over the years due to shifting drainage channels in the Creek delta. The boundaries of the Watershed are shown in the inset of Figure 1.

At the end of the 2015 season four automatic water level monitoring stations were in operation. These were located in the Columere Marina, on the Headwaters Creek in the Columbia River Headwaters Park near Canal Flats, on the Columbia River near Fairmont Hot Springs and on Dutch Creek at the Highway 93/95 Bridge (see Figure 1 for locations).

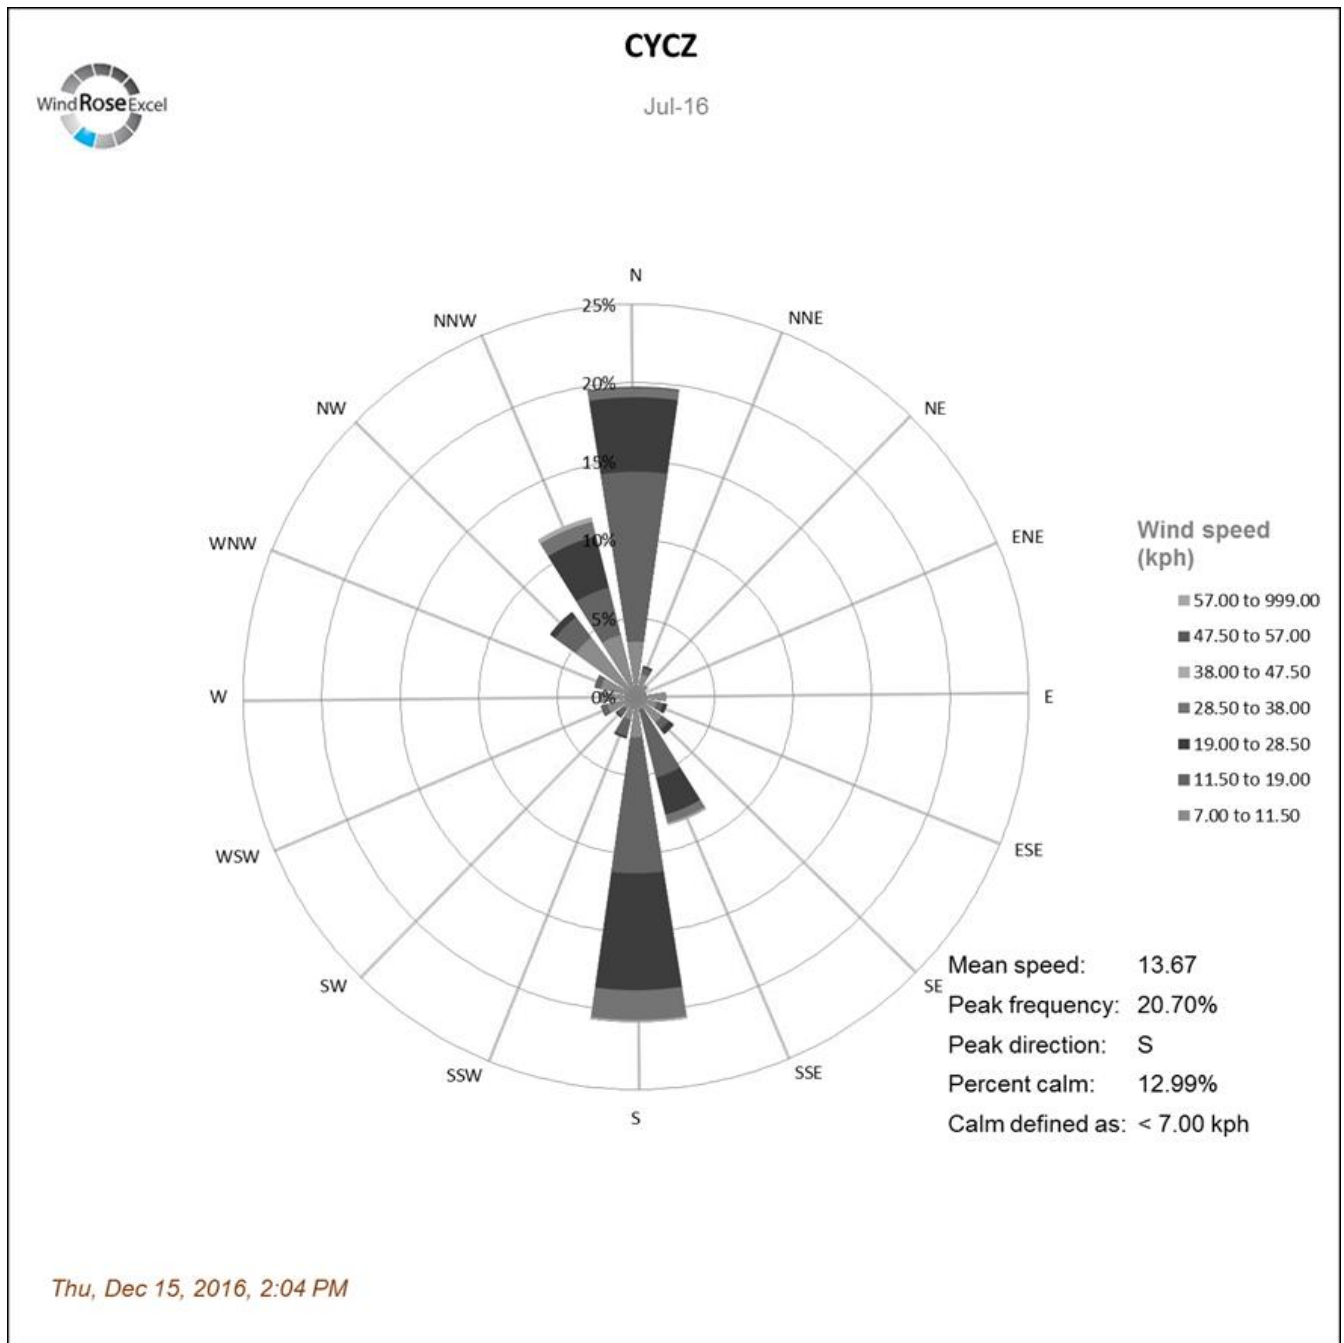
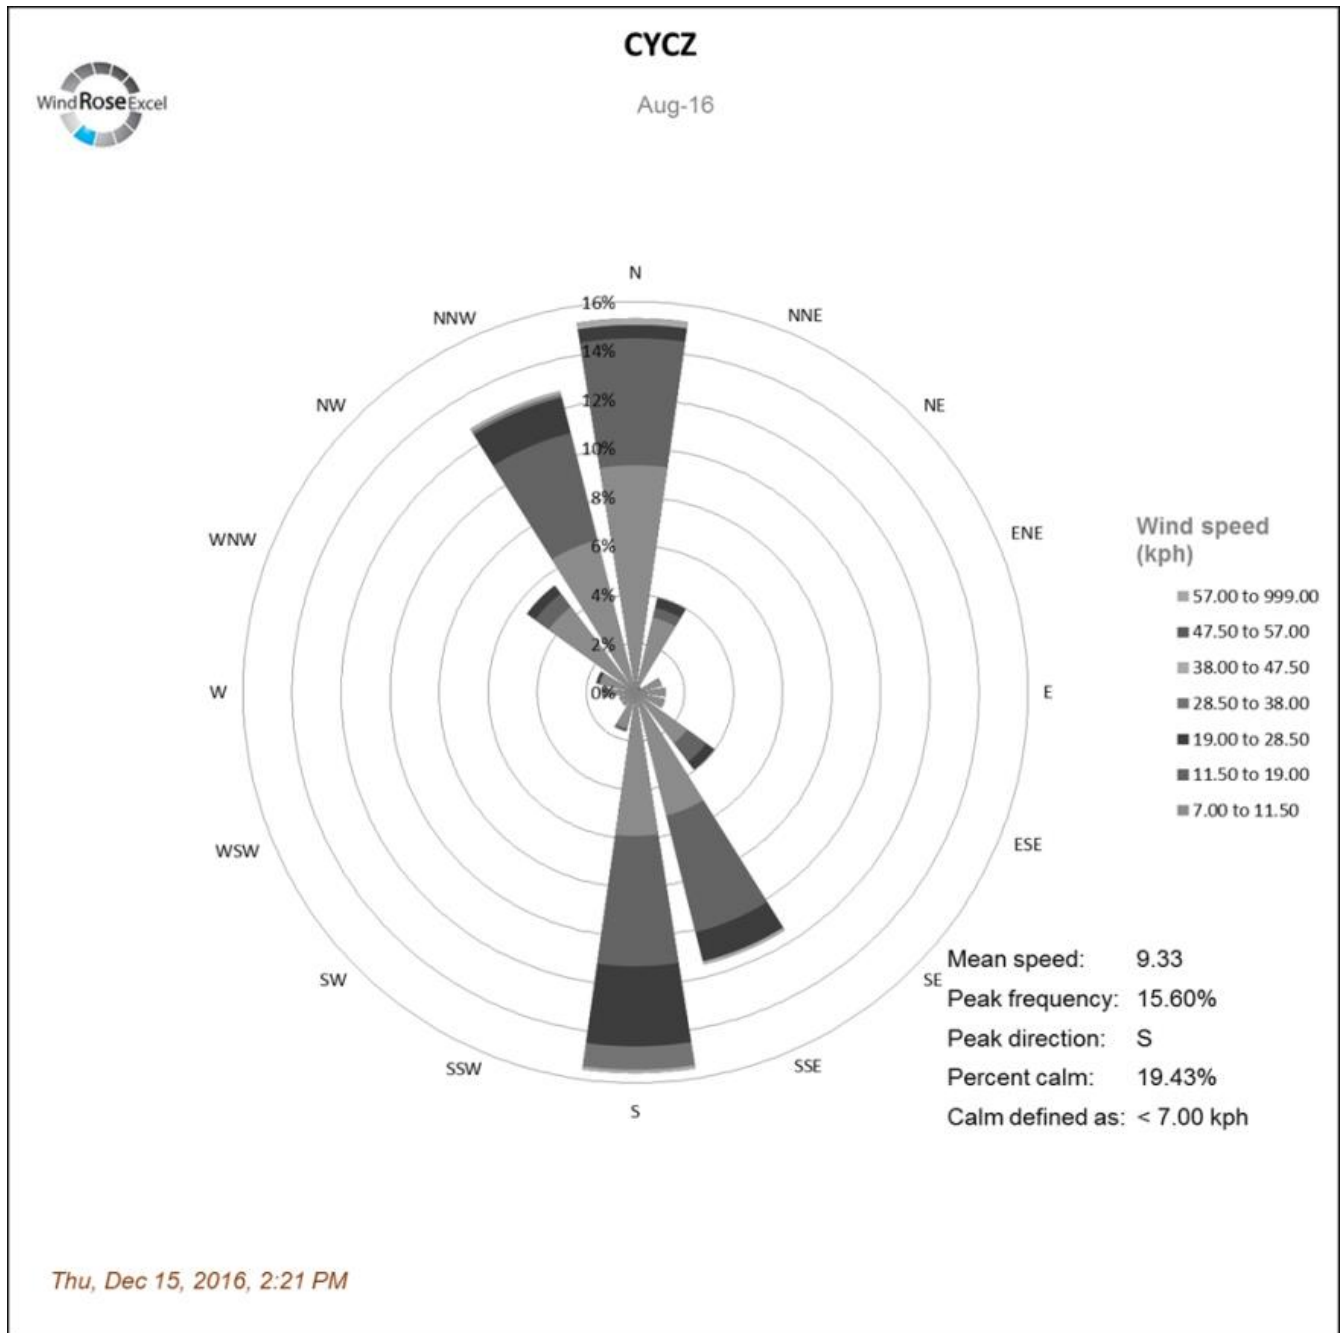
## Appendix B

The wind roses for July and August contained in Appendix B were derived from manually abstracted data and are presented to give an approximation of the distribution of wind directions and speed as well as an indication of the amount of data available. Out of a possible 744 hourly observations in each month, 739 were available to prepare the July wind rose and 731 for the August wind rose.
