**GOLDEN FLOOD STUDY AND MAPPING  
COLUMBIA RIVER, KICKING HORSE RIVER, AND HOSPITAL CREEK  
TOWN OF GOLDEN, BRITISH COLUMBIA**

Prepared for:  
**THE TOWN OF GOLDEN**

Prepared by:  
**MATRIX SOLUTIONS INC.**

Version 1.0  
March 2020  
Calgary, Alberta

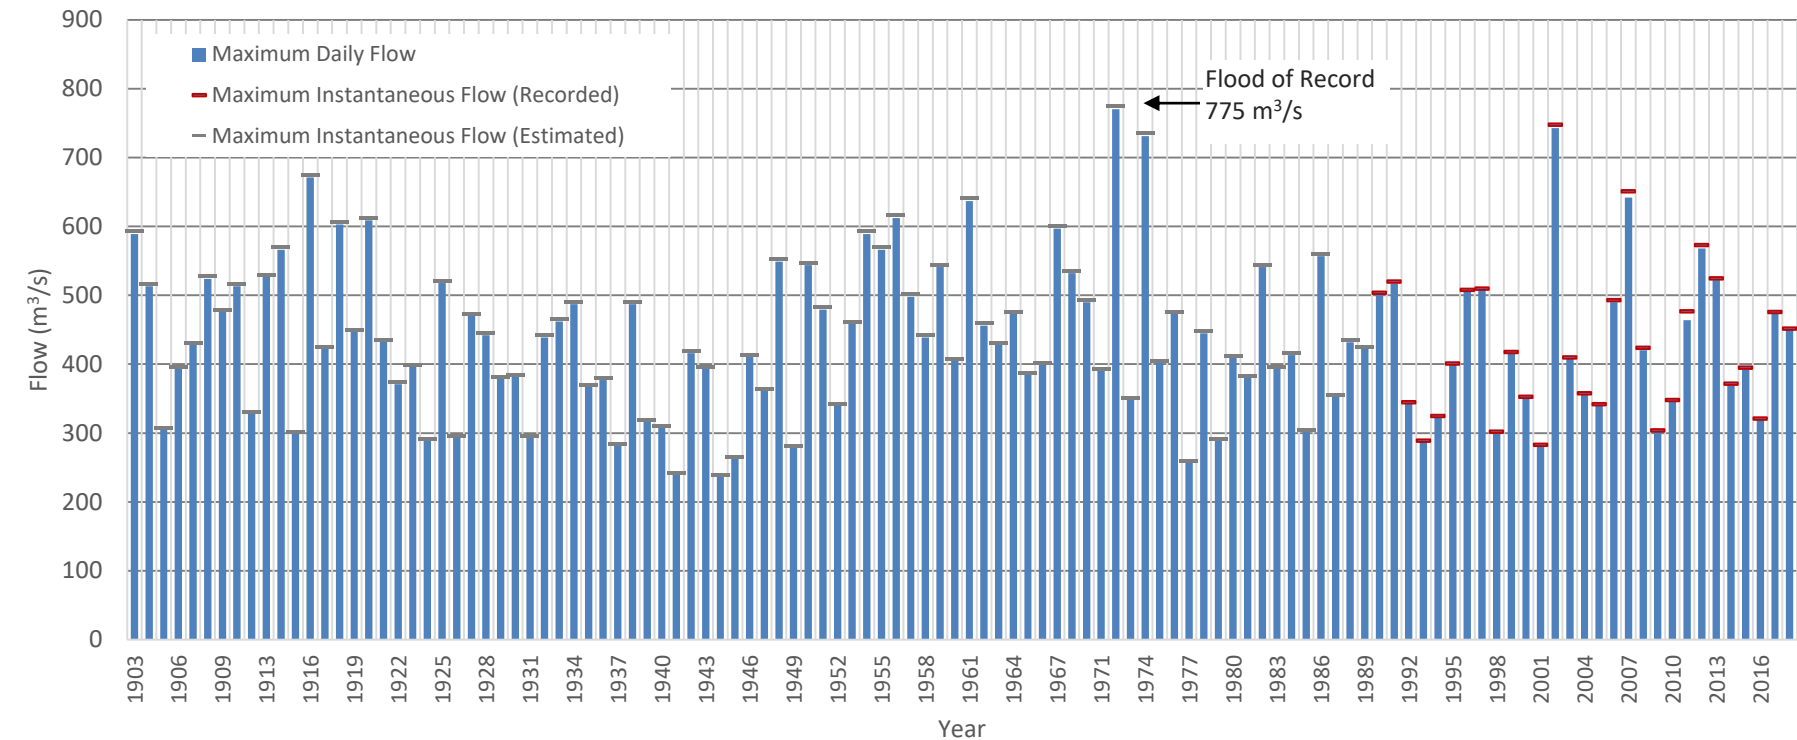
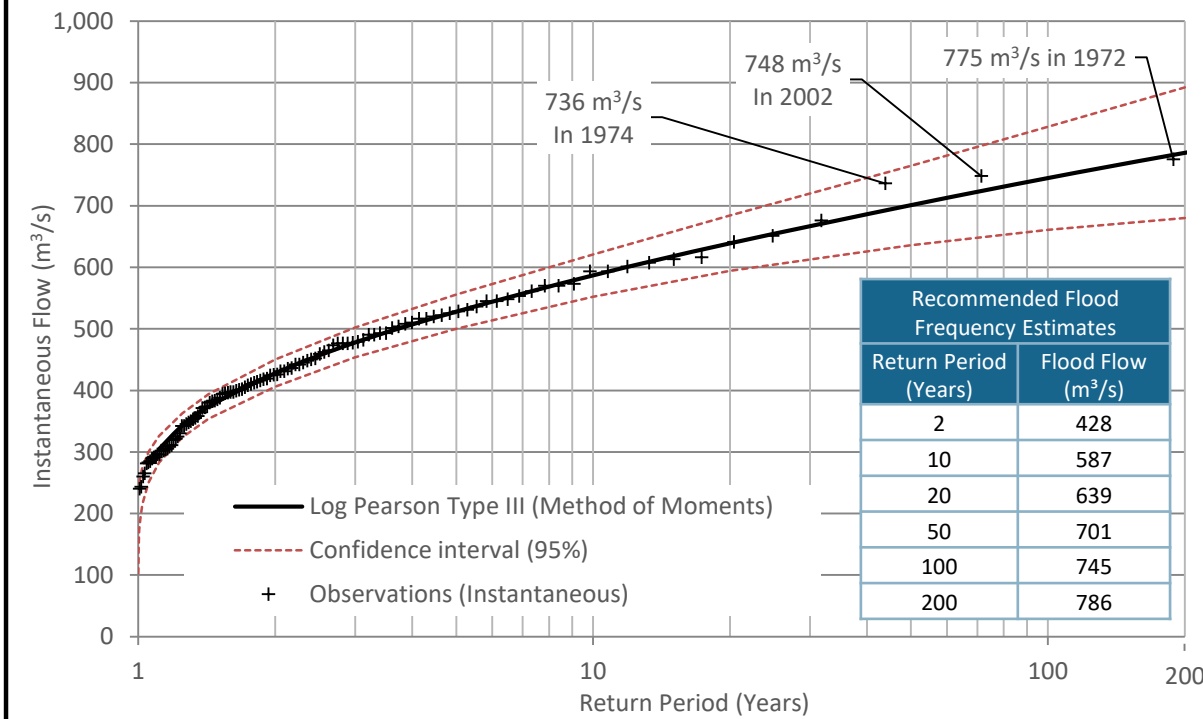
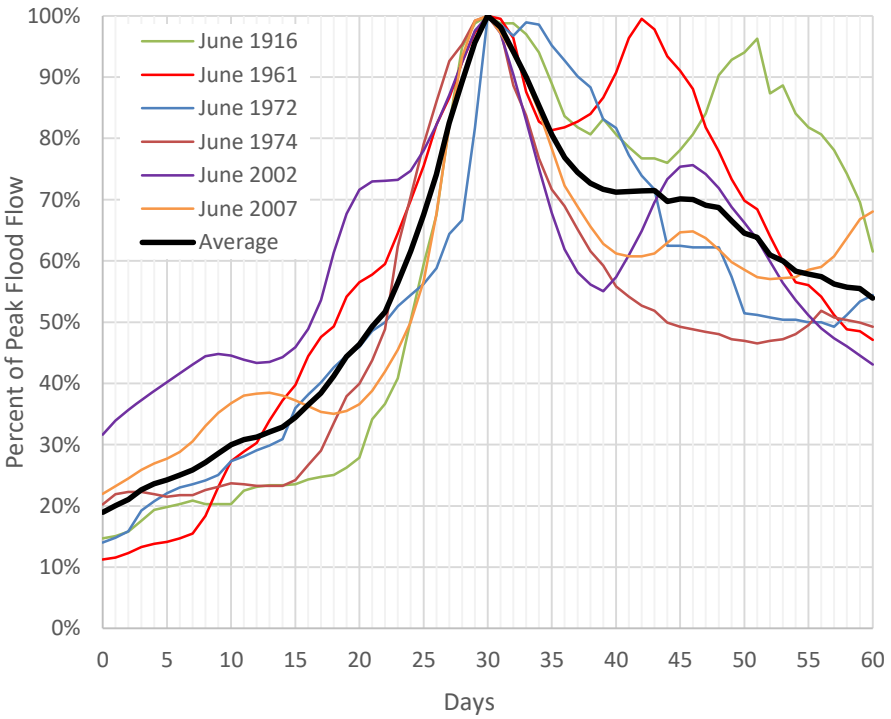
Annual Hydrographs

Annual Maximum Flow History

Flood Frequency Analysis

Historical Flood Hydrographs

Historical Unit Flood Hydrographs

1. FLOODING TYPICALLY OCCURS IN JUNE, DRIVEN BY SNOWMELT COMBINED WITH HIGH PRECIPITATION.
2. FLOW RECORDS TAKEN FROM WATER SURVEY OF CANADA HYDROMETRIC STATION 08NA002, LOCATED ON THE COLUMBIA RIVER ABOVE THE CONFLUENCE WITH THE KICKING HORSE RIVER.
3. WHEN NOT AVAILABLE, MAXIMUM INSTANTANEOUS FLOW IS ESTIMATED FROM DAILY AVERAGE FLOW BY APPLYING THE AVERAGE RATIO OF MAXIMUM INSTANTANEOUS TO DAILY AVERAGE FLOW (1.0068).
4. FIGURES MUST BE USED IN CONJUNCTION WITH THE ATTACHED REPORT AND ARE SUBJECT TO THE LIMITATIONS AND CONDITIONS STATED IN THE REPORT.

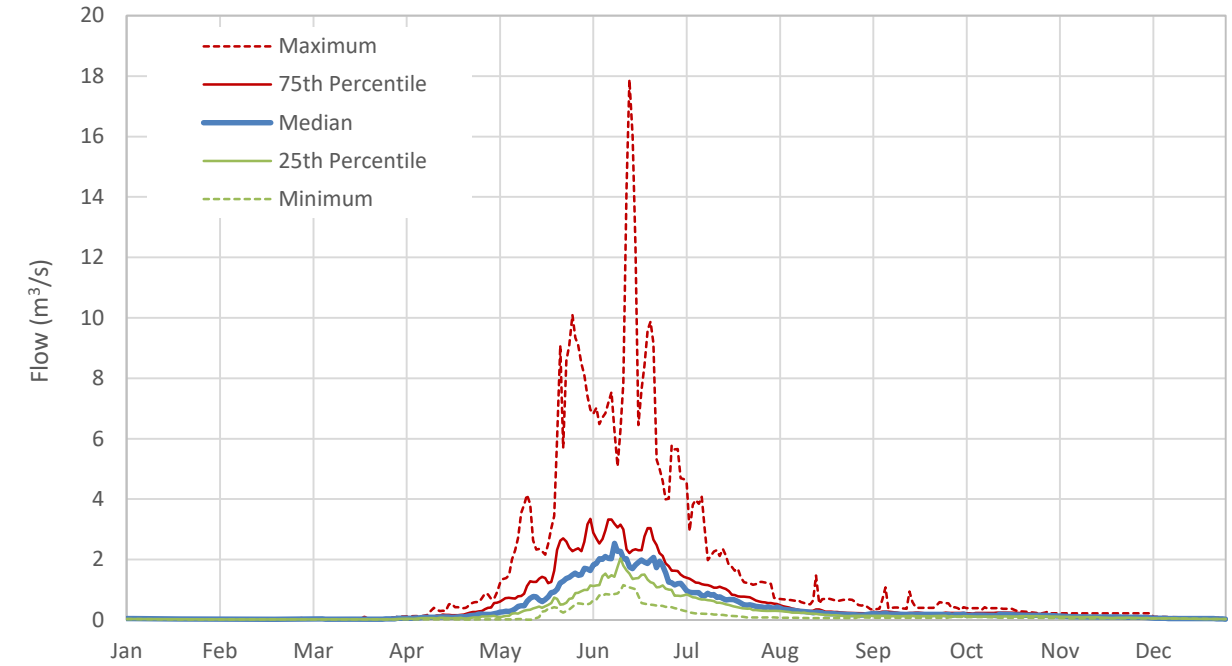
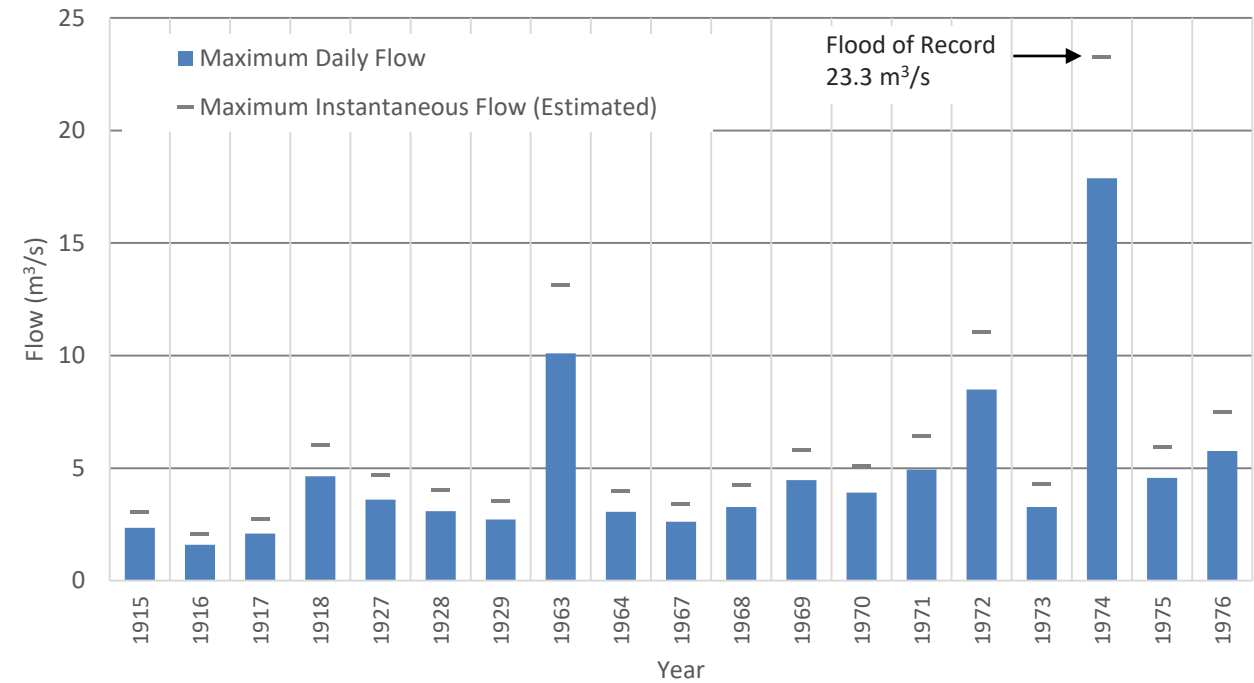
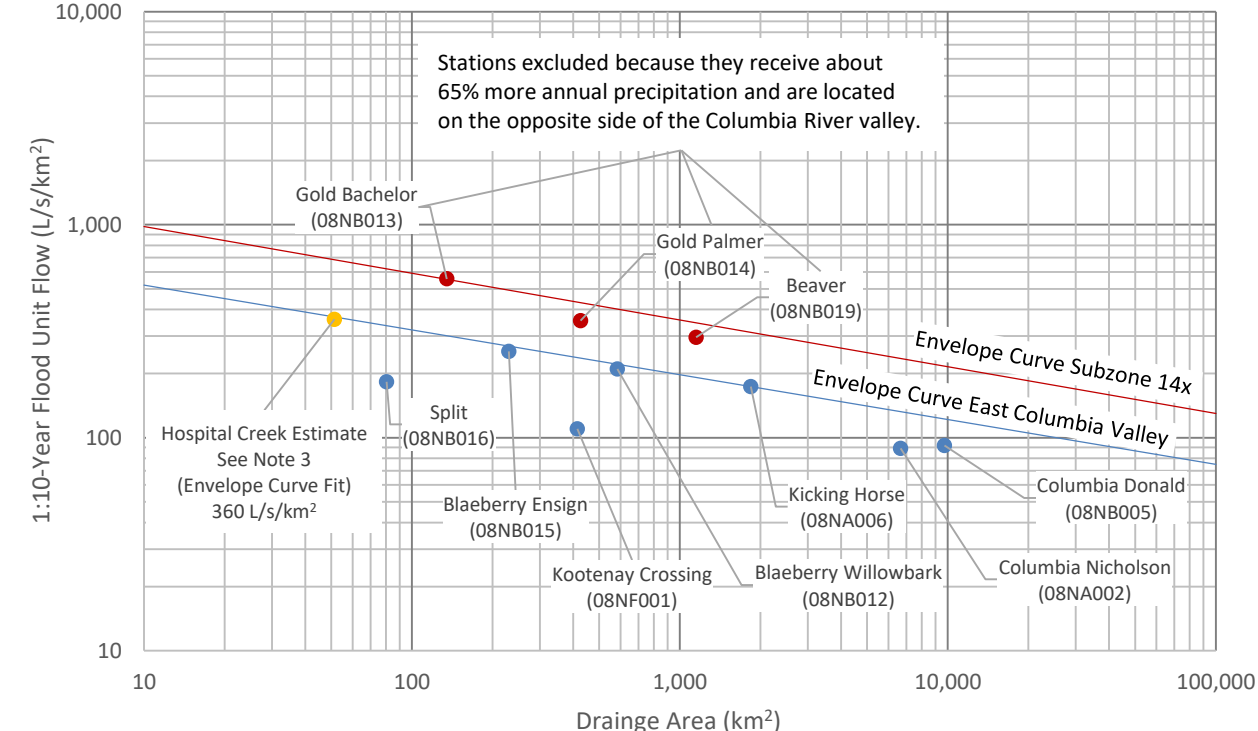
Figure 4

Annual Hydrographs

Annual Maximum Flow History

Flood Frequency Analysis

Regional Analysis (Adapted From Obedkoff 2002 Subzone 14x)

1. THE HOSPITAL CREEK DRAINAGE AREA AT THE HIGHWAY 1 CULVERT IS 54.1 km<sup>2</sup>.
2. A 19-YEAR RECORD OF AVERAGE DAILY FLOW WAS DEVELOPED BY COMBINING THE RECORDS FROM THREE WATER SURVEY OF CANADA (WSC) STATIONS ON HOSPITAL CREEK. FLOW DATA FROM STATION 08NA009 AND 08NA0010 WERE COMBINED (REPRESENTING A TOTAL DRAINAGE AREA OF 46.6 km<sup>2</sup>). THIS COMBINED FLOW WAS THEN ADJUSTED TO WSC 08NA002 LOCATION (54.1 km<sup>2</sup>) BY THE RATIO OF THE DRAINAGE AREAS TO THE EXPONENT OF 0.75, A RECOMMENDED EQUATION FOR BRITISH COLUMBIA (EATON 2002). PEAK INSTANTANEOUS FLOW WAS CONSERVATIVELY ESTIMATED AS 1.3 TIMES THE DAILY AVERAGE FLOW.

The 2002 regional hydrology study proposed groups of regions with similar hydrologic characteristics and developed flood frequency envelope curves for these regions. The Columbia River, Kicking Horse River, and Hospital Creek are located within subzone 14x. Plotting 1:10-year flood data for subzone 14x (Figure 5) shows a significant difference in unit flood flow for basins located in the east versus the west side of the Columbia River valley (station locations are shown on Figure 1).

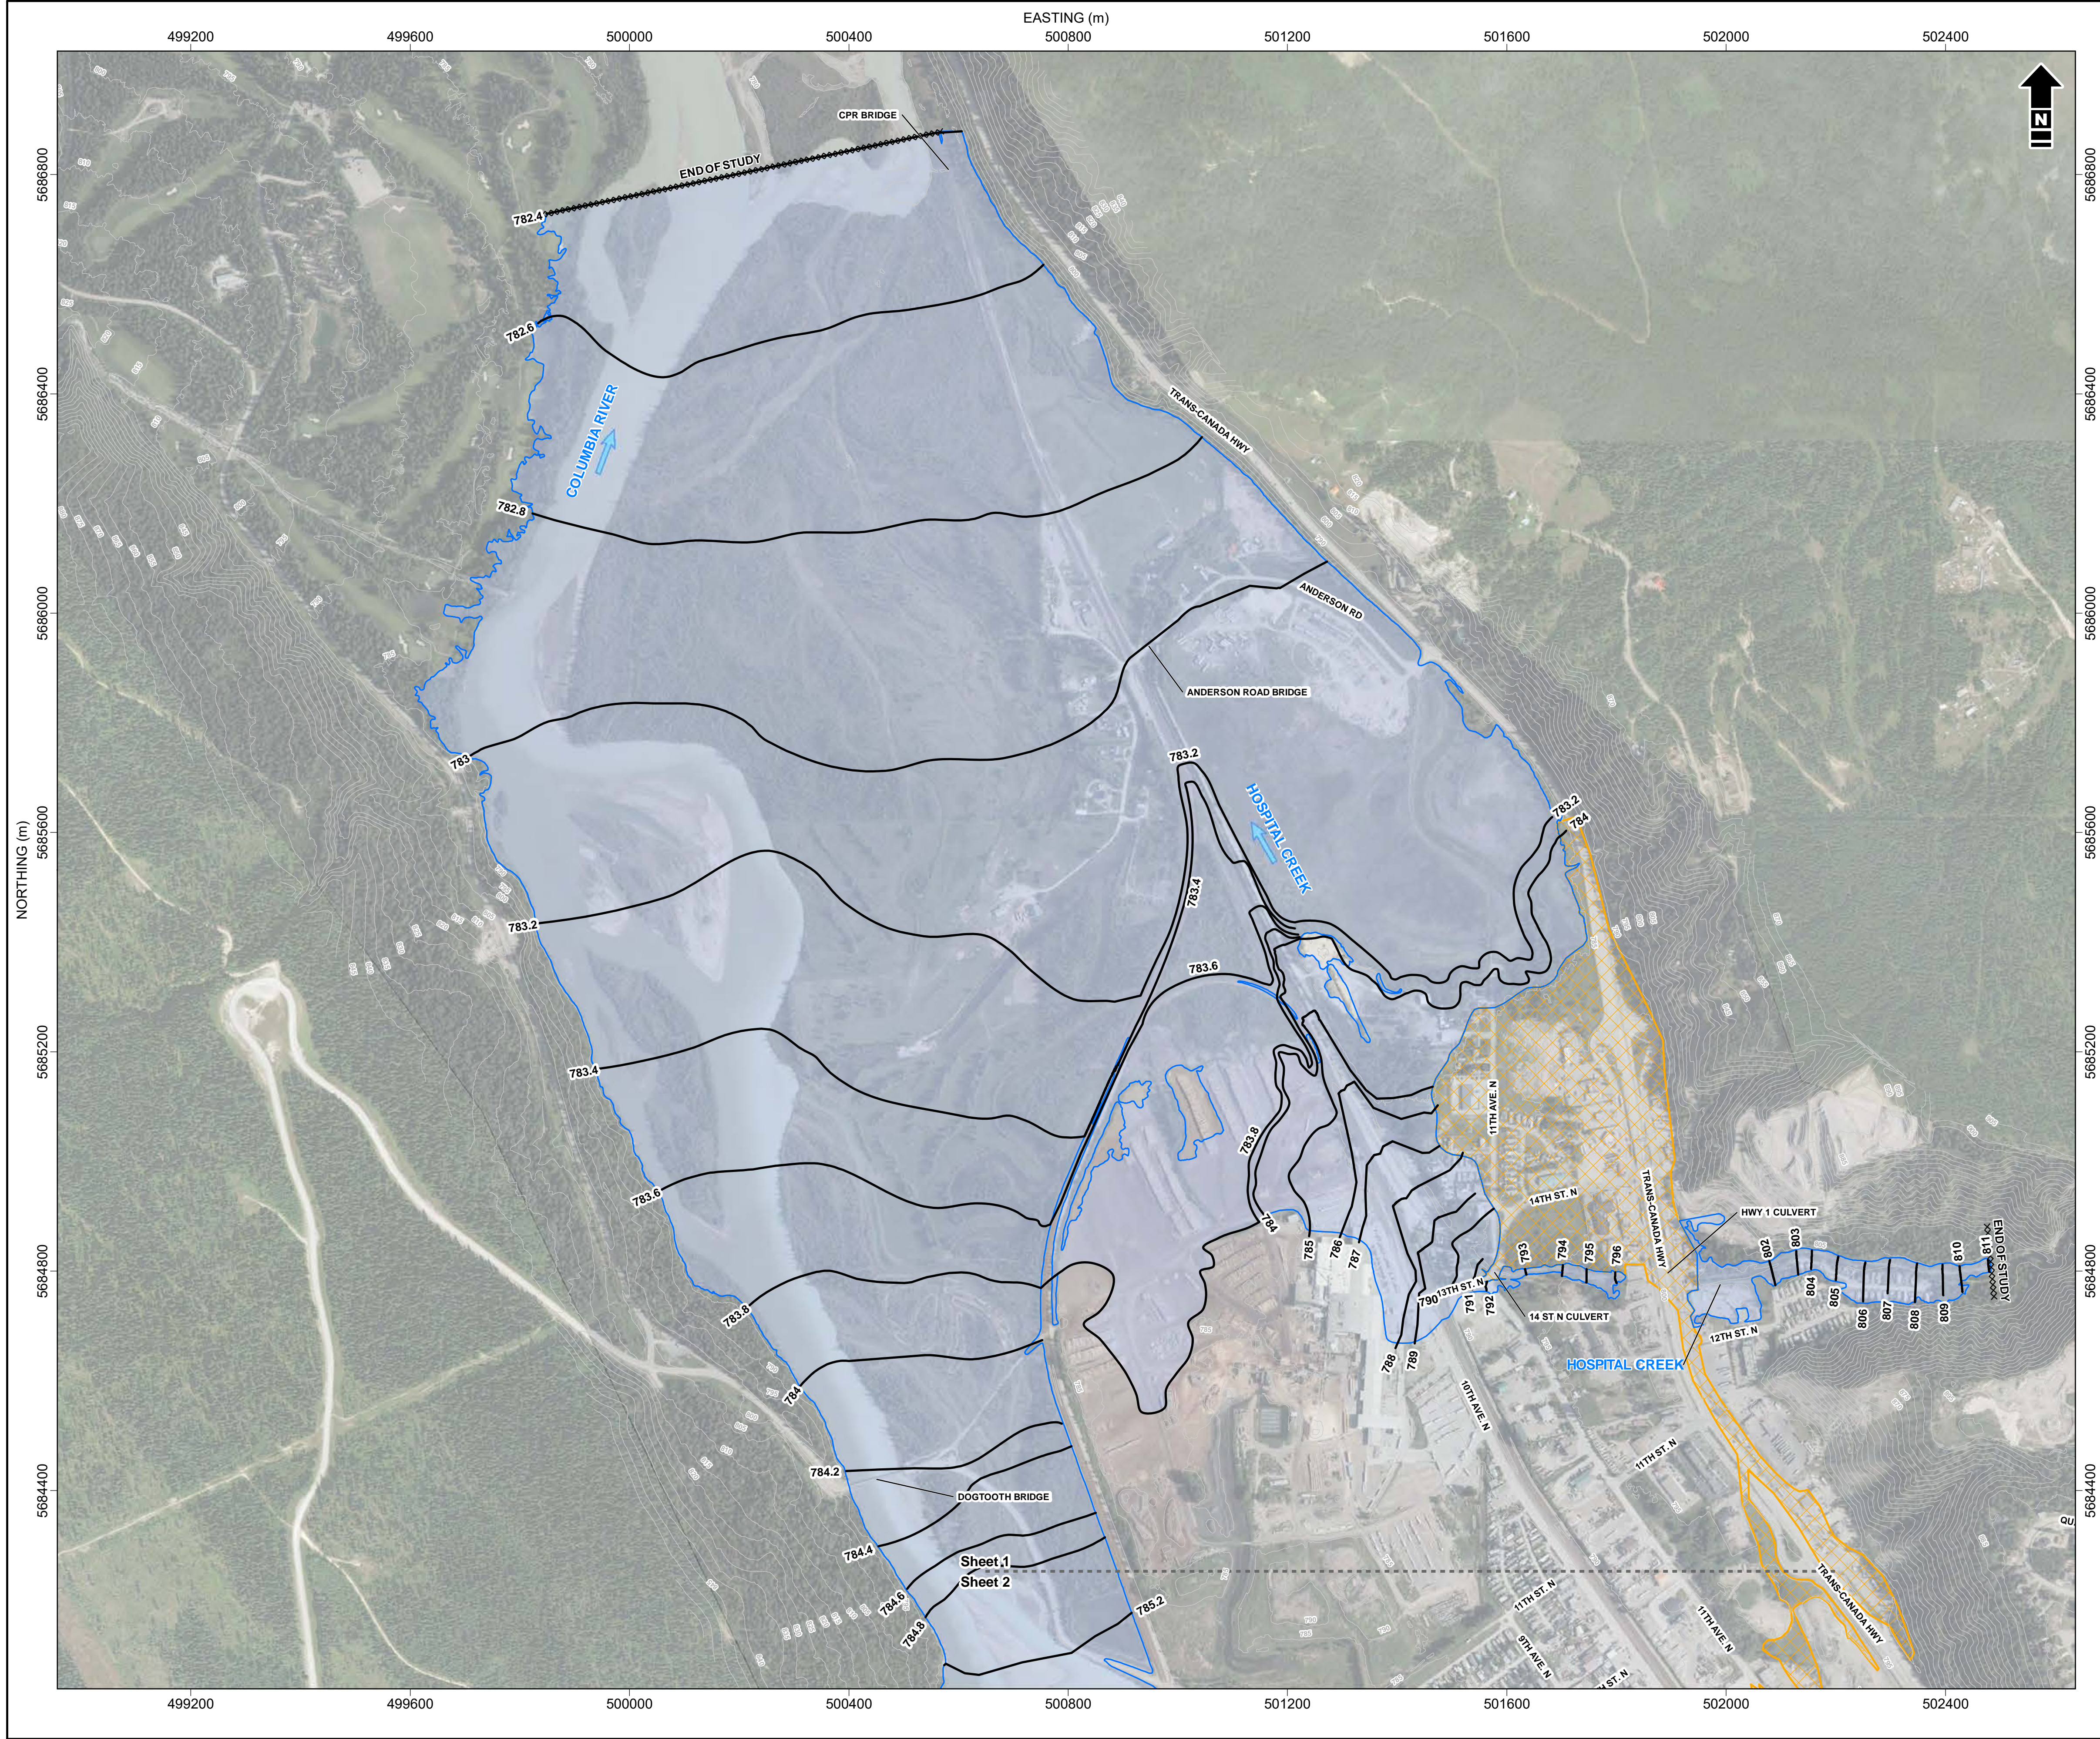
Sheet 1 of 3

- FLOW DIRECTION
- CONTOUR INTERVAL (5 m; masl)
- ×××× STUDY LIMIT
- 1:200 YEAR FLOOD EXTENT (SEE NOTE 3)
- 1:200 YEAR WATER LEVEL (masl)
- CULVERT OVERTOPPING HAZARD AREA (SEE NOTE 4)
- MATCHLINE

The Highway 1 culvert is susceptible to overtopping during an extreme flood. The flood inundation maps delineate an area at flood risk if the culvert capacity is exceeded or the culvert is partially blocked. This area would be subject to shallow depths (less than 0.3 m) and low velocities (less than 0.2 m/s), except along ditches and roads, with maximum velocity approaching 1 m/s. It is recommended that either this hazard be mitigated, or development restrictions be implemented within the Town floodplain bylaw for this area. The Town of Golden is aware of this hazard and further assessment is warranted.

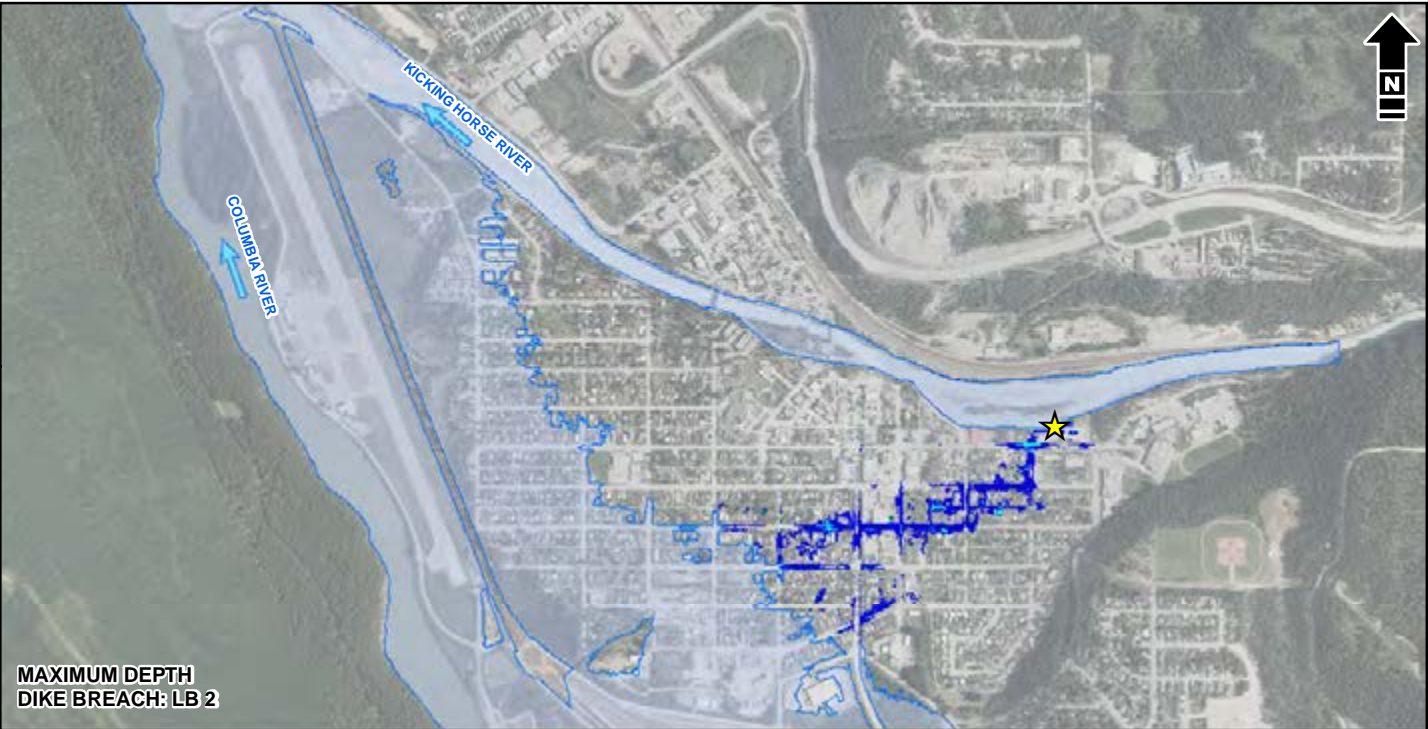
Figure B1

- ★ SIMULATED DIKE BREACH LOCATION
- 1:200 YEAR FLOOD EXTENTS (INCLUDING 0.6 m FREEBOARD)
- FLOW DIRECTION

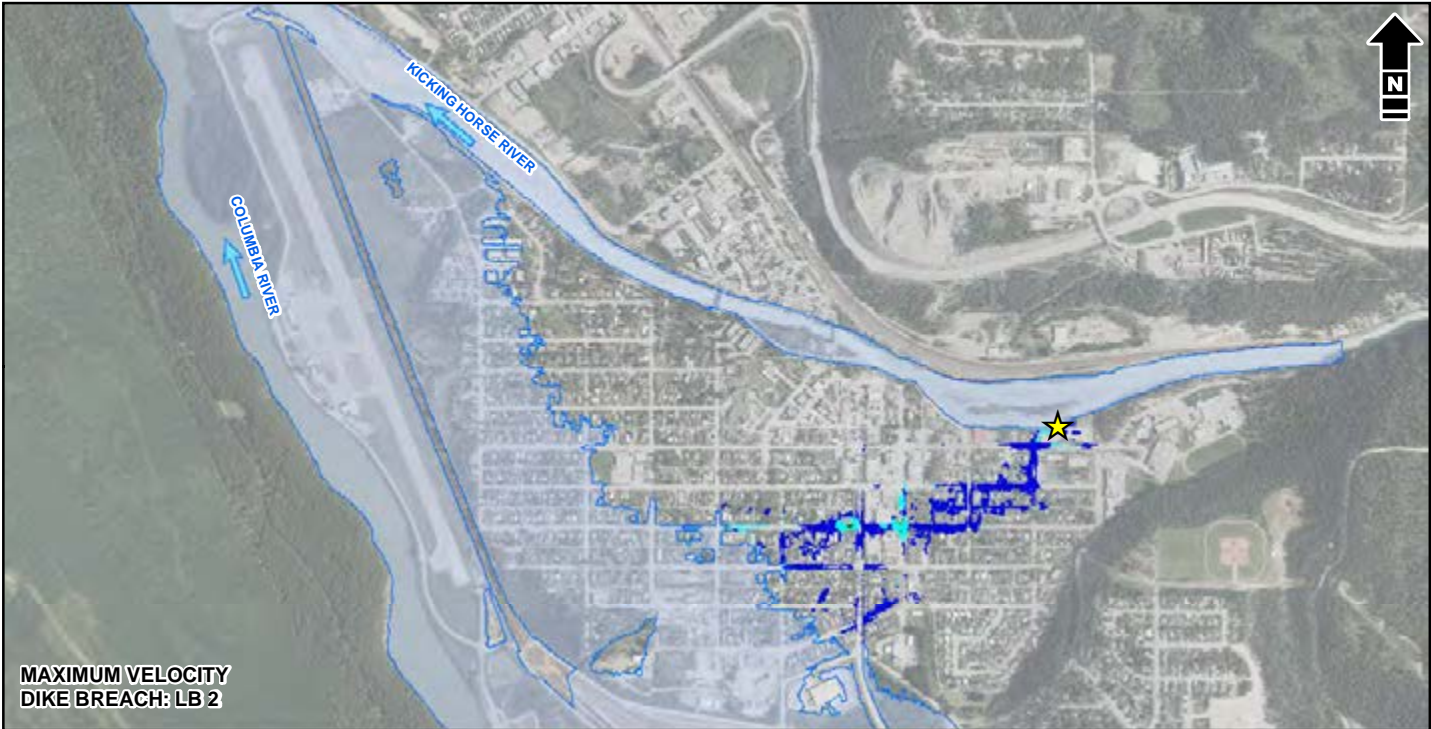
- ★ SIMULATED DIKE BREACH LOCATION
- 1:200 YEAR FLOOD EXTENTS (INCLUDING 0.6 m FREEBOARD)
- FLOW DIRECTION

- FIGURE SHOWS RESULTS FROM A HYDRAULIC MODEL FOR AN ASSUMED 30 m WIDE DIKE BREACH DURING AN EXTREME FLOOD EVENT ON THE KICKING HORSE RIVER, WHERE THE WATER LEVEL IS 0.6 m ABOVE THE 1:200-YEAR FLOOD (I.E., THE FREEBOARD LEVEL).
- FIGURES MUST BE USED IN CONJUNCTION WITH THE ATTACHED REPORT AND ARE SUBJECT TO THE LIMITATIONS AND CONDITIONS STATED IN THE REPORT.

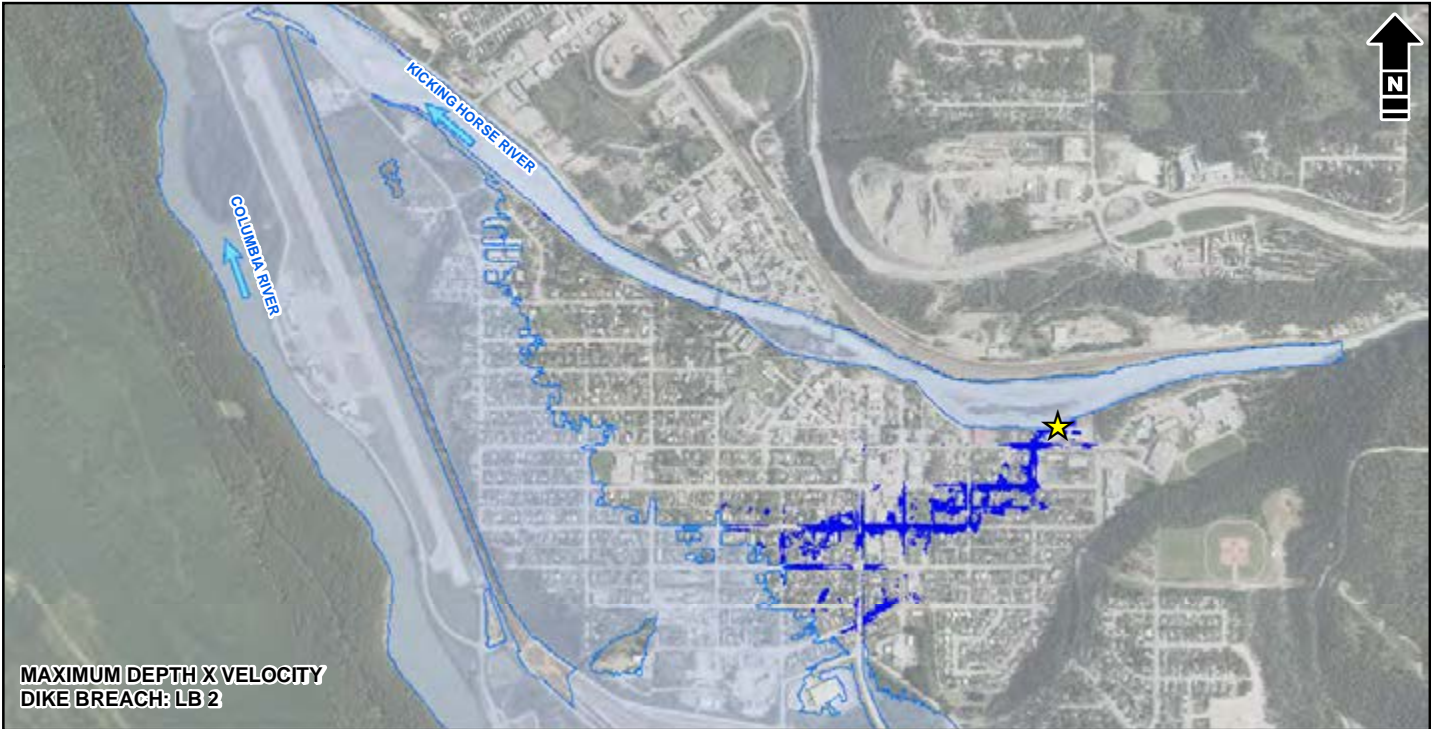
- ★ SIMULATED DIKE BREACH LOCATION
- 1:200 YEAR FLOOD EXTENTS (INCLUDING 0.6 m FREEBOARD)
- FLOW DIRECTION

**NOTES:**  
1. FIGURE SHOWS RESULTS FROM A HYDRAULIC MODEL FOR AN ASSUMED 30 m WIDE DIKE BREACH DURING AN EXTREME FLOOD EVENT ON THE KICKING HORSE RIVER, WHERE THE WATER LEVEL IS 0.6 m ABOVE THE 1:200-YEAR FLOOD (I.E., THE FREEBOARD LEVEL).  
2. FIGURES MUST BE USED IN CONJUNCTION WITH THE ATTACHED REPORT AND ARE SUBJECT TO THE LIMITATIONS AND CONDITIONS STATED IN THE REPORT.

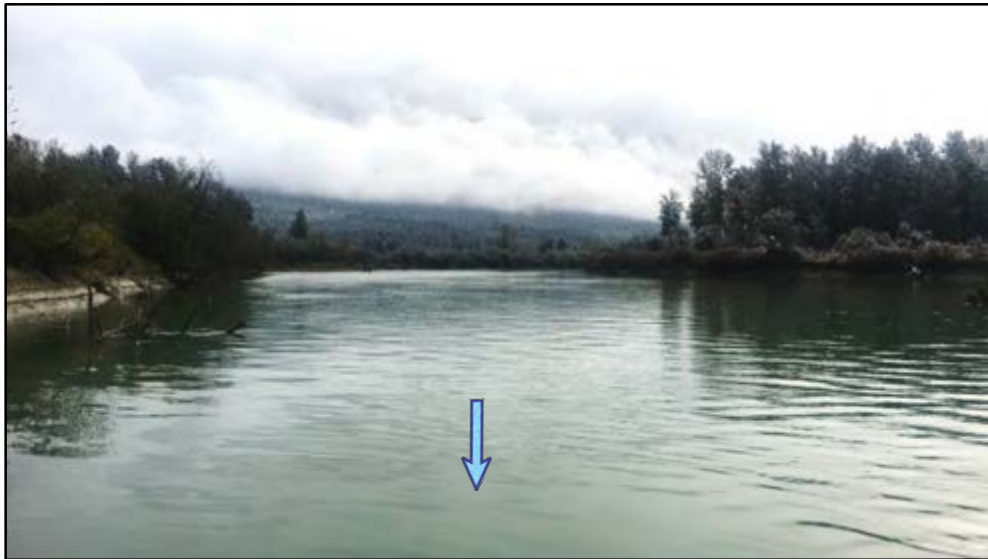
Photo 2 - September 30, 2019 (8+000): Near upstream end of Town. Channel and banks are well defined.

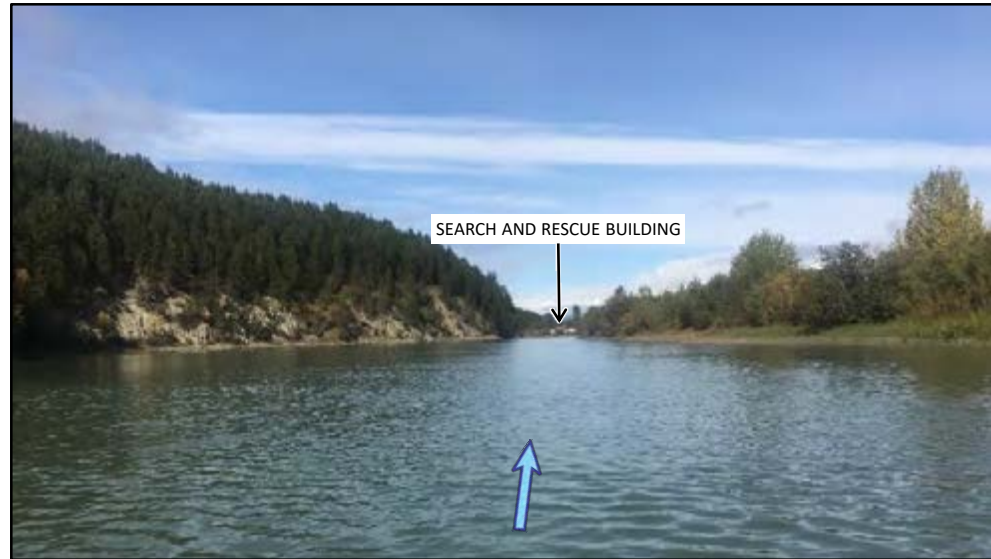
Photo 3 - September 30, 2019 (6+300): Near the municipal wastewater facility. Golden search and rescue building visible in background. Note the steep left bank.

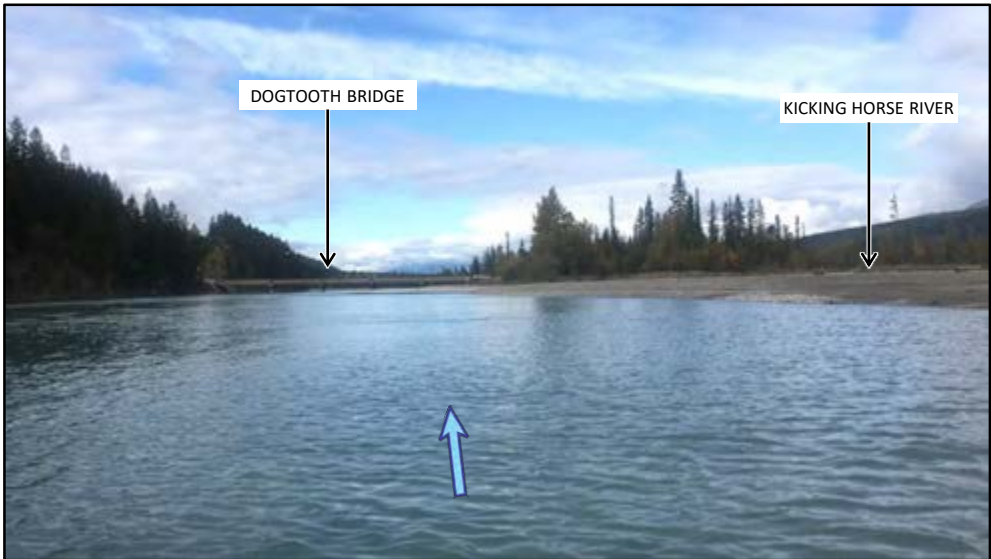
Photo 4 - September 30, 2019 (4+300): Upstream of the confluence of Columbia and Kicking Horse Rivers.

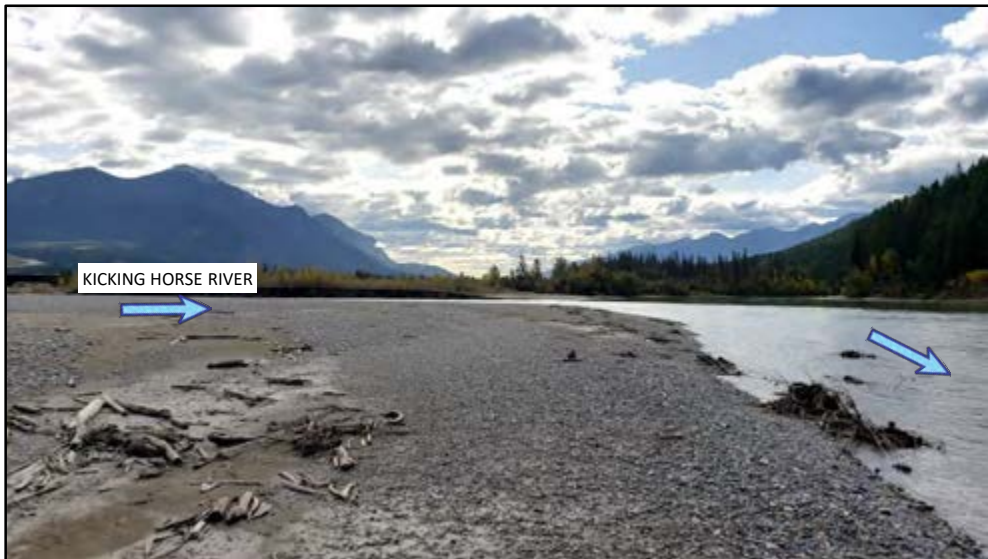
Photo 5 - September 30, 2019 (3+700): Downstream of the confluence of Columbia and Kicking Horse Rivers at the upstream end of a large gravel bar.

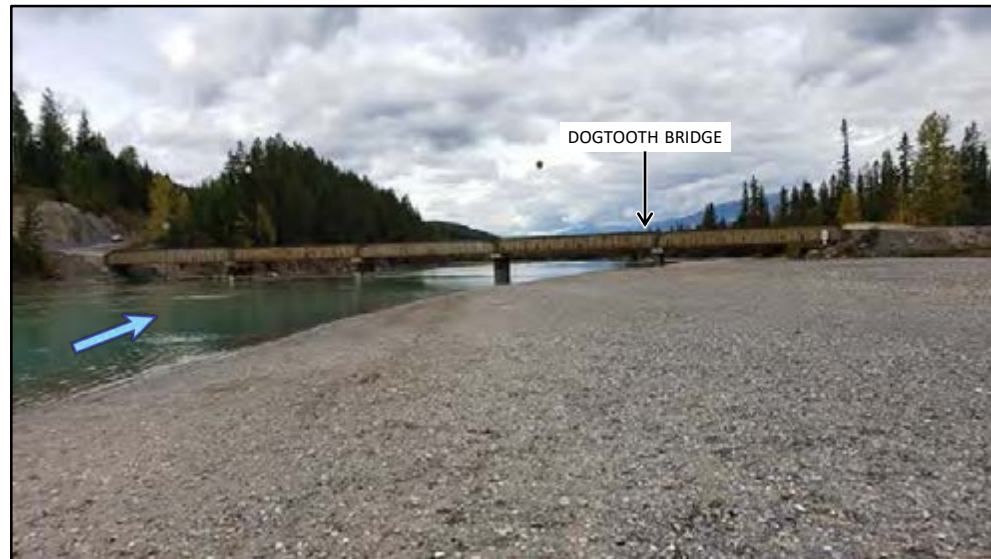
Photo 6 - September 30, 2019 (3+400): Downstream of the confluence of Columbia and Kicking Horse Rivers. Looking at upstream side of Dogtooth Bridge.

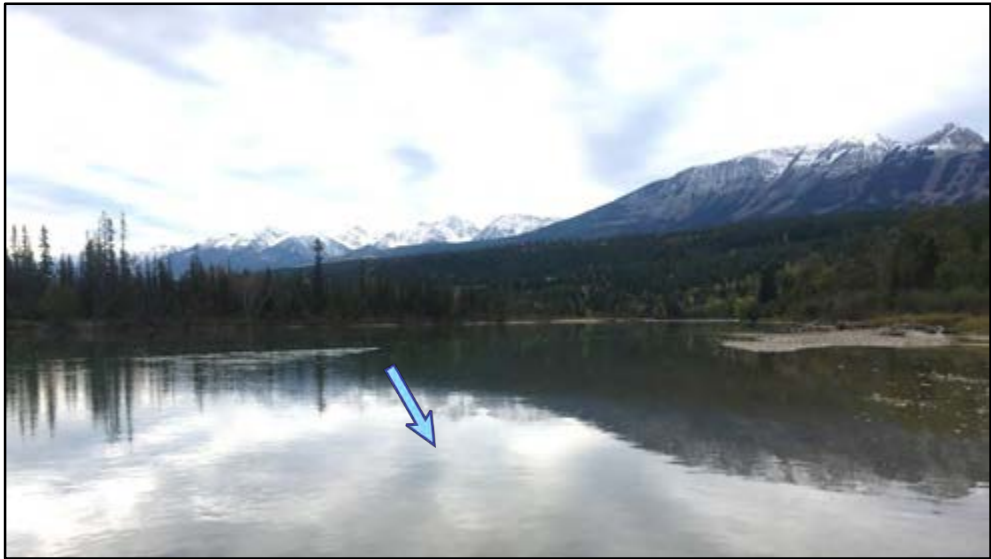
Photo 7 - September 30, 2019 (0+800): Near the downstream study limit. The river splits into multiple sub-channels in this area. (only the main channel is visible in this photo).

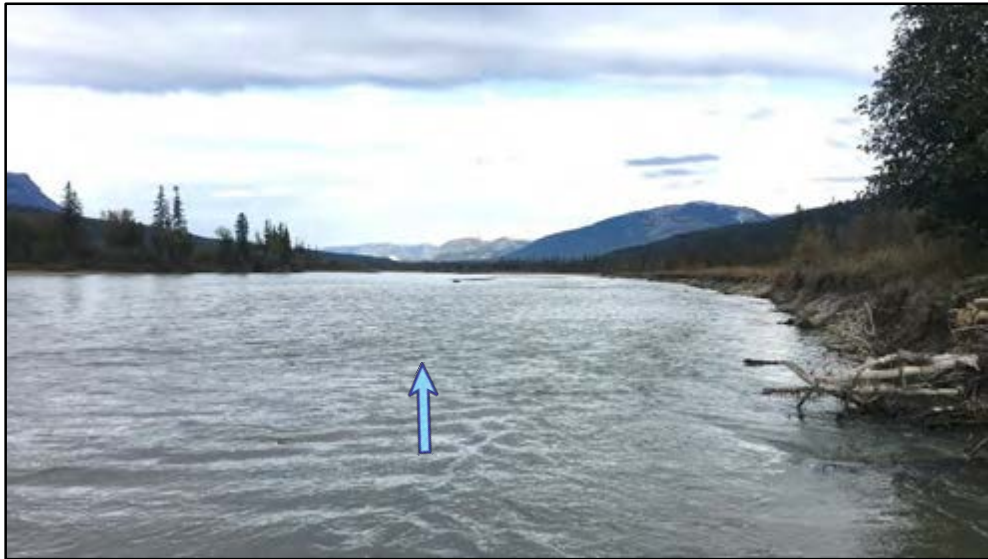
Photo 8 - September 30, 2019 (0+700): Near the downstream study limit. The river splits into multiple sub-channels in this area (only the main channel is visible in this photo).

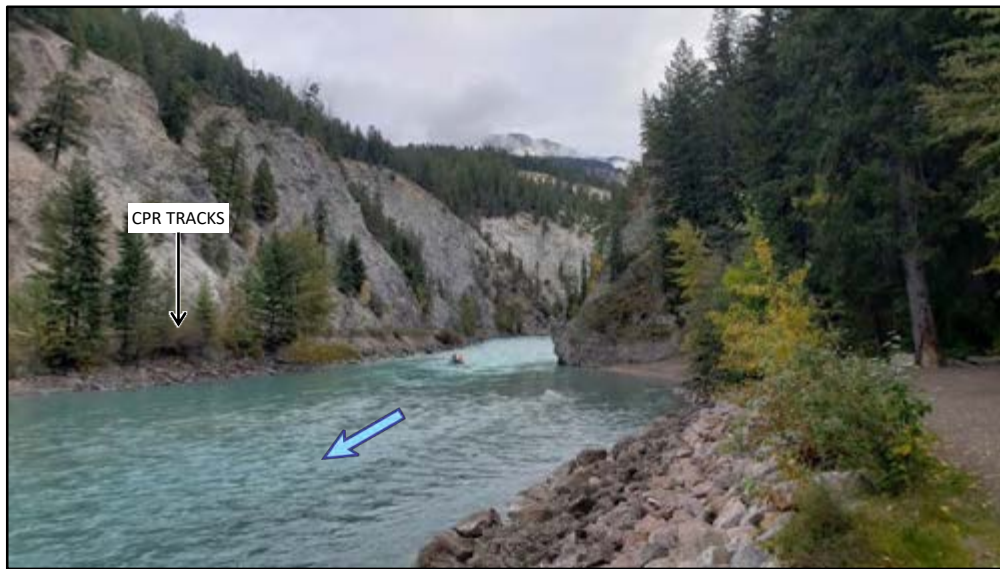
Photo 9 - September 27, 2019 (3+300): Looking at the mouth of canyon taken from the municipal campground. Bathymetry survey conducted from a boat using an Echo Sounder.

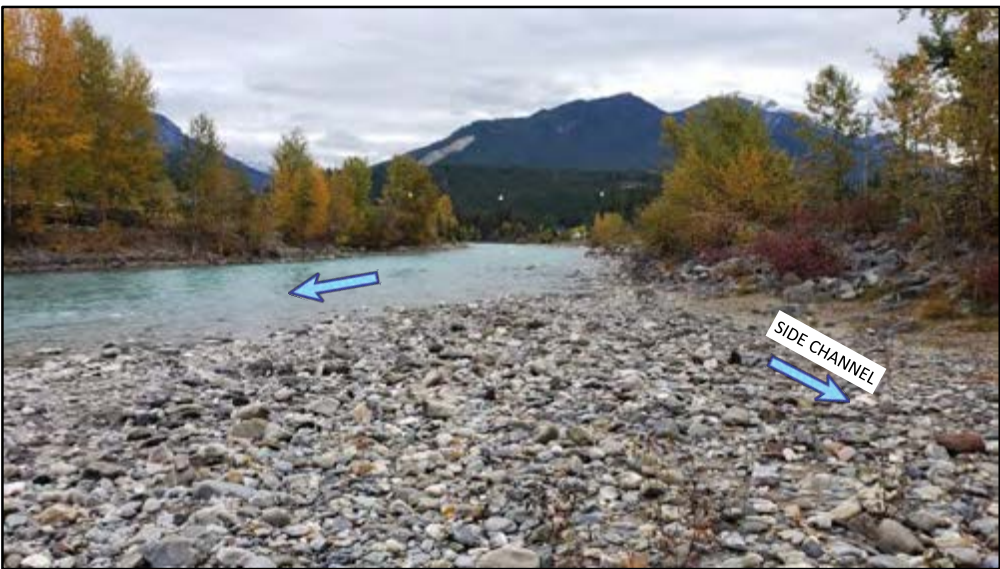
Photo 15 - September 29, 2019 (2+300): Taken from Gould's Island. The side channel was dry during the survey.

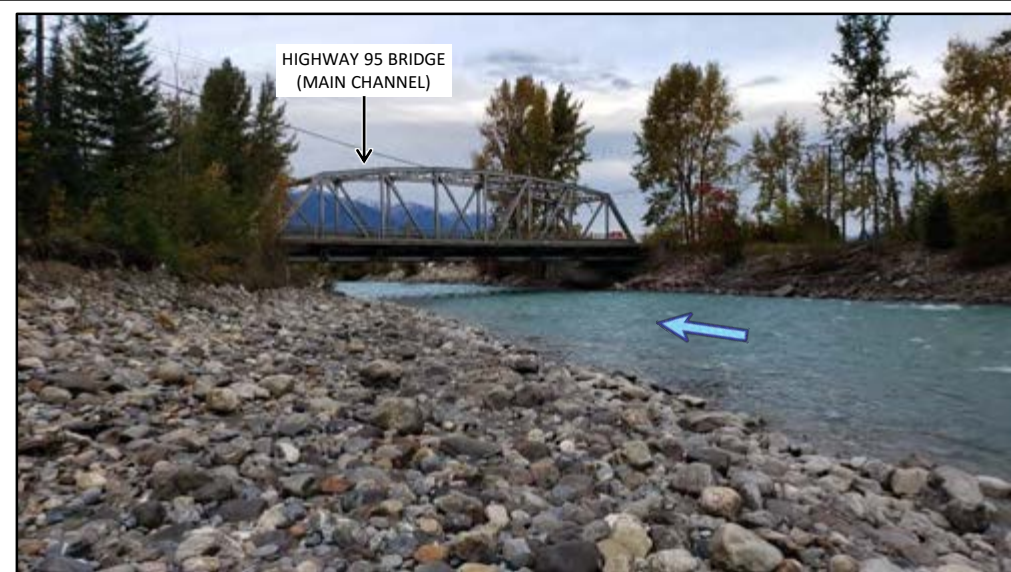
Photo 17 - September 29, 2019 (2+250): Highway 95 Bridges across Gould's Island.

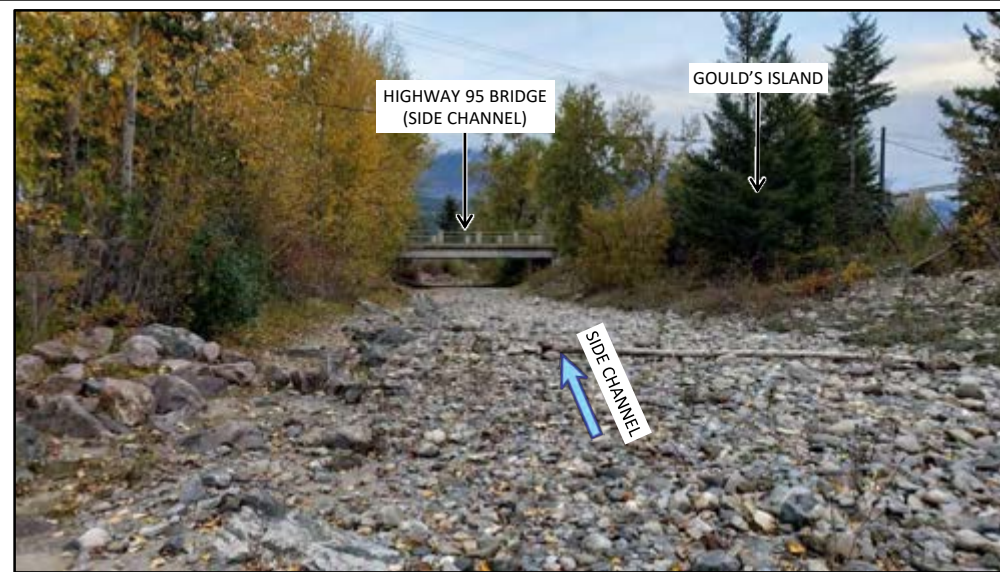
Photo 18 - September 29, 2019 (2+250): Side channel beside Gould's Island.

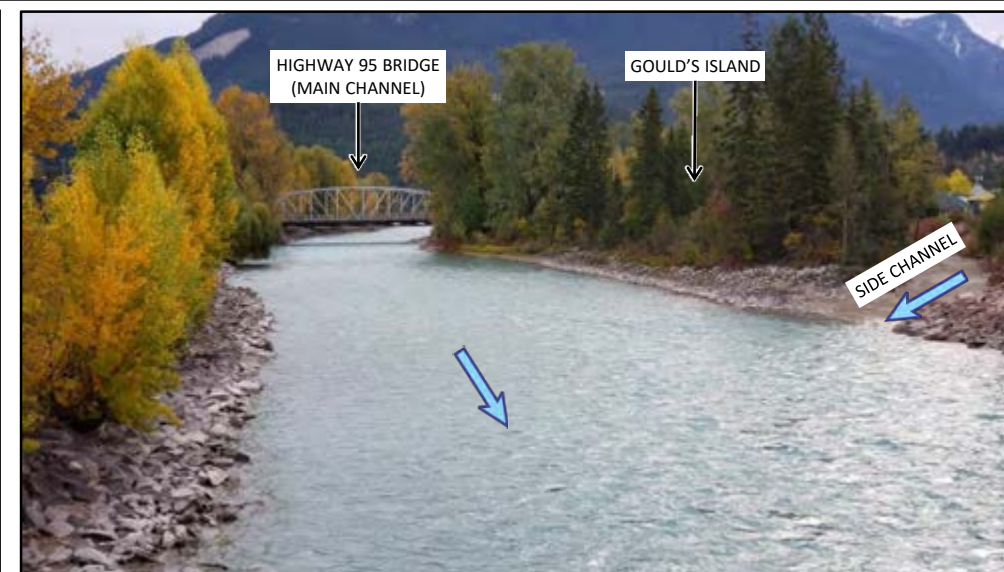
Photo 19 - September 29, 2019 (1+900): Highway 95 Bridges across Gould's Island.

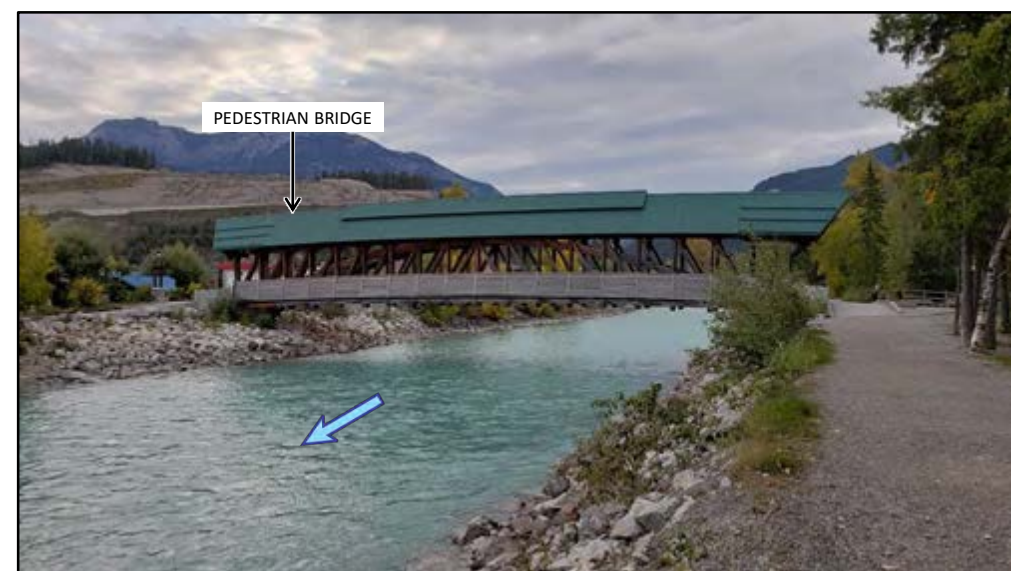
Photo 20 - September 29, 2019 (1+900): Pedestrian bridge.

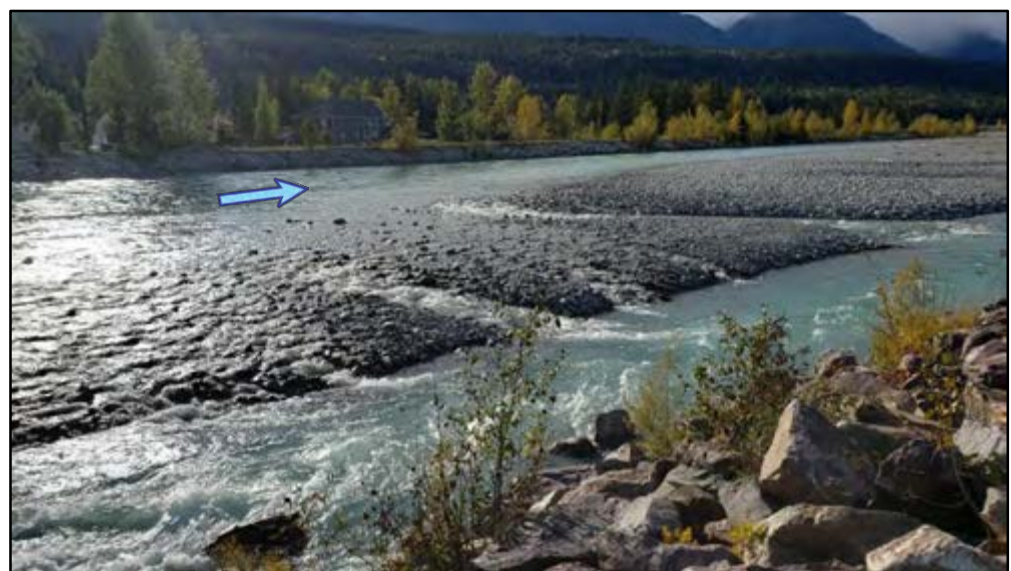
Photo 23 - September 27, 2019 (1+400): Instream gravel bars.

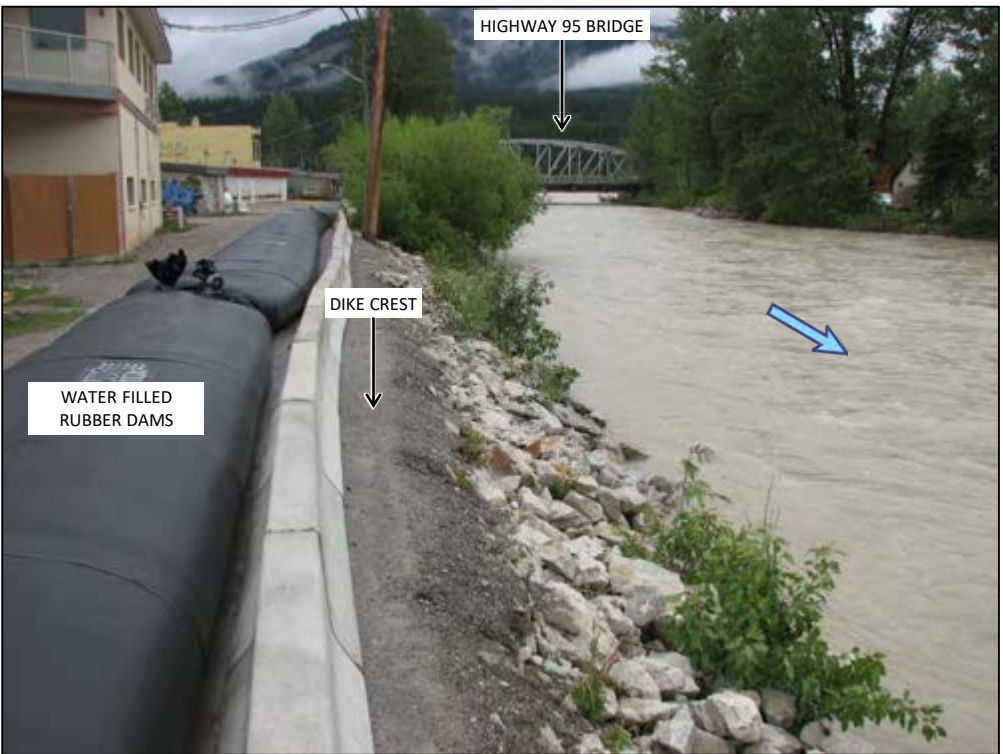
Photo 28 - June 9, 2012 (2+100): Flood of 2012 (highest since 2007). Peak flow of 352 m<sup>3</sup>/s was reported by the Water Survey of Canada, which occurred about 3 days before photo was taken (June 6). The Town installed barriers and water filled rubber dams to mitigate potential flooding of the historical downtown. Peak water level compared to the dike crest was observed by Town staff on June 6 and used to validate the hydraulic model.
