**GOLDEN FLOOD STUDY AND MAPPING  
COLUMBIA RIVER, KICKING HORSE RIVER, AND HOSPITAL CREEK  
TOWN OF GOLDEN, BRITISH COLUMBIA**

Prepared for:  
**THE TOWN OF GOLDEN**

Prepared by:  
**MATRIX SOLUTIONS INC.**

Version 1.0  
March 2020  
Calgary, Alberta

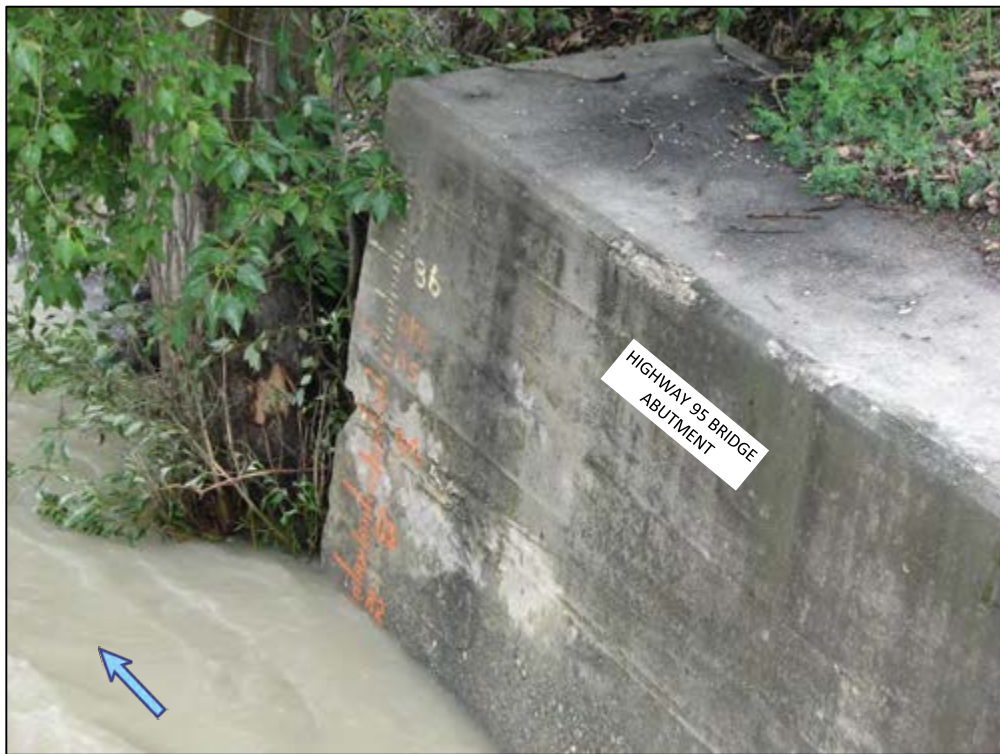
Photo 29 - June 9, 2012 (2+192): Water level at Highway 95 bridge abutment during the flood of 2012 (highest since 2007). Peak water level occurred about 3 days before photo was taken.

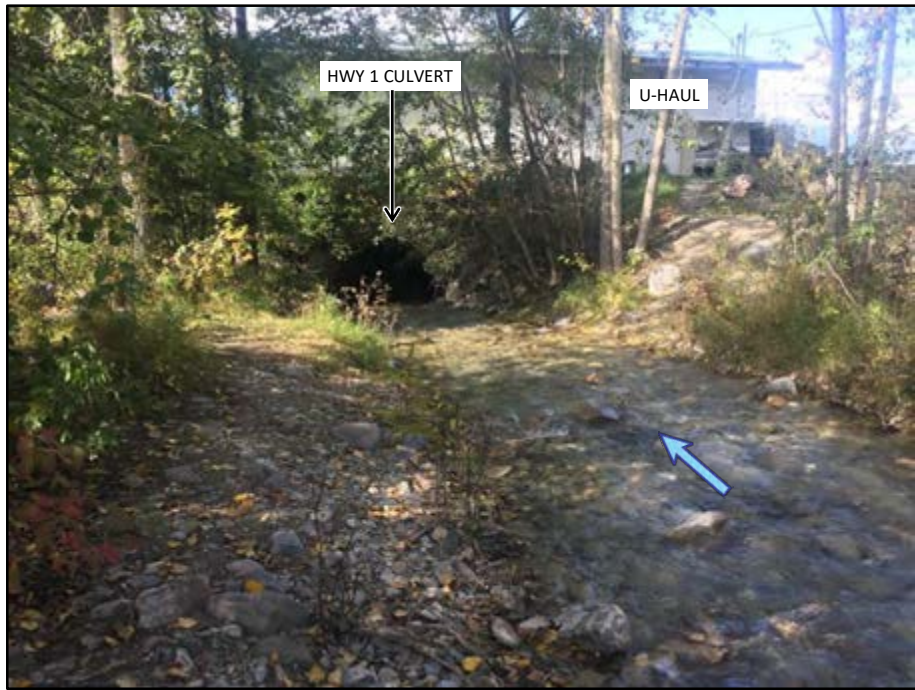
Photo 32 - September 28, 2019: Highway 1 culvert.

- ✦ Three hydraulic structures were included in the model; the Highway 1 arch culvert (2D), the 14 Street North arch culvert (1D), and the Anderson Road bridge (1D). The CPR bridge near the Columbia River was not included as a structure because it is a clear span and has a negligible effect on the 1:200-year flood levels<sup>1</sup>; the CPR bridge and tracks are overtopped by the Columbia River and the vast majority of flow from Hospital Creek is over the tracks. A beaver dam was observed at the CPR bridge (Photograph 44) but was not included in the model. Beaver dams at this location are expected to have negligible effect on the 1:200-year flood level (majority of flow over the tracks) but will increase the flood level during smaller floods which do not overtop the CPR tracks.

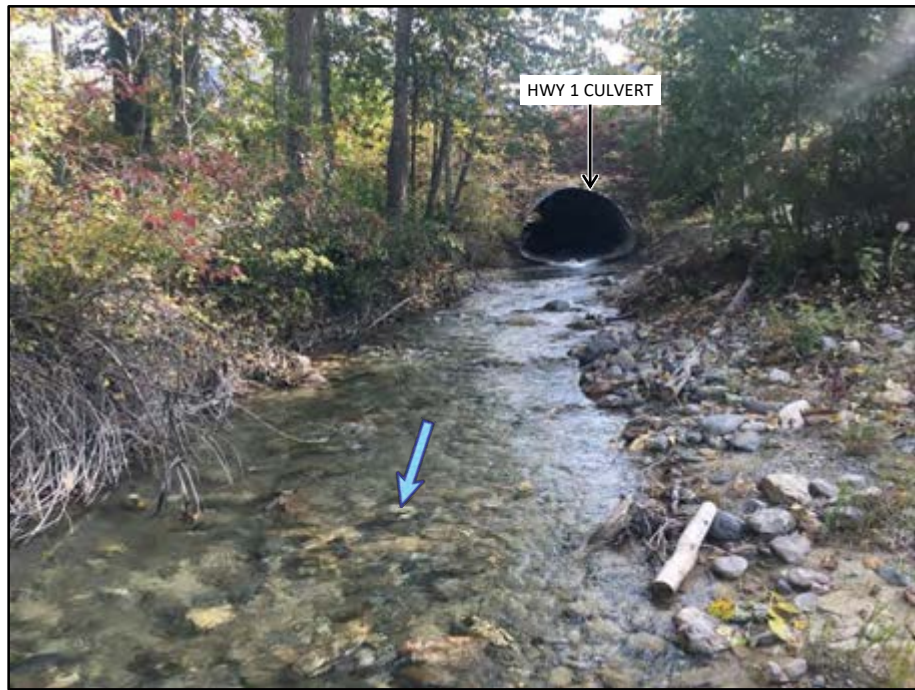
Photo 33 - September 28, 2019: Highway 1 culvert.

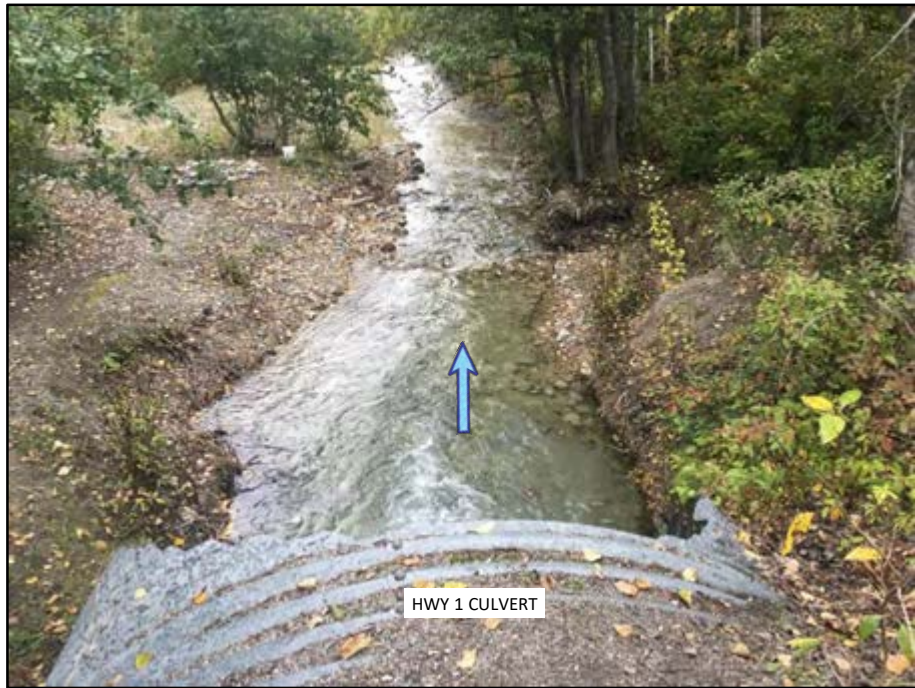
Photo 34 - September 28, 2019: Highway 1 culvert.

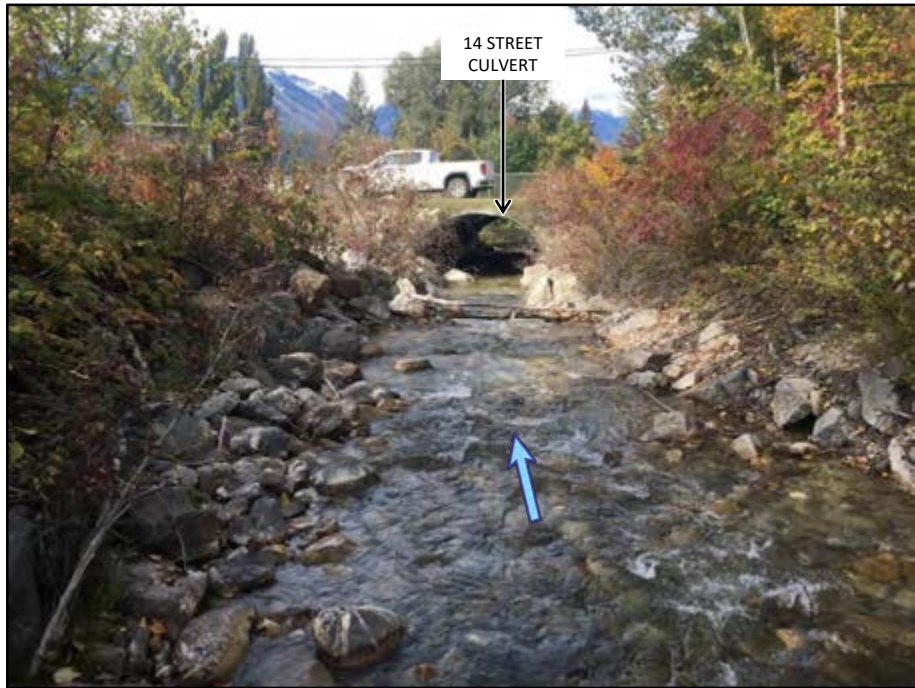
Photo 35 - September 28, 2019: 14 Street culvert.

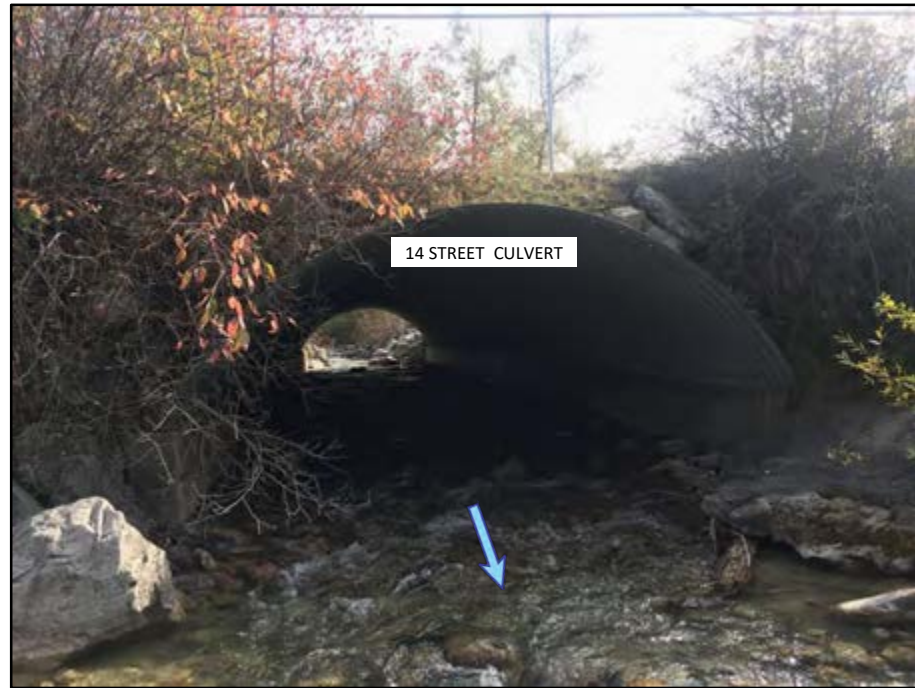
Photo 36 - September 28, 2019: 14 Street culvert.

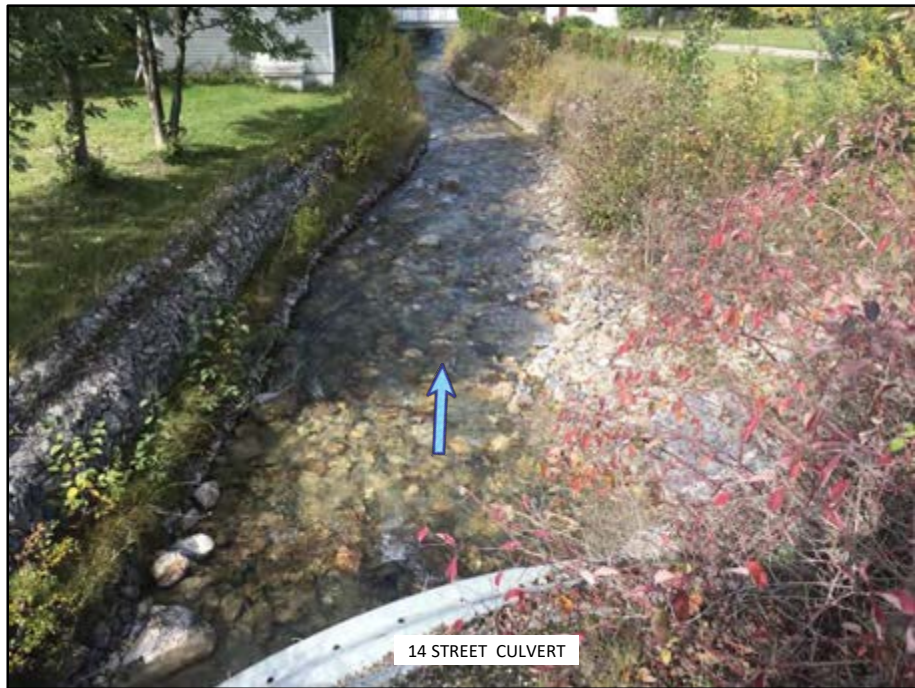
Photo 37 - September 28, 2019: 14 Street culvert.

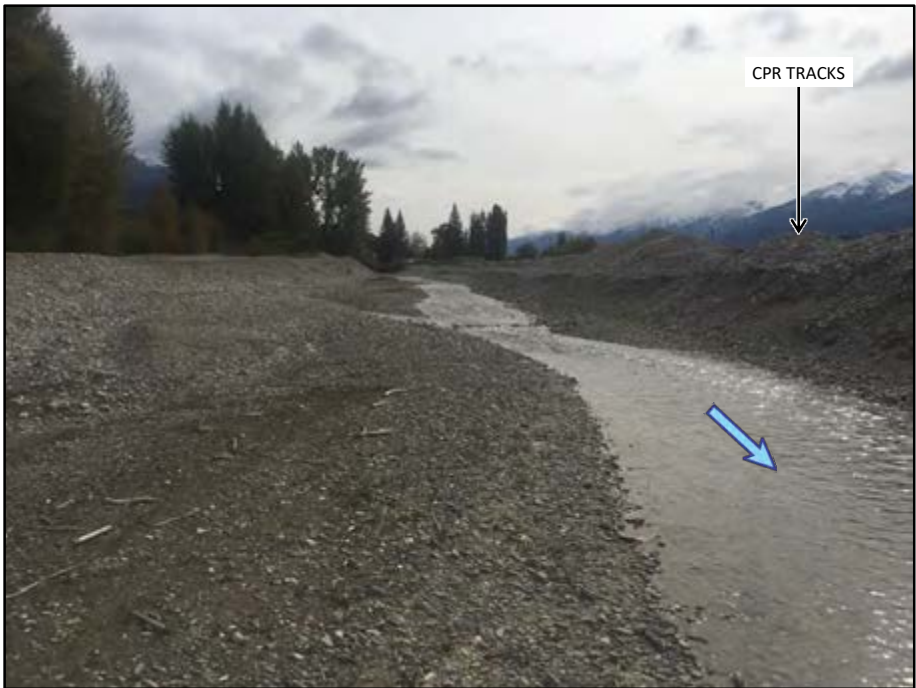
Photo 38 - September 28, 2019: Channel 300 m downstream of 14 Street culvert. In this area, Canadian Pacific Railway has dredged the channel and used the dredged material to construct training berms on both sides of the creek.

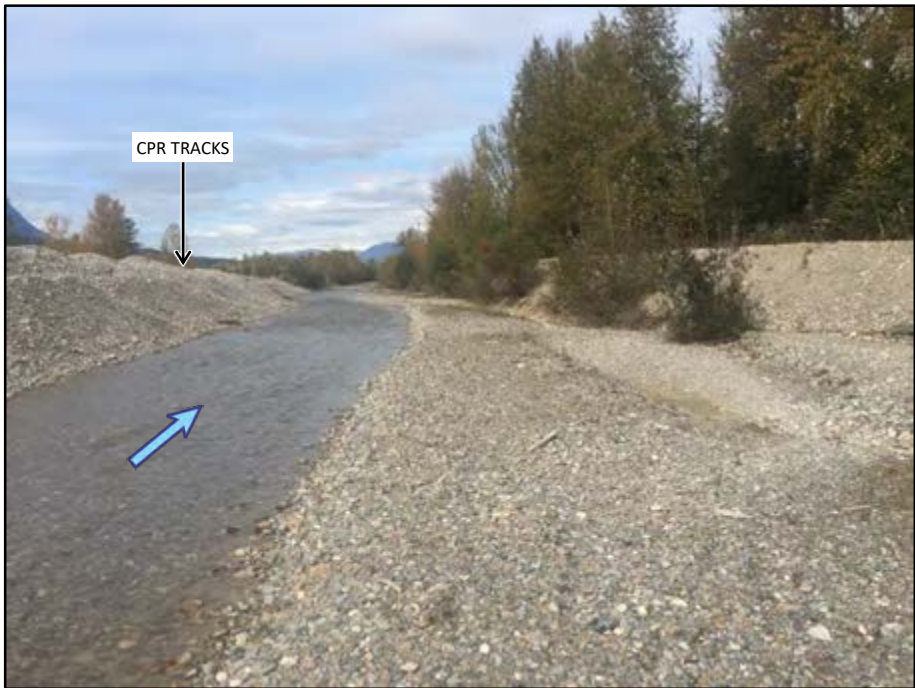
Photo 39 - September 28, 2019: Channel 300 m downstream of 14 Street culvert. In this area, Canadian Pacific Railway has dredged the channel and used to construct training berms on both sides of the creek.

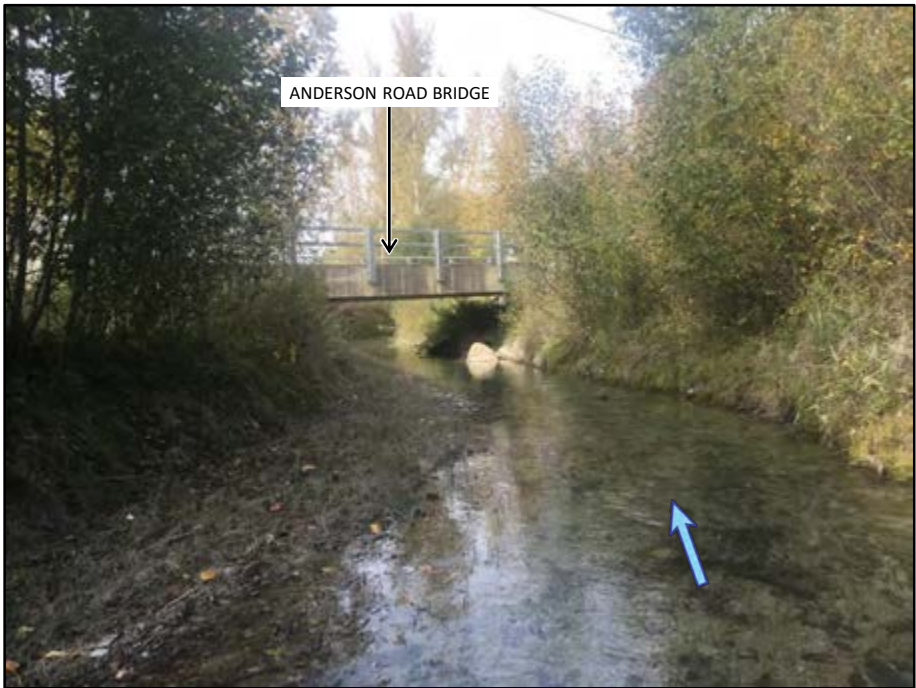
Photo 41 - September 28, 2019: Anderson Road Bridge.

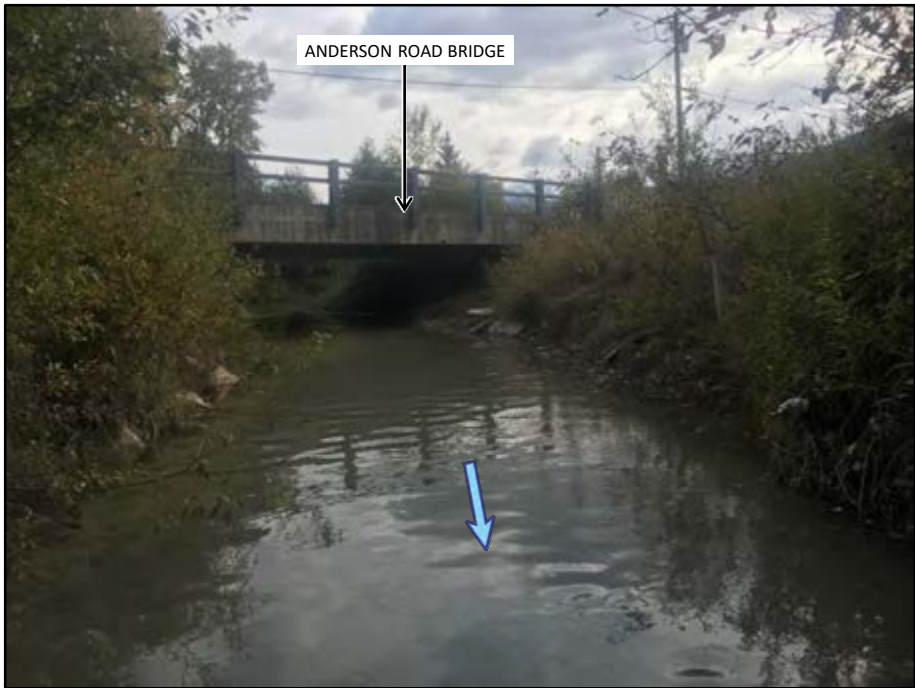
Photo 42 - September 28, 2019: Anderson Road Bridge.

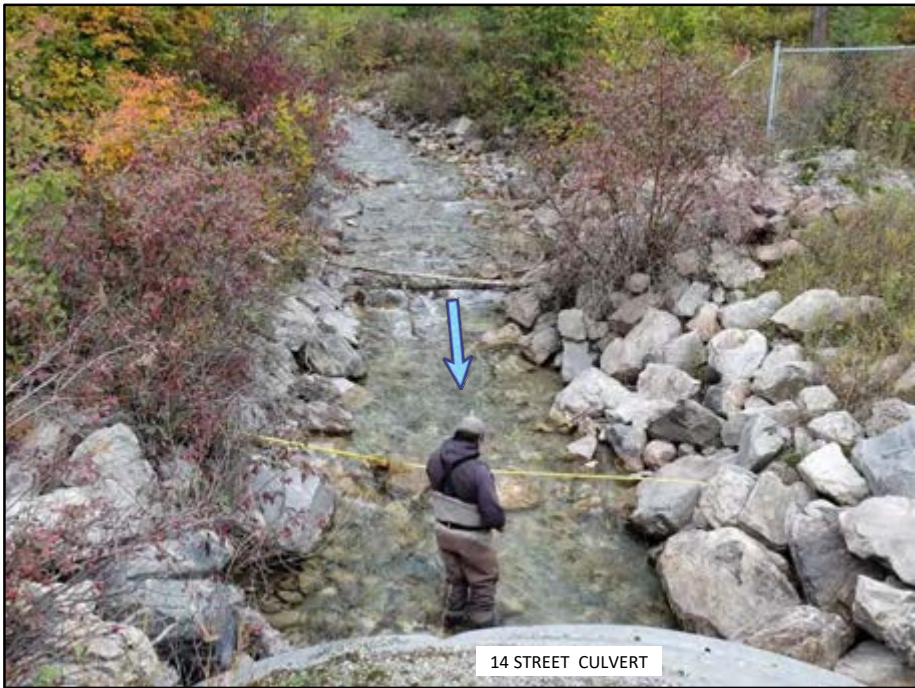
Photo 46 - September 28, 2019: Measuring flow upstream of the 14 Street culvert with an Acoustic Doppler Velocimeter.
