# **NCC Land Stewardship Activities F19**

# FWCP Project No. COL-F19-W-2853-DCA

Nature Conservancy of Canada – BC Region Kate MacKenzie, Stewardship Coordinator, Canadian Rocky Mountains #200 – 825 Broughton Street, Victoria, BC V8W 1E5

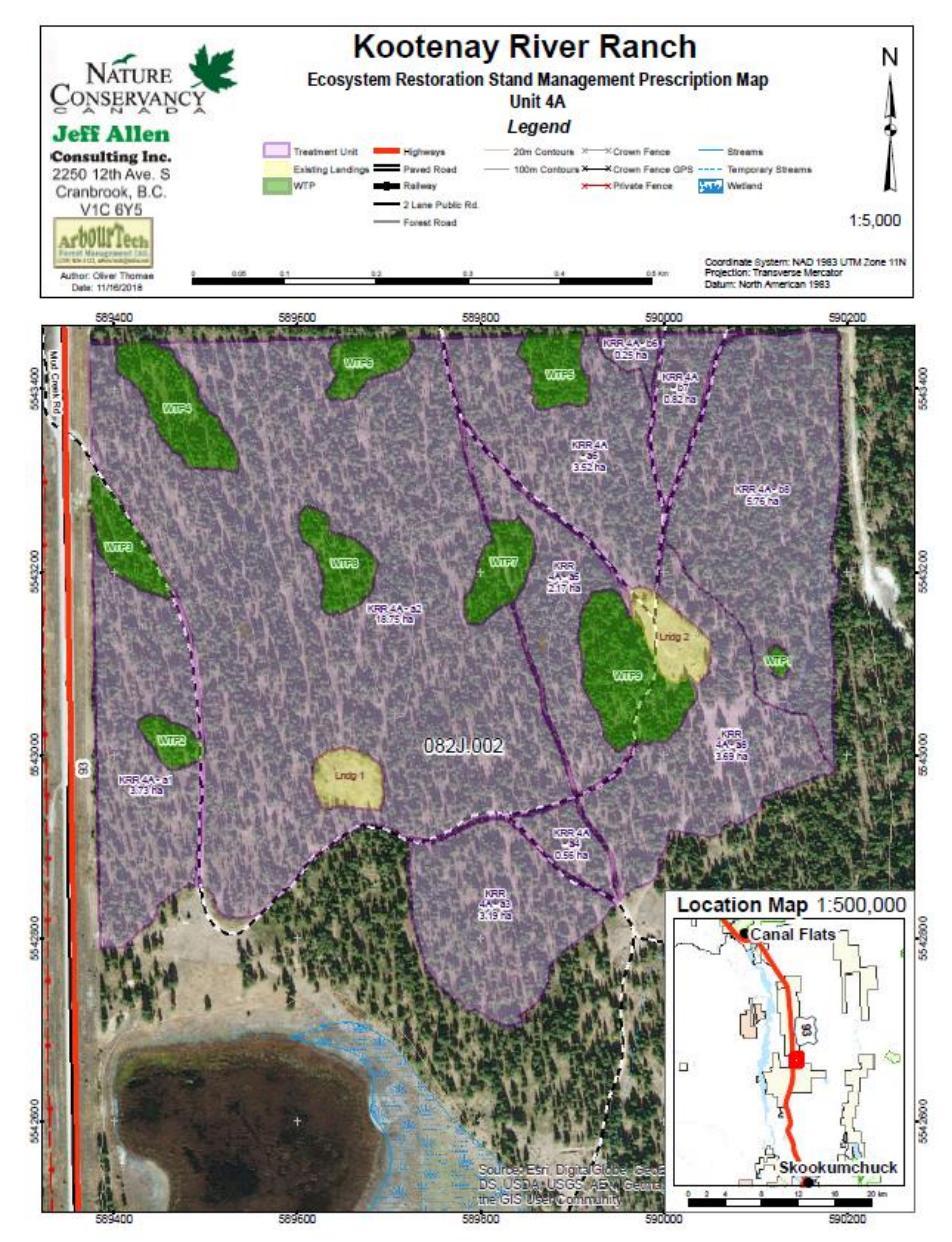
**Figure 3.** Map describing the location of 2018-19 restoration work at Kootenay River Ranch. Treatment units 4A-a and 4A-b are highlighted in purple, and Wildlife Tree Patches to be retained are highlighted in green.

or piled for burning if slash densities exceeded 1 tonne/ha. In the treatment unit overall, stocking will be reduced to approximately 400 layer 1 Douglas-fir/Ponderosa pine leading stems per hectare (sph), with target species including Douglas-fir, Ponderosa pine and Lodgepole pine with stems greater than 0.3 m tall and less than 15 cm dbh. Trees are cut with a maximum stump height of 0.1 m with all live limbs removed, and all deciduous species (e.g. aspen) are retained. The final stocking density will be variable over the treatment unit, as small patches of high crown closure areas identified as Wildlife Tree Patches will be retained in order to maintain diverse forest structure on the landscape (Figure 3).

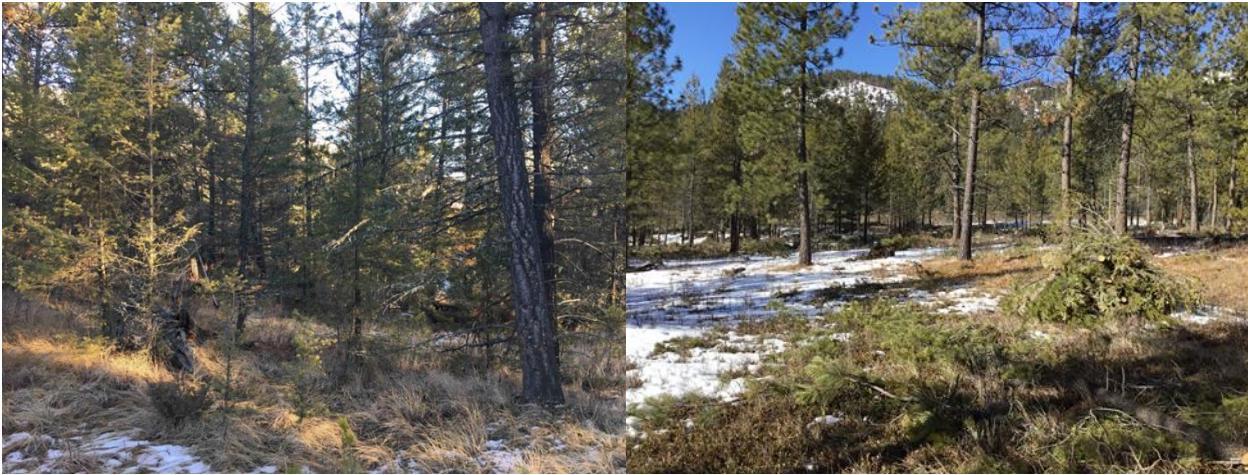
a. Pre-treatment conifer in-growth in treatment unit 4A-a on Kootenay River Ranch.

b. Completed slashing in a portion of treatment unit 4A-a.

Figure 4. Before and after treatment photos of unit 4A-a and 4A-b at Kootenay River Ranch.

Strategic Fire Control Ltd. was hired to complete restoration work on approximately 32 ha (treatment unit 4A-a). Treatment is being completed through the use of chainsaws, and slash is either scattered

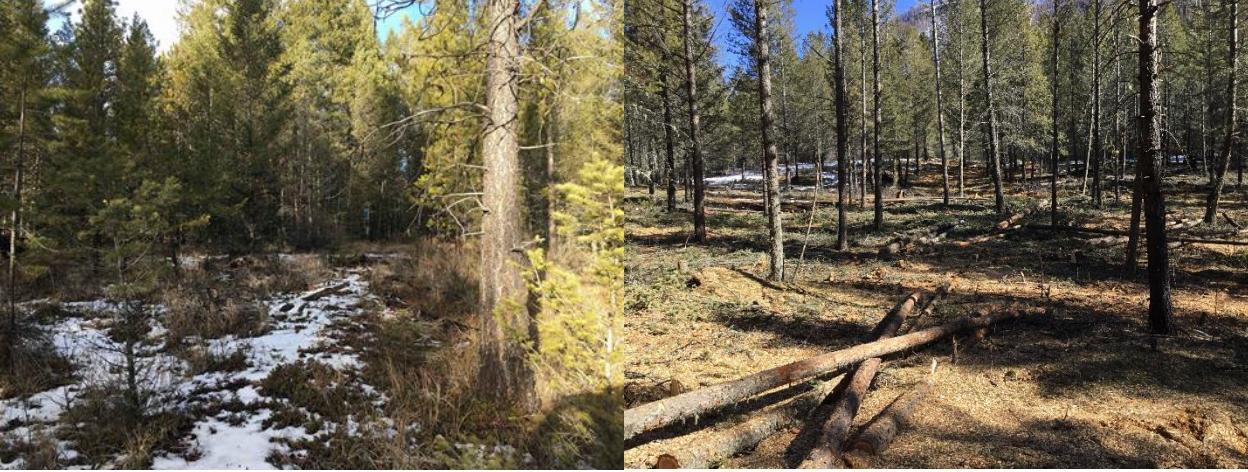
c. Pre-treatment conifer in-growth in the high density treatment unit 4A-b.

d. Completed slashing/chipping in the high density treatment unit 4A-b.

Summit Valley Contracting Ltd. was hired to complete restoration work on 5.5 ha within treatment unit 4A-b. While the prescription was the same as for 4A-a, it was anticipated that the slash loading would be much higher in this unit. In order to avoid excessive fuel loading from scattered slash, specialized equipment is being used to chip excess material as well as to prepare larger logs for use off-site as pulp. See Figure 4 for pre- and post-treatment images for both treatment units.

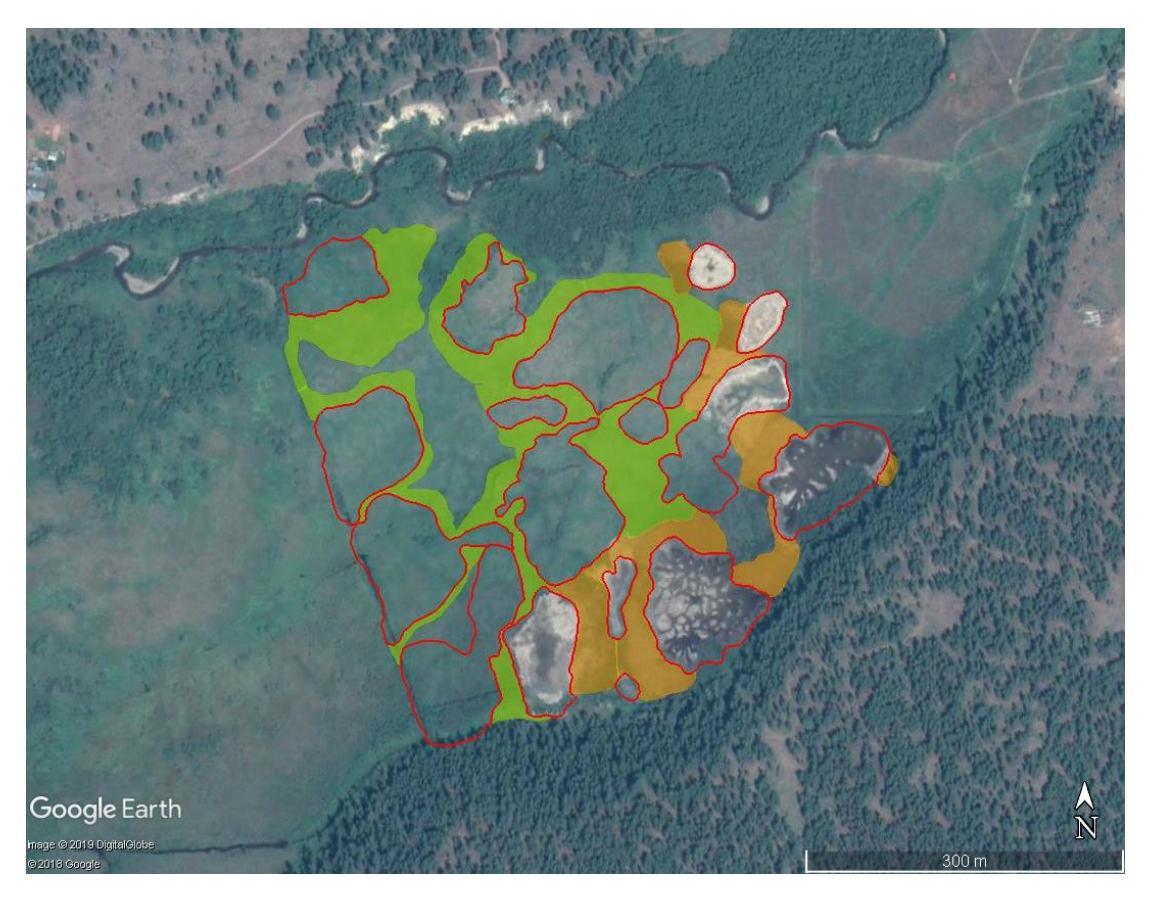
Figure 6. Map showing outline of restored wetlands (red), and associated restored upland areas (2017 areas in orange and 2018 areas in green).

In 2018, restoration work built on the efforts of the previous year, and Fiorentino Brothers Contracting was hired again to continue earthmoving for the final 10 wetland features. See Figure 6 for the location of all 18 of the new wetland features.

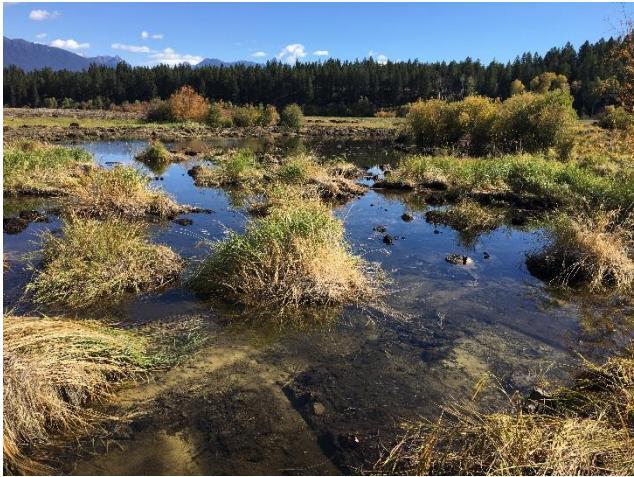
a. Wetlands constructed in 2018 showing diversity of shoreline edges and features such as hummocks.

- The wetlands were built to have naturally appearing, irregular edges which featured peninsulas, points, bays, coves, islands, ridges, and hummocks to provide habitat diversity.

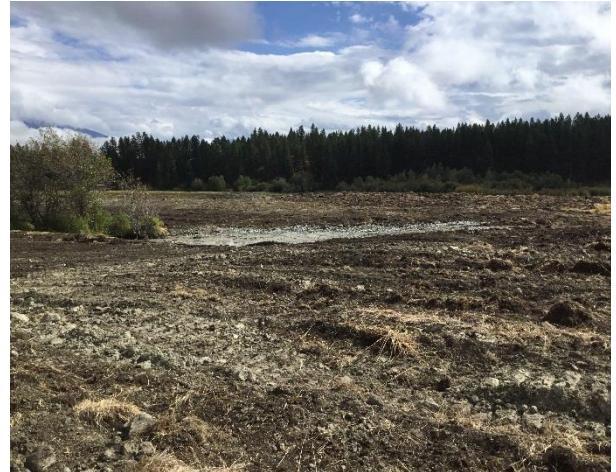
b. Large, shallow-water ephemeral wetland with retained shrubs constructed in 2018.

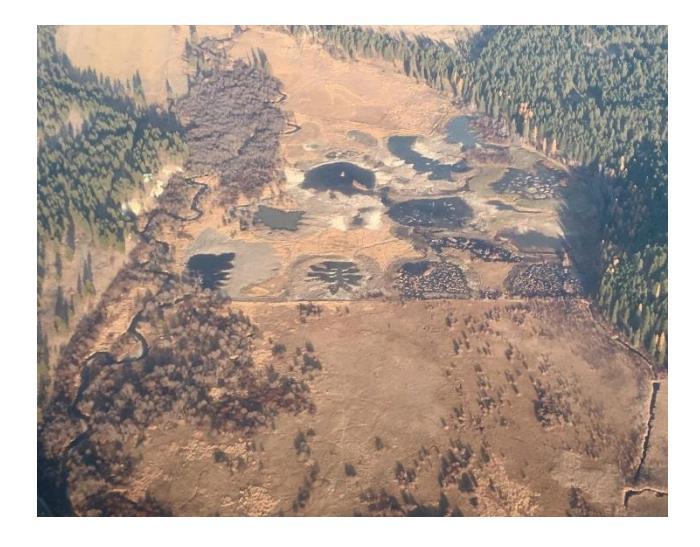
c. Aerial view of all 18 constructed wetlands showing diversity of size, depth, and shape (photo taken in October 2018).

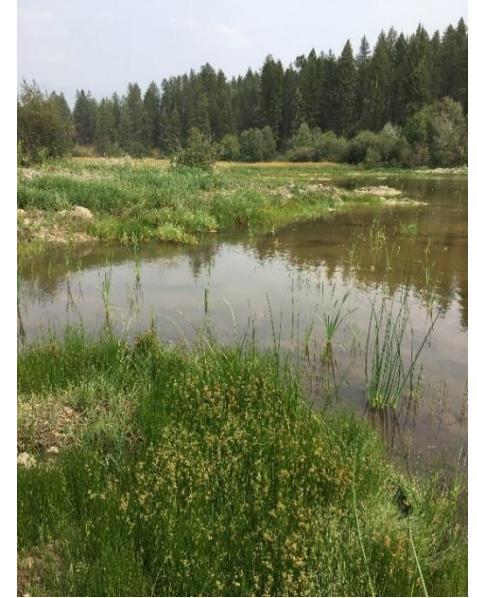
d. Native vegetation establishment after one full growing season in a wetland constructed in 2017.
